Grand Tower Energy Center
Closed CCR Landfill
Quarterly Inspection Form

Date 3/22/22
Time 1100
Name Matt Halley
(Inspector)

Grand Tower Energy Center Q1 2022 Closed CCR Impoundment Cap Inspection

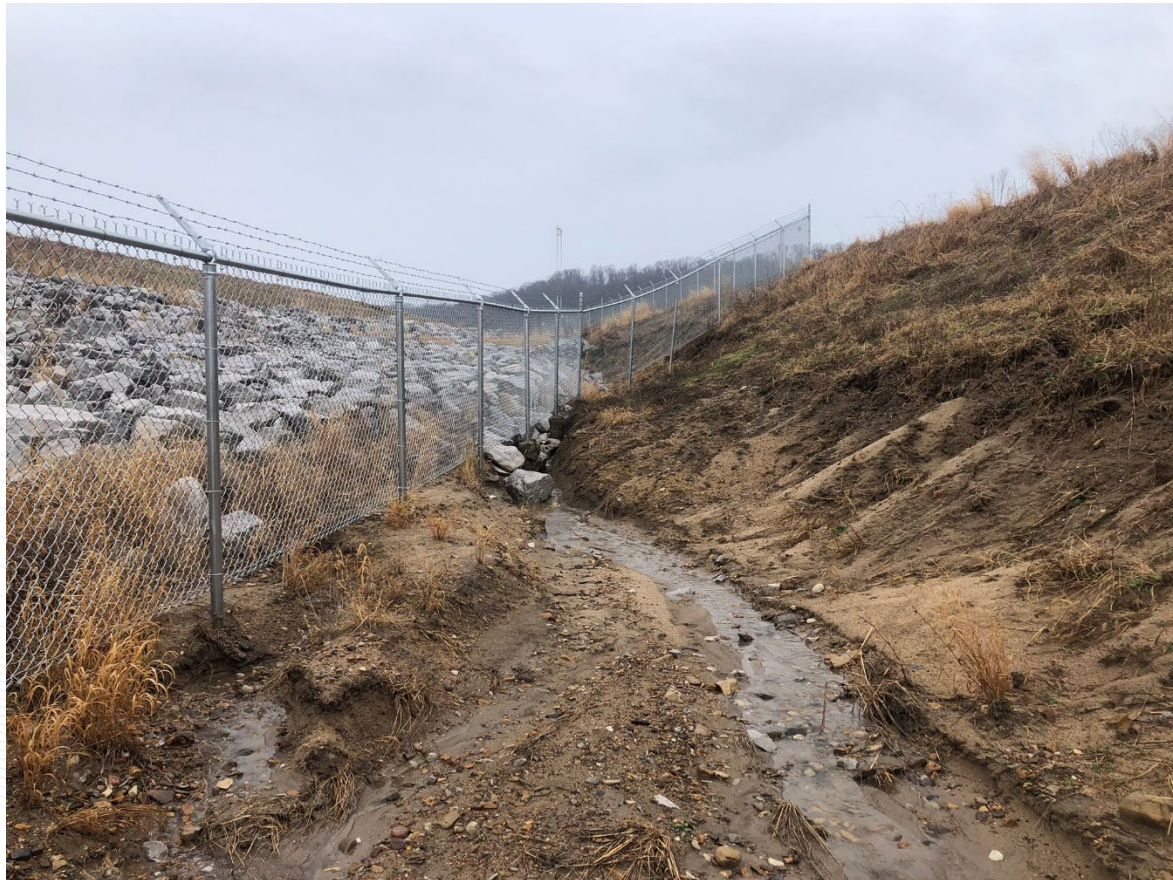
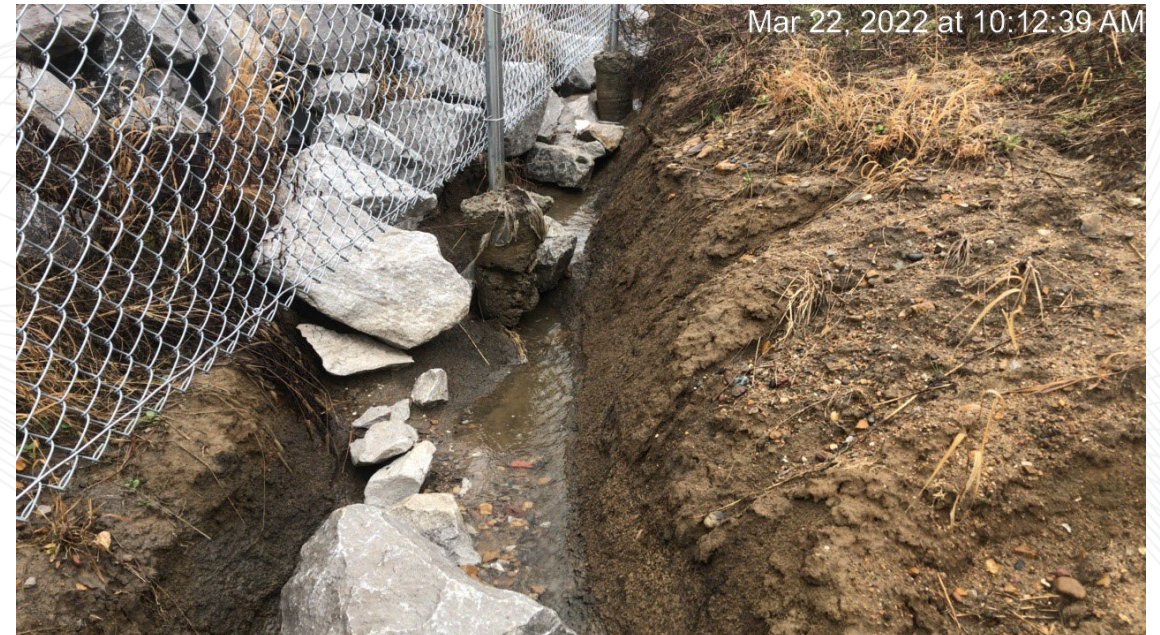
- Erosion and fence undermining noted on east side of CCR impoundment cap (see figure). Ponding noted in

Fence undermining and GTEC levee erosion on SE side of closed CCR impoundment cap.

- Inspector recommends addressing erosion and fence undermining on east side of the site by adding soil

and riprap around undermined fencing and on the eroded face of GTEC levee as determined by qualified

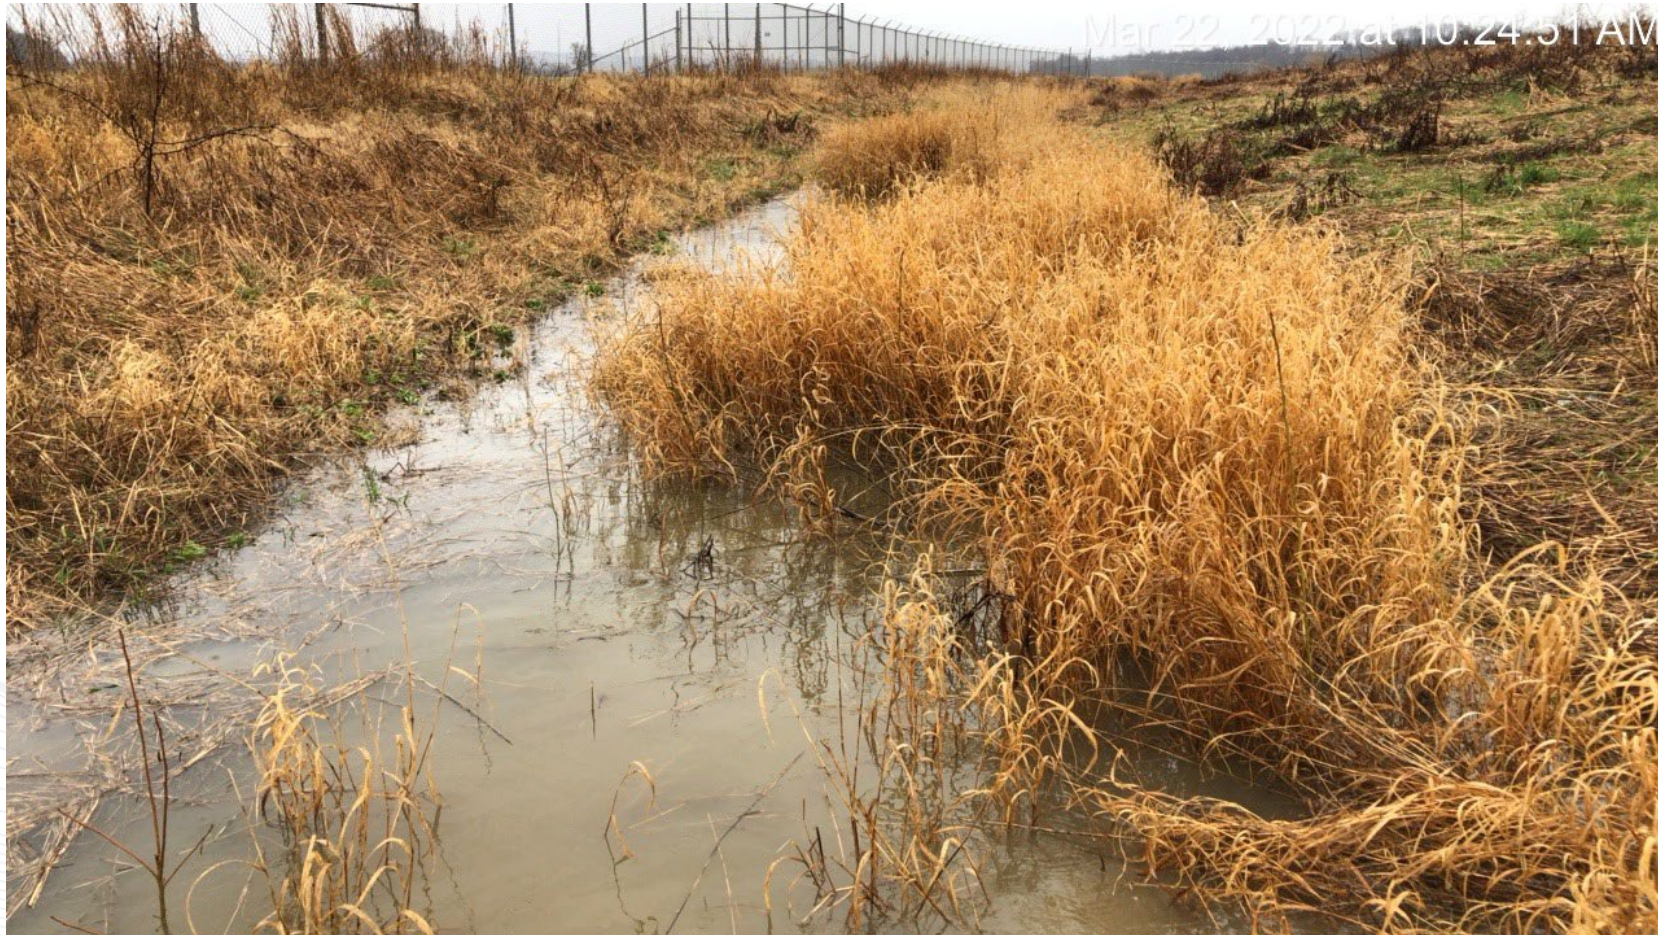
NE area along GTEC levee. Limited area of erosion noted on NE side of CCR impoundment cap. No woody

Ponding on NE side of closed CCR impoundment cap along GTEC levee (looking south).

accordance with applicable regulations, and backfill or grading to address ponding on NE side of site.

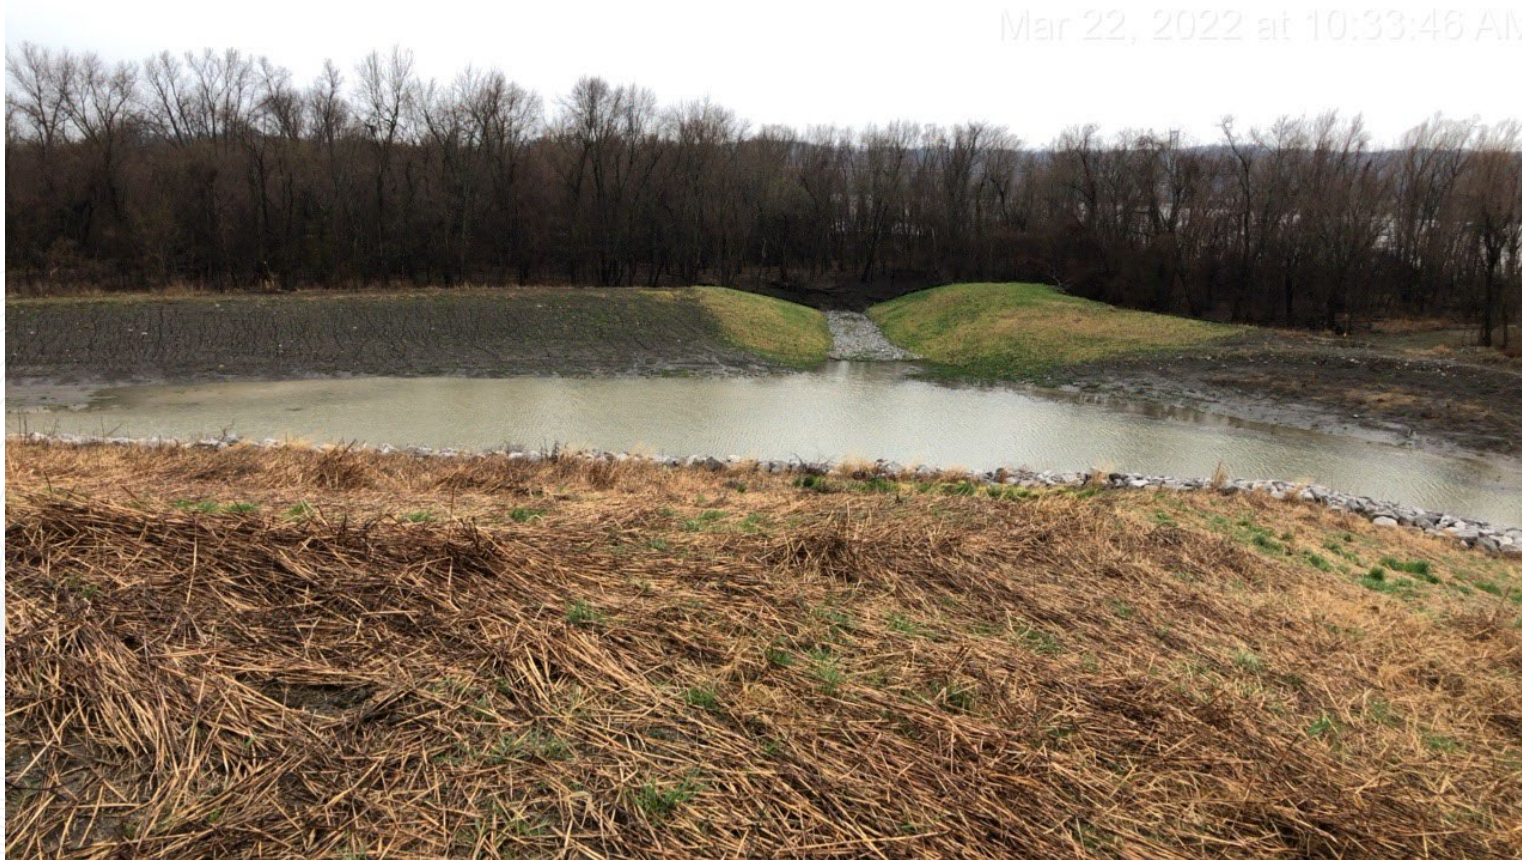
up to 6" deep. Ponding noted in basin at the SW corner of site. CCR impoundment cap liner remains intact.

Ponding in SW corner of site at drainage.

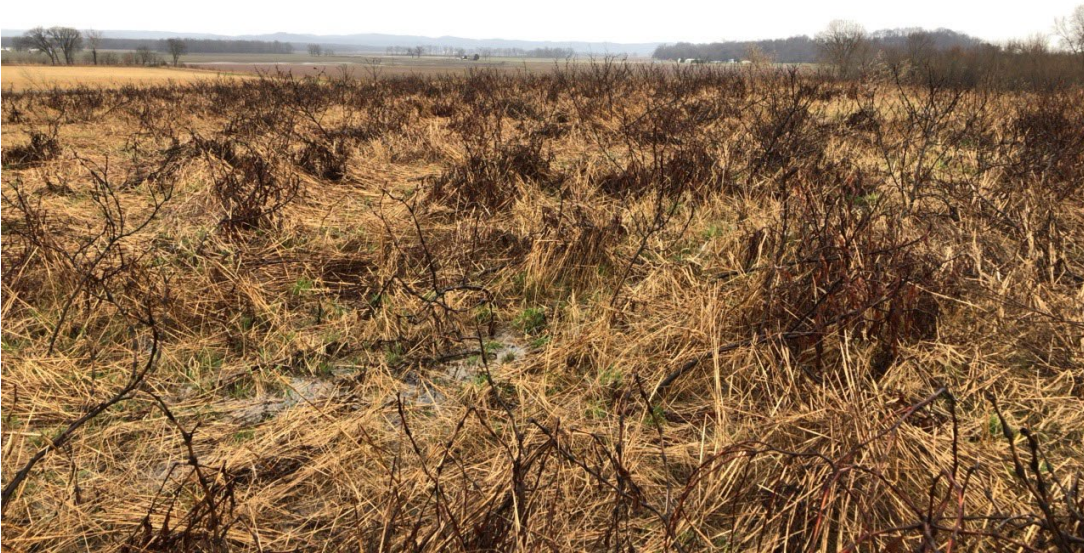
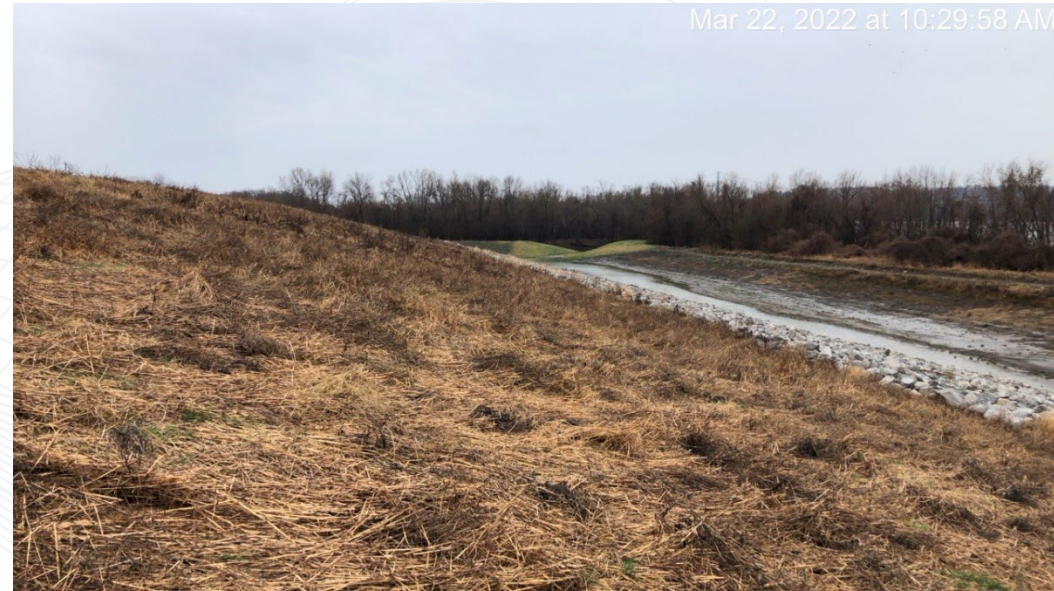
growth noted at this time. Minor erosion noted across north, west, and southern CCR impoundment cap faces

Closed CCR impoundment cap condition looking north from top center and the western face of cap.

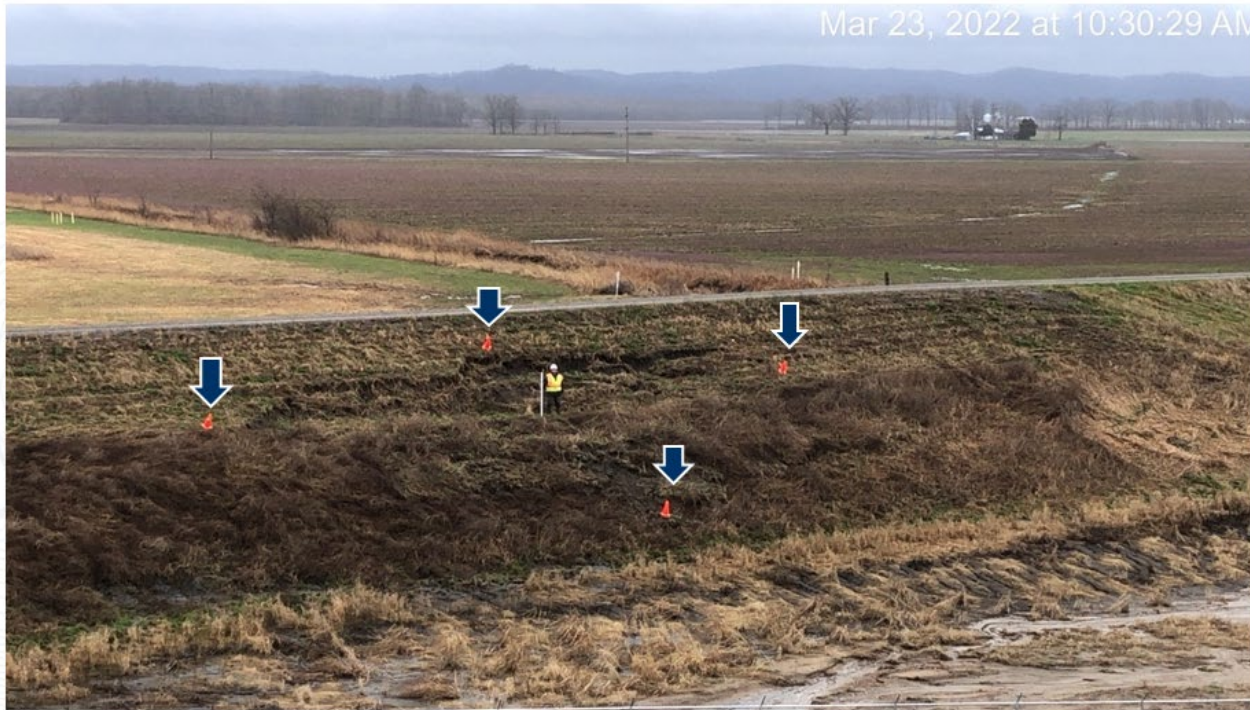
Army Corps of Engineers Levee Slump

Slumping on the COE levee near the SE side of the site was documented (see figure).

Facing east toward COE levee.

personnel. Inspector also recommends repair of the slumped area of the Army Corps of Engineers levee in
