Grand Tower Energy Center Closed CCR Impoundment Quarterly Inspection Form

Grand Tower Energy Center Q4 2022 Closed CCR Impoundment Cap Inspection

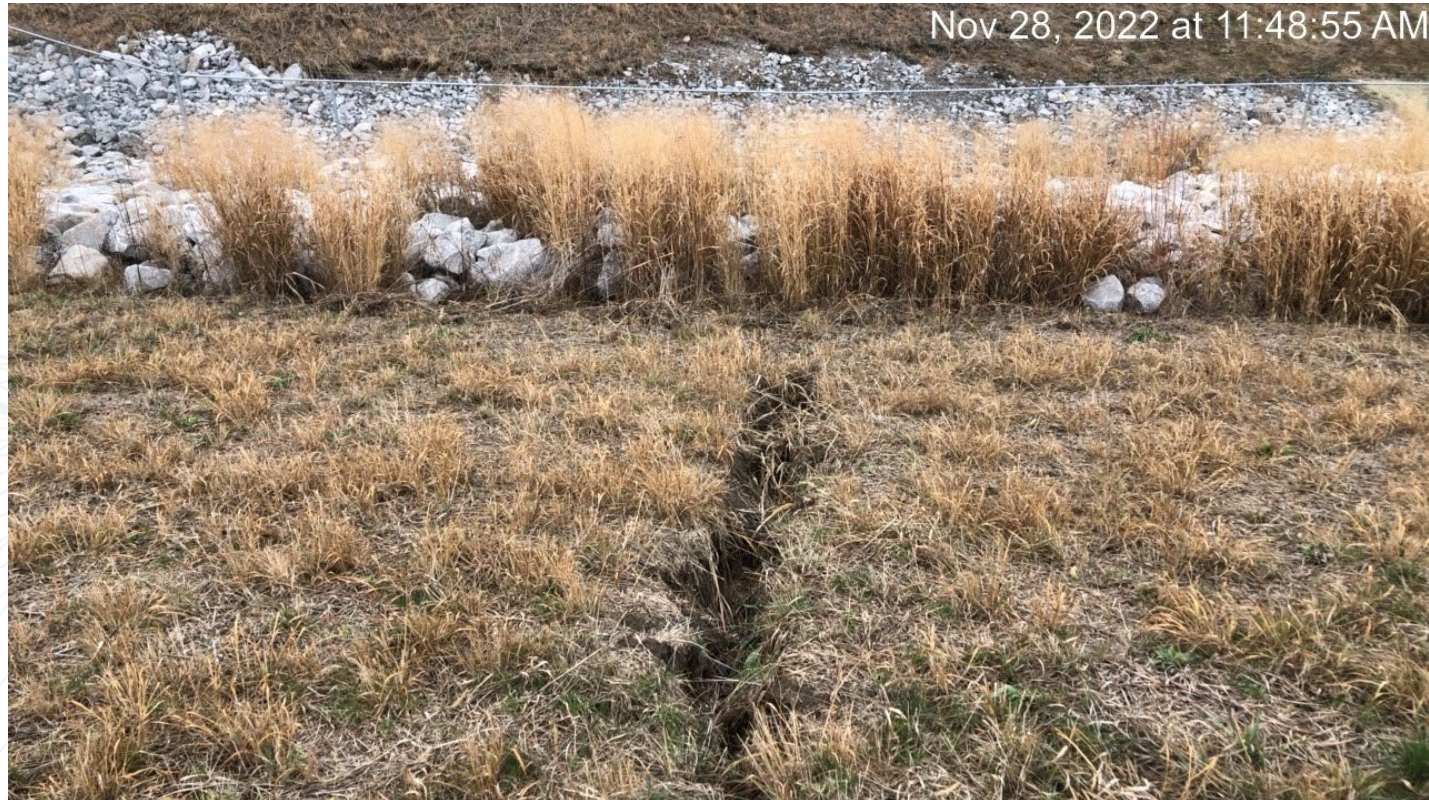
Erosional channel up to 9" deep. Facing east on southeast side of impoundment cap.

- Ponding noted in SW corner of the basin.
- Impoundment cap was mowed during Q3 of 2022 and found to be in generally good condition.
- Inspector recommends removal of woody growth, repair of erosional channels, and re-installing straw matting.
