Rockland Capital, LLC

2022 Grand Tower Energy Center Annual Inspection Report

26 July 2023

Project No.: 0599247

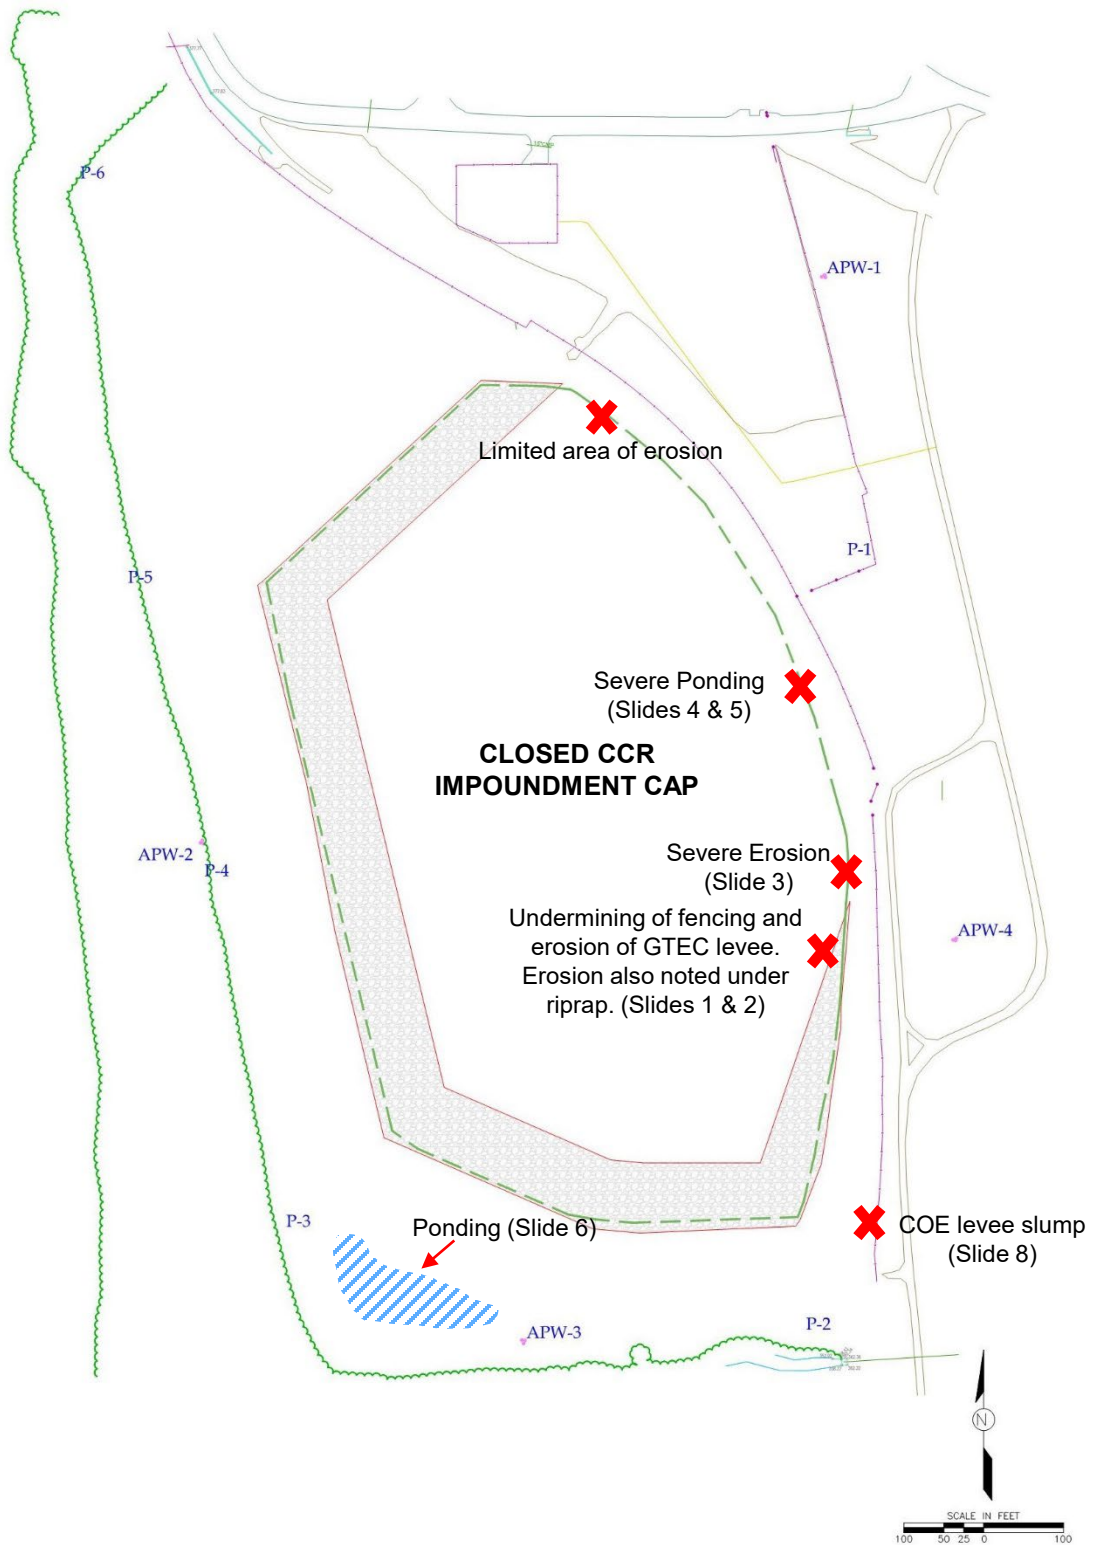
Observation Locations Map

Slumping on the COE levee near the SE side of the site was documented (see figure).

- Erosion and fence undermining noted on east side of CCR impoundment cap (see figure). Ponding noted in

NE area along GTEC levee. Limited area of erosion noted on NE side of CCR impoundment cap. No woody

growth noted at this time. Minor erosion noted across north, west, and southern CCR impoundment cap faces

up to 6" deep. Ponding noted in basin at the SW corner of site. CCR impoundment cap liner remains intact.

- Inspector recommends addressing erosion and fence undermining on east side of the site by adding soil

and riprap around undermined fencing and on the eroded face of GTEC levee as determined by qualified

personnel. Inspector also recommends repair of the slumped area of the Army Corps of Engineers levee in

accordance with applicable regulations, and backfill or grading to address ponding on NE side of site.

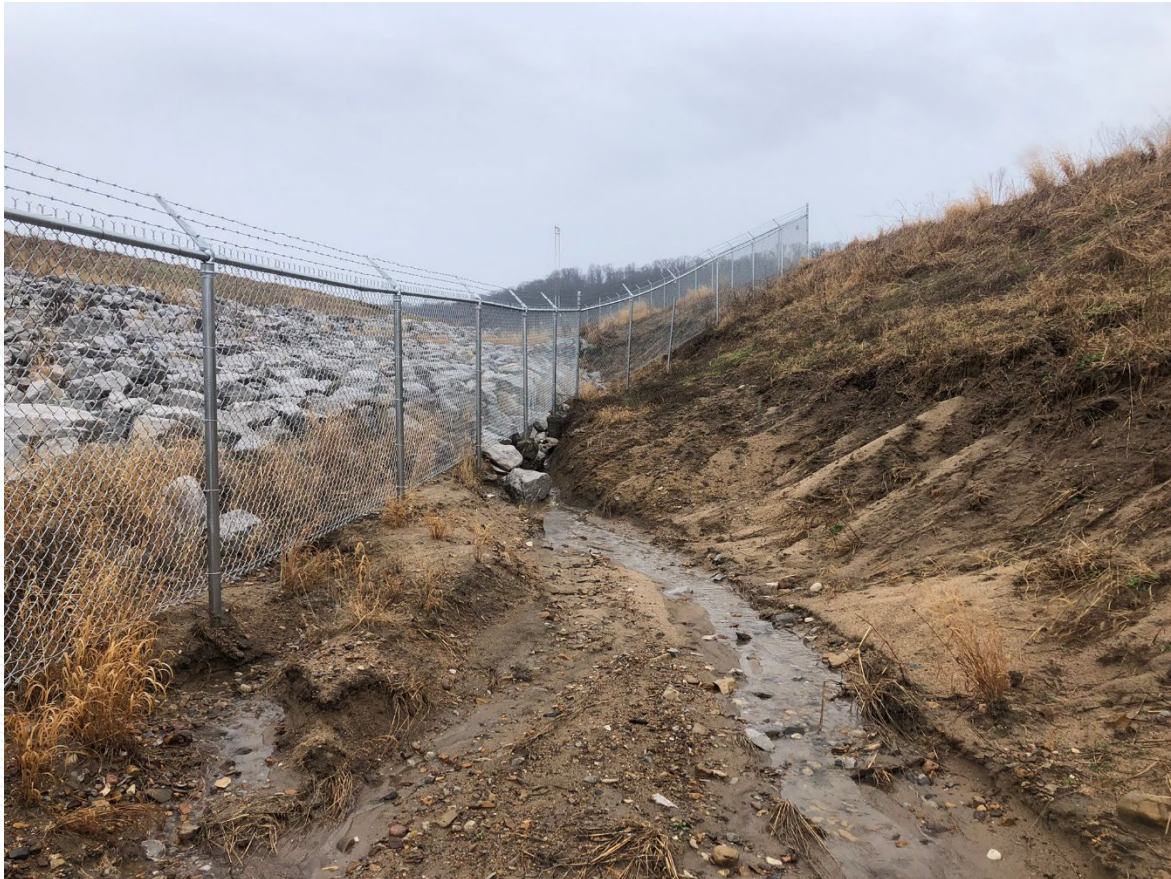
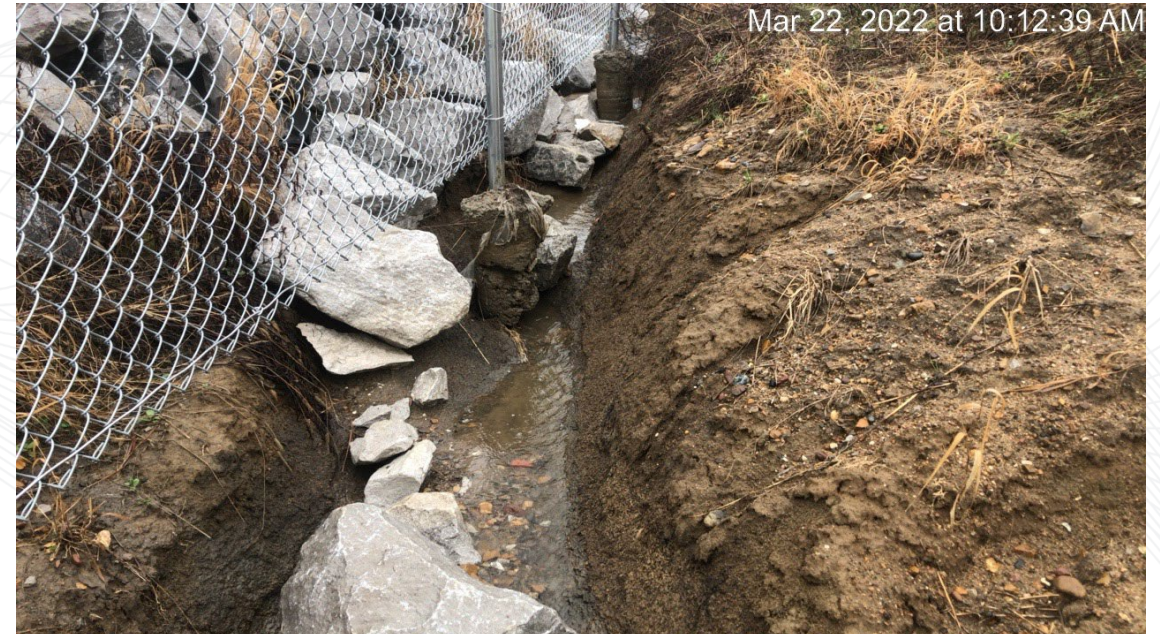
Fence undermining and GTEC levee erosion on SE side of closed CCR impoundment cap.

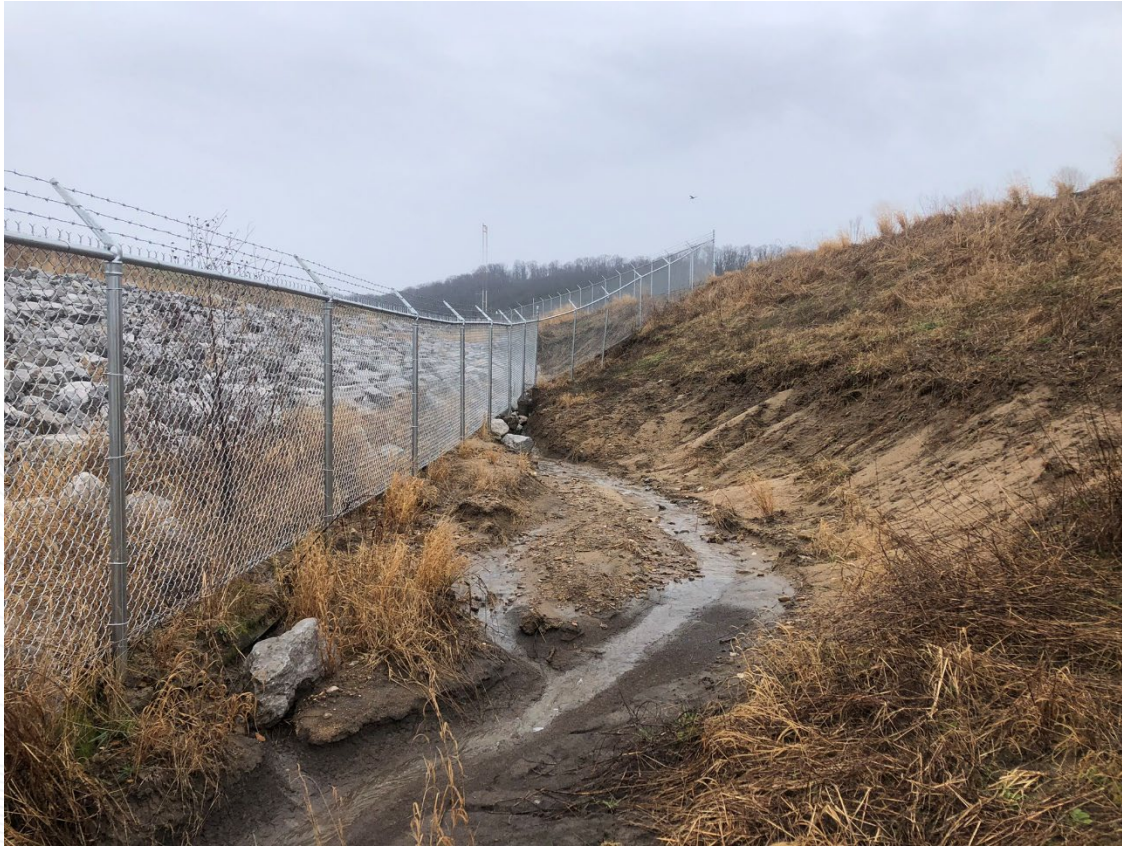
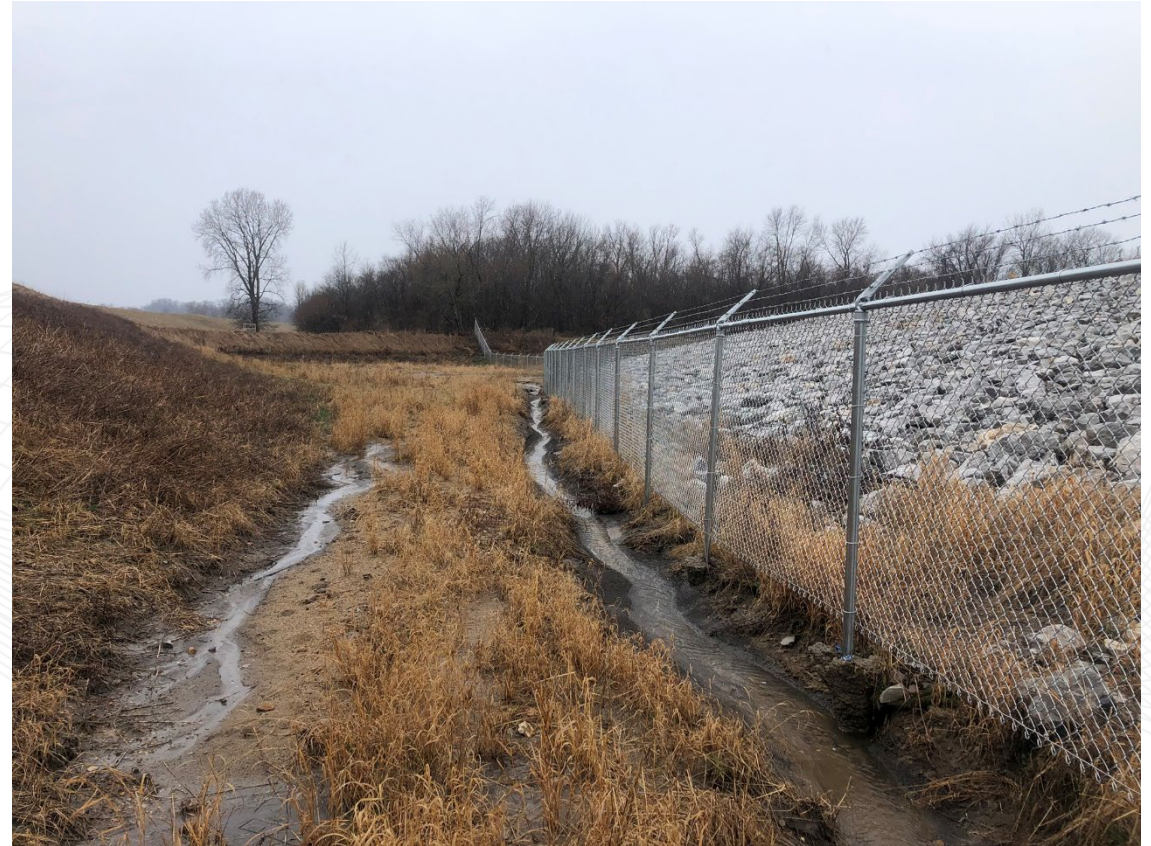
Fence undermining and GTEC levee erosion on SE side of closed CCR impoundment cap.

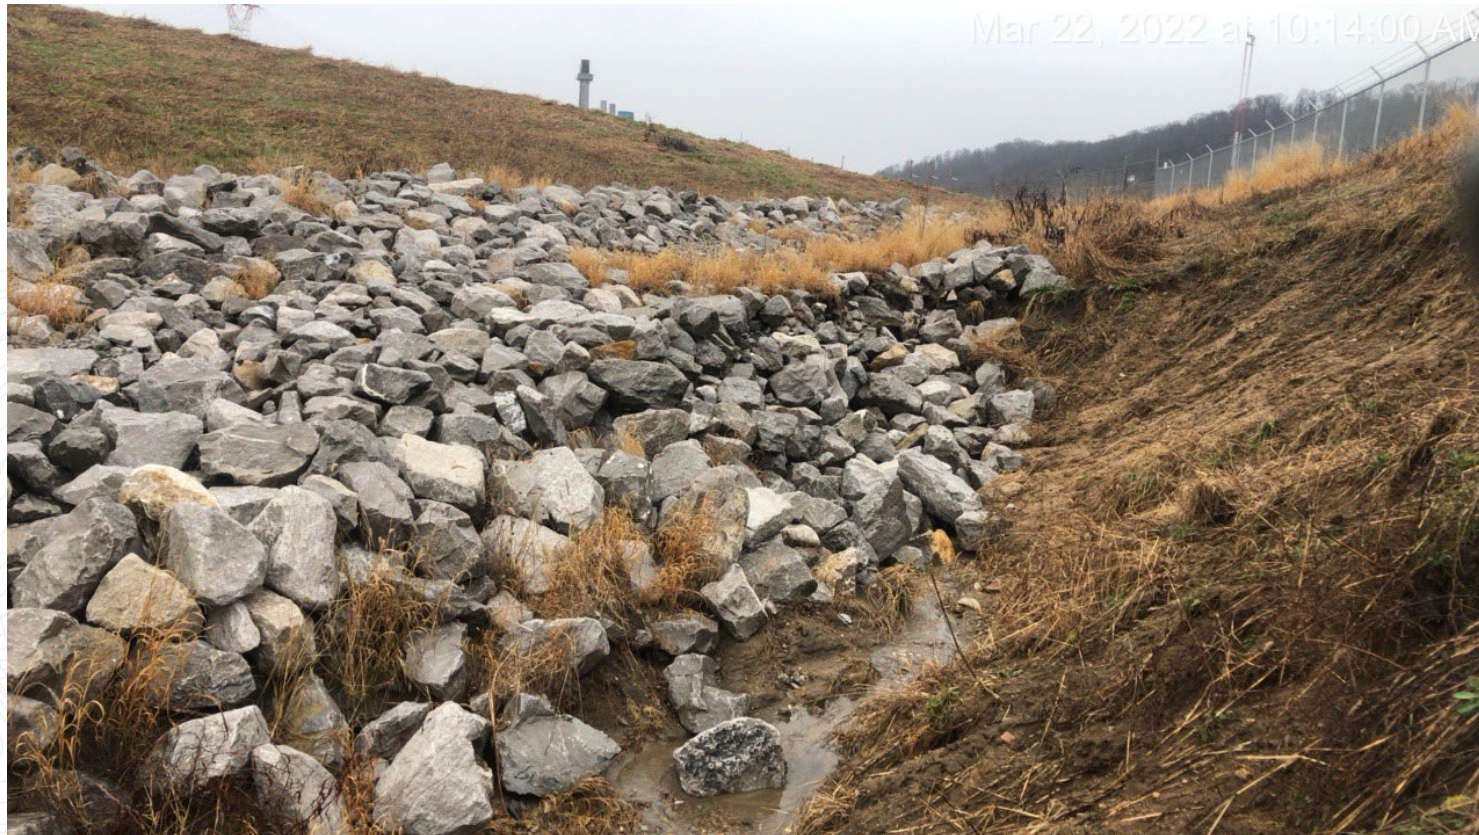
GTEC levee erosion and riprap undermining on SE side of closed CCR impoundment cap.

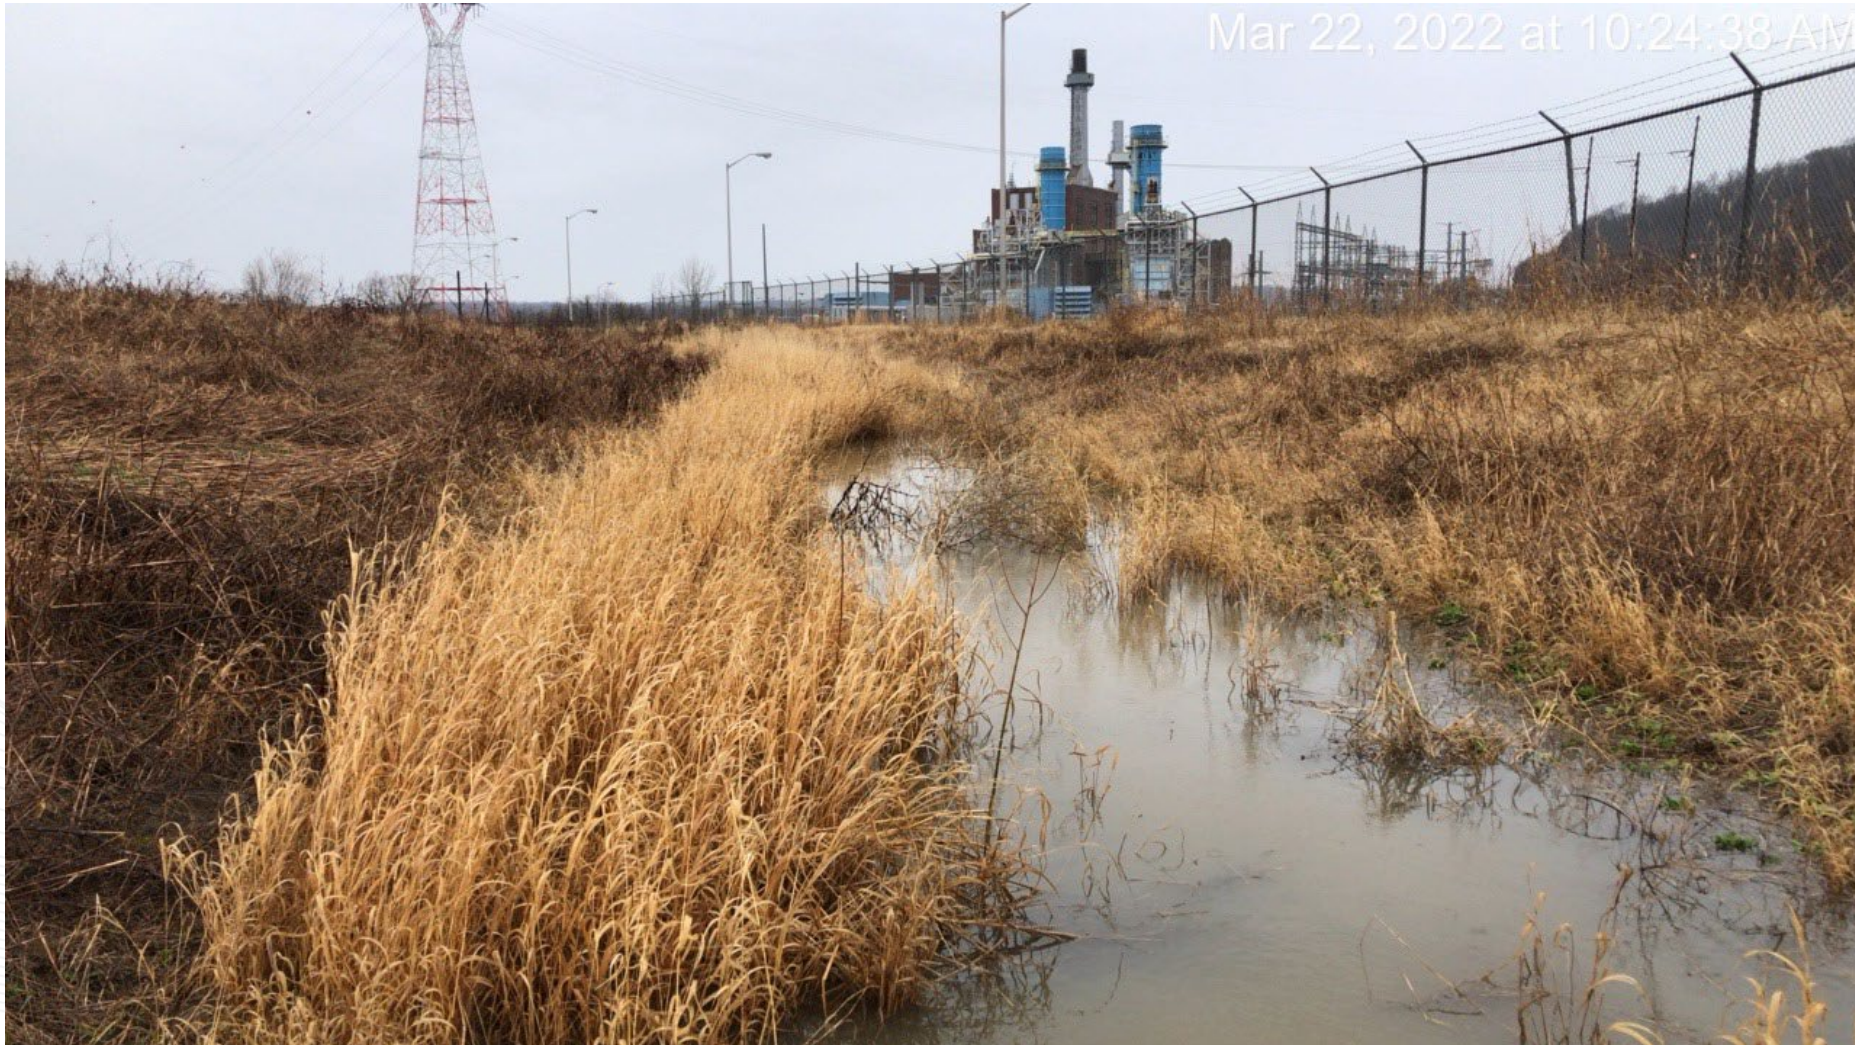
Ponding on NE side of closed CCR impoundment cap along GTEC levee (looking north).

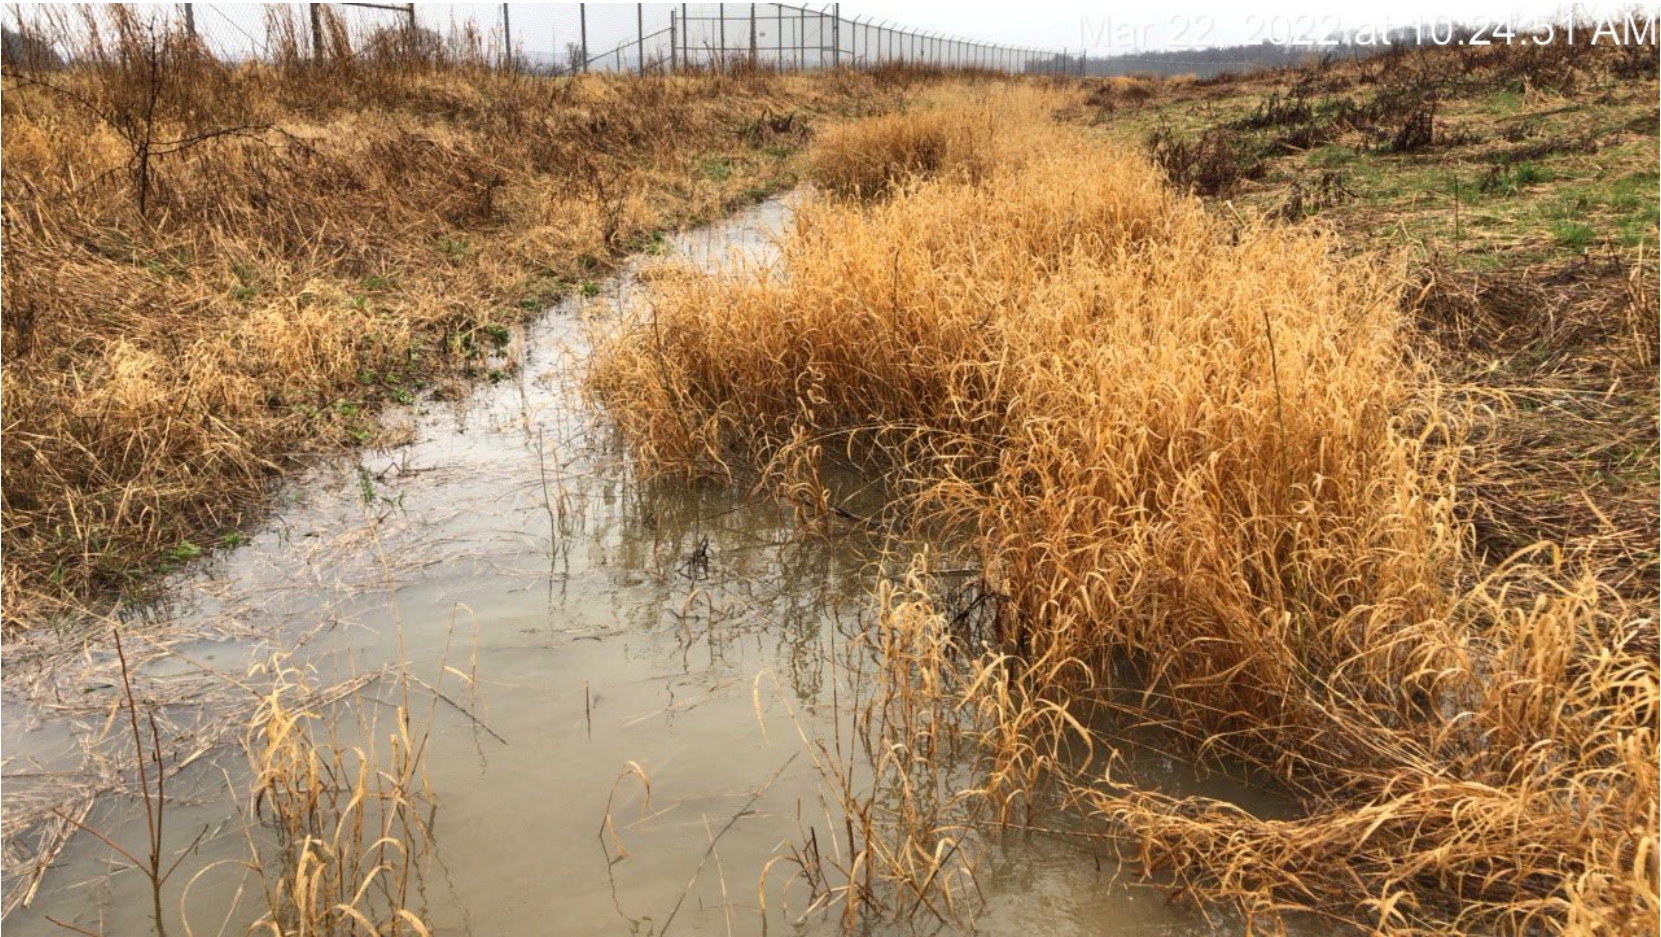
Ponding on NE side of closed CCR impoundment cap along GTEC levee (looking south).

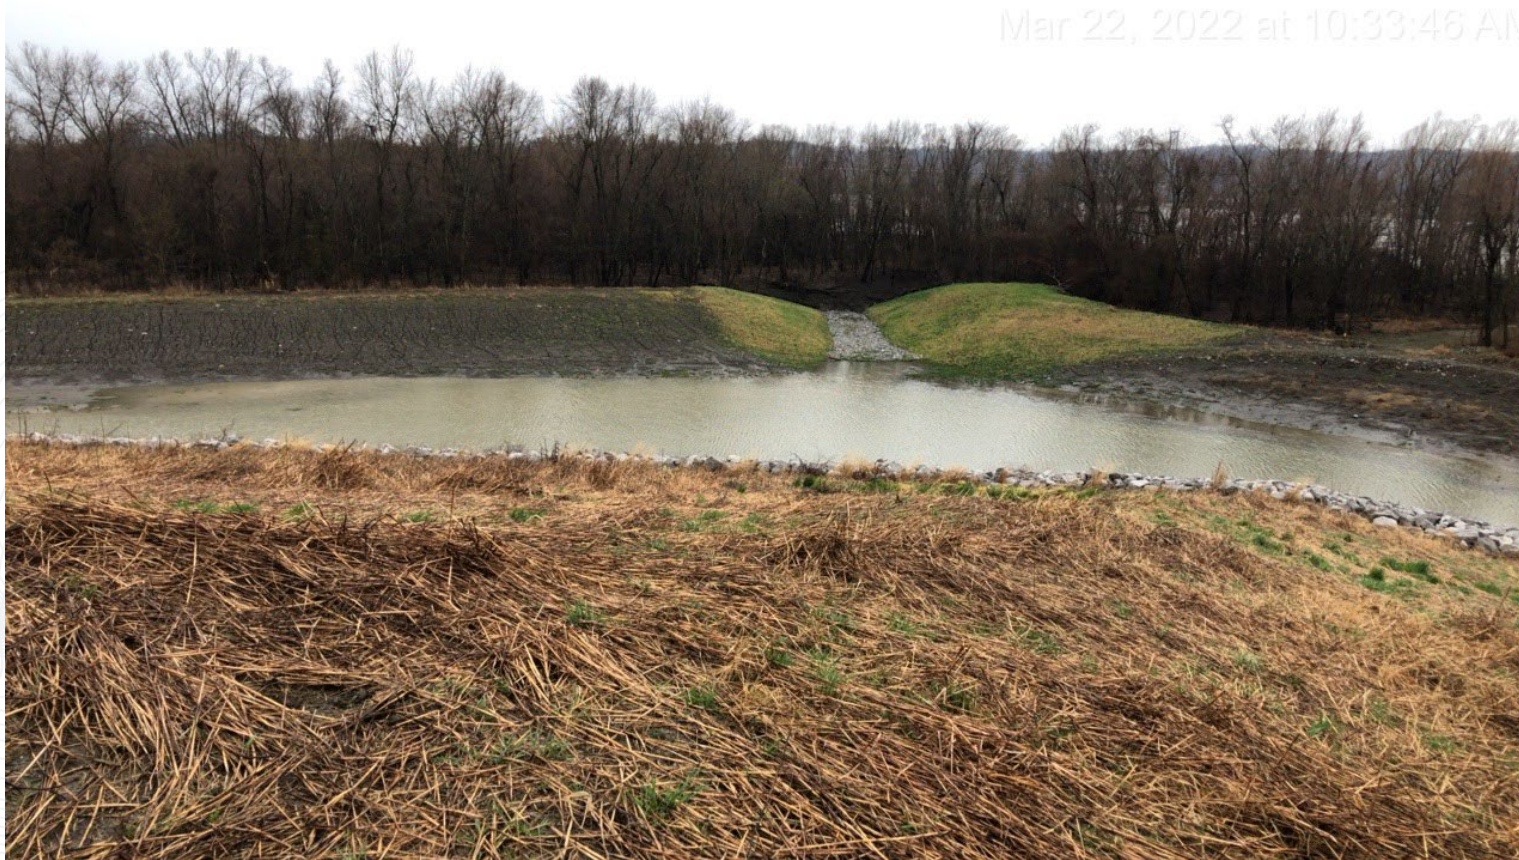
Ponding in SW corner of site at drainage.

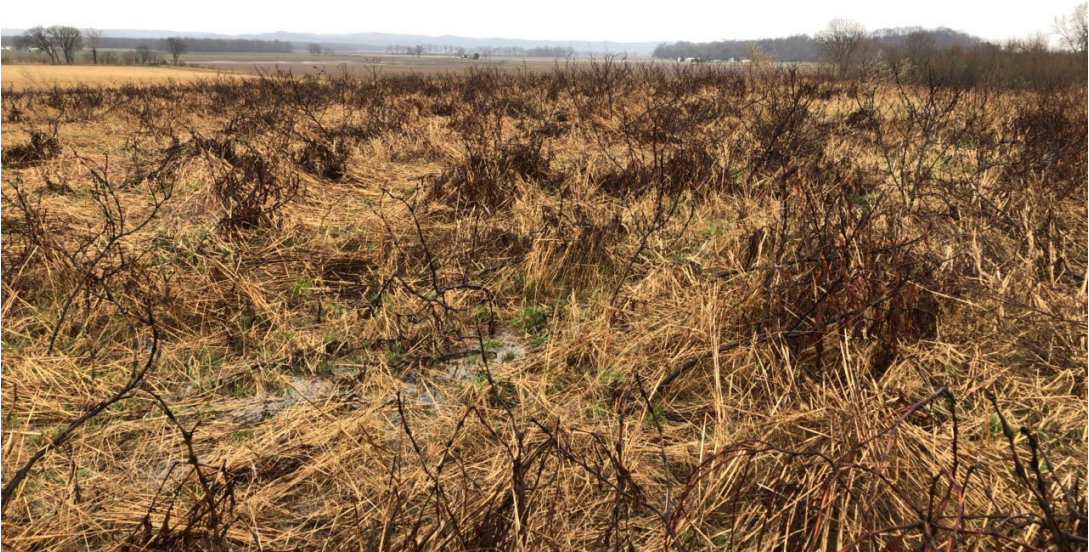
Closed CCR impoundment cap condition looking north from top center and the western face of cap.

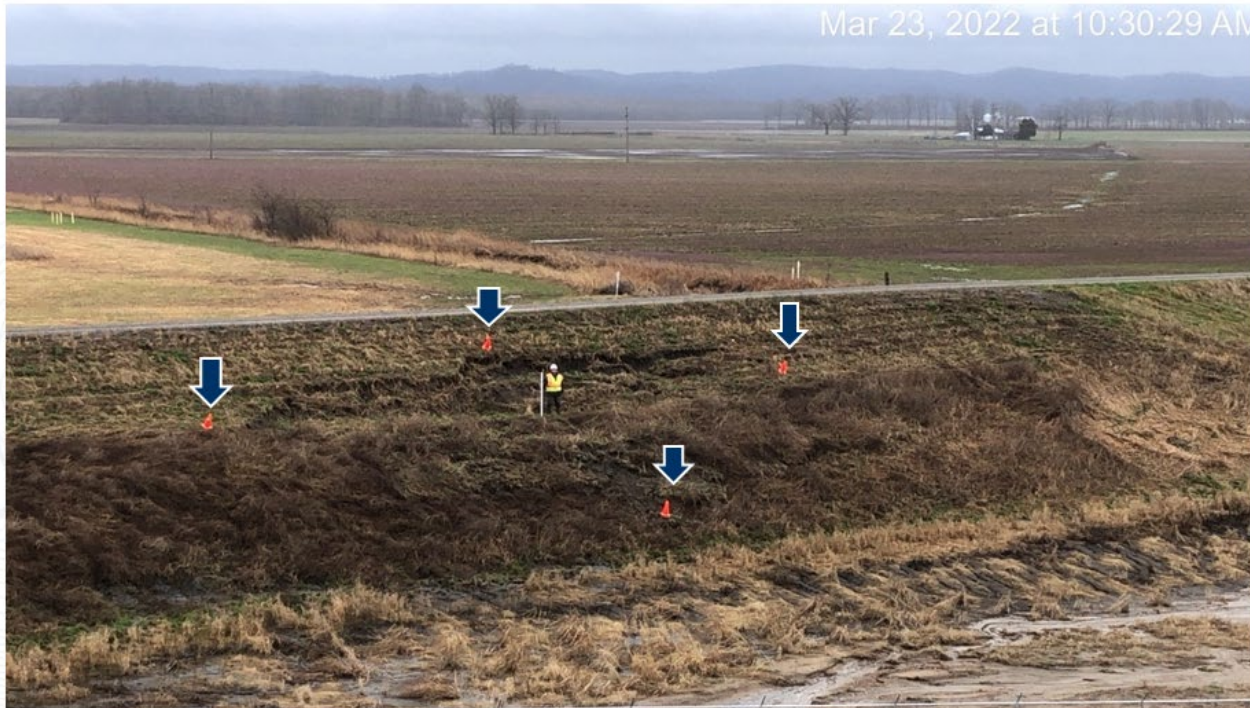
Army Corps of Engineers Levee Slump

Facing east toward COE levee.

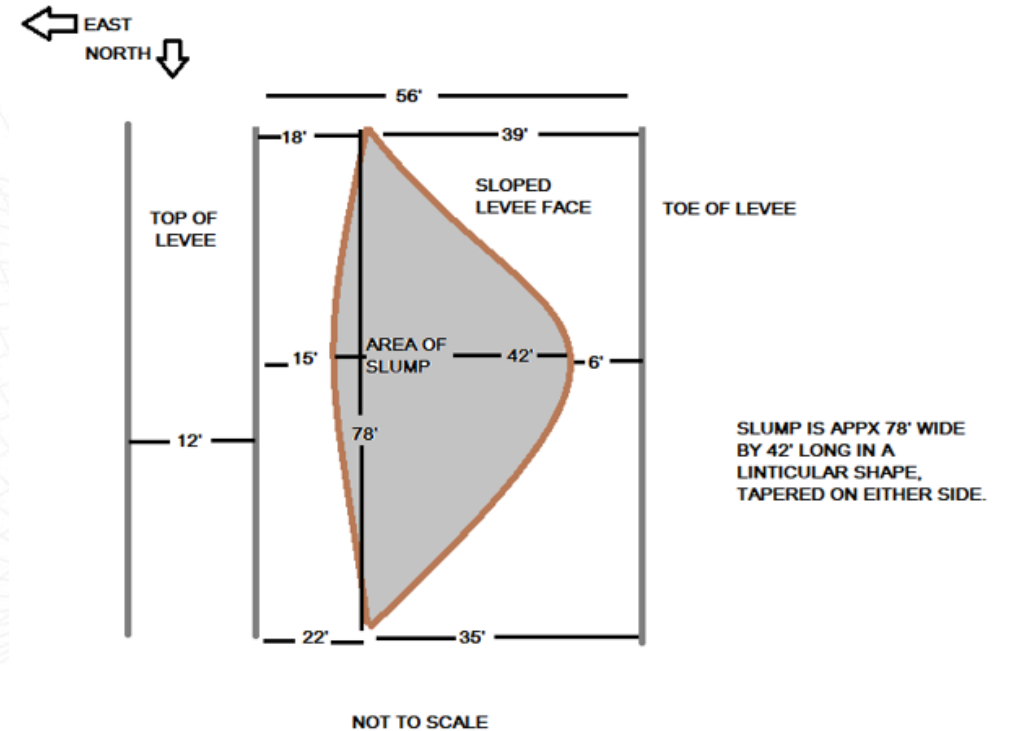
General dimensions of slumped area

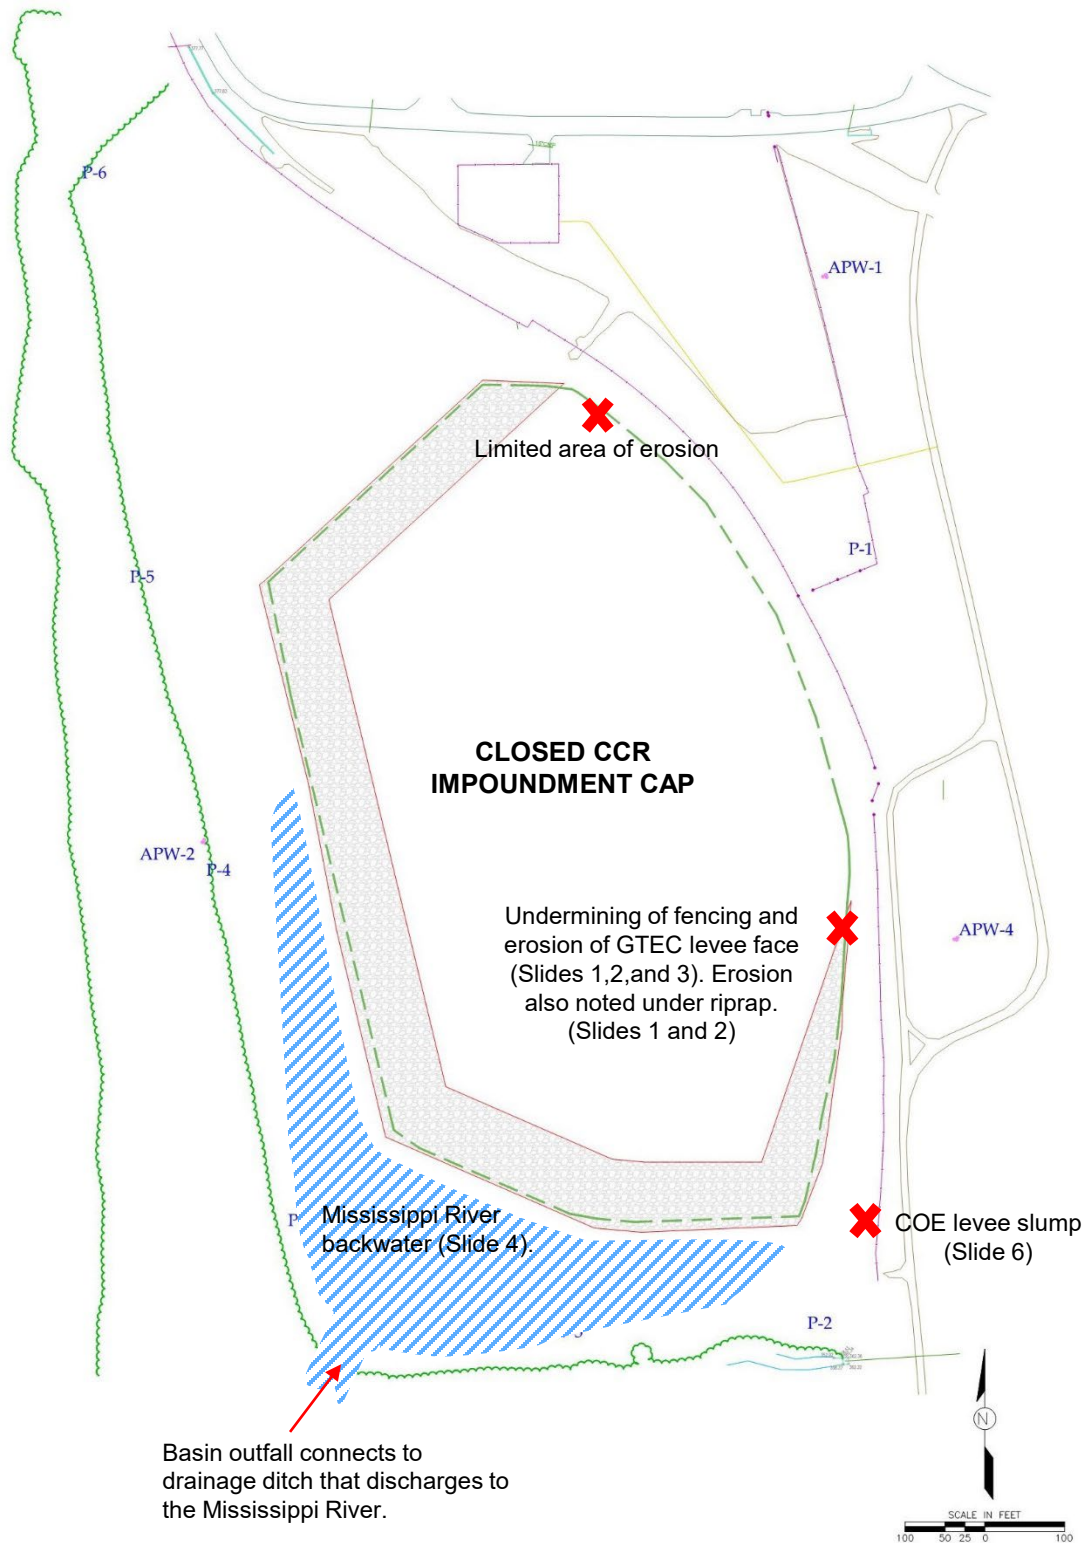
Observation Locations Map

- ERM onsite for the Q2 impoundment inspection and ground water sampling event.
- The U.S. Army Corps of Engineers (USACE) Levee was found to be in the same condition as Q1 (see Q1 GTEC Impoundment Inspection Report). Slumping on west face of levee noted.

- Erosion and fence undermining continues to be noted on east/SE side of site (see figure). Limited area of erosion noted on NE side of CCR impoundment adjacent to basin access ramp. No woody growth noted at this time. Minor erosion noted across north, west, and southern CCR impoundment cap faces up to 6" deep.

- Backwater of the Mississippi River noted in SW corner of the basin.
- Overall impoundment condition was found to be similar to Q1 2022.
- Inspector recommends addressing erosion and fence undermining on east side of the site by adding soil and riprap around undermined fencing and on the eroded face of GTEC levee. Inspector also recommends repair of the slumped area of the USACE levee in accordance with applicable regulations.

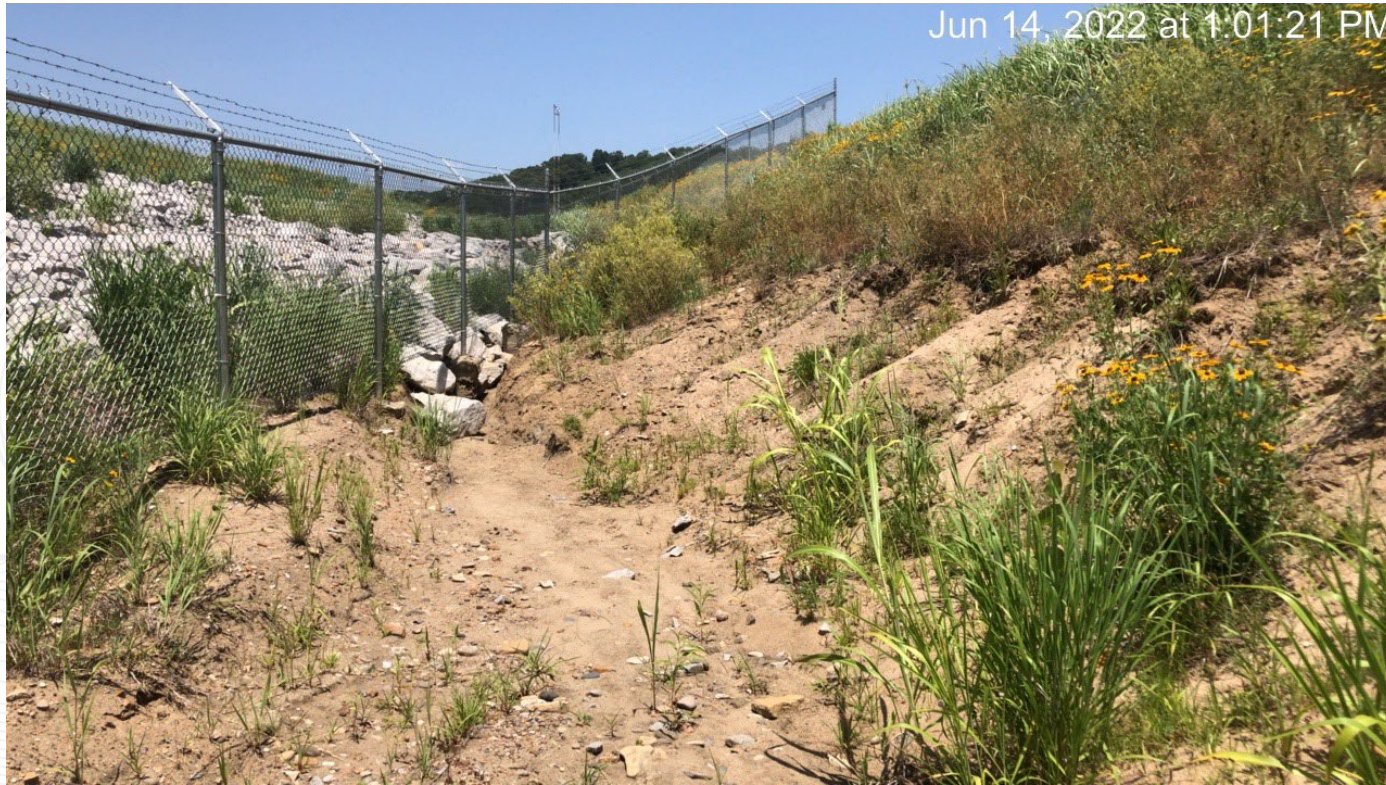
Fence Undermining, Riprap Undermining, and GTEC Levee Erosion on the SE Side of Closed CCR Impoundment Cap.

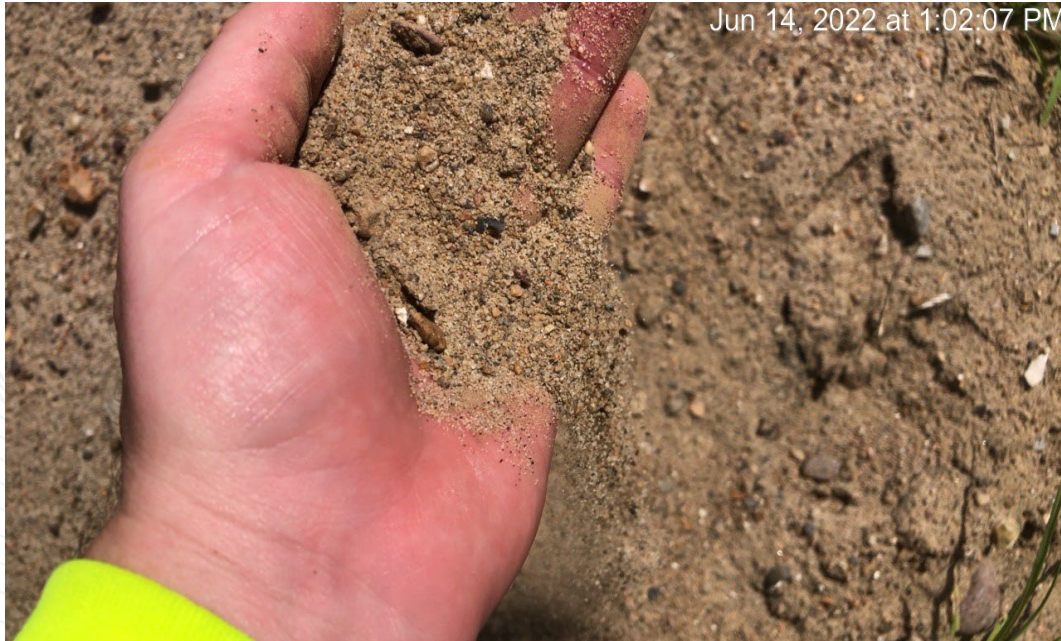
Fence Undermining, Riprap Undermining, and GTEC Levee Erosion on the SE Side of Closed CCR Impoundment Cap.

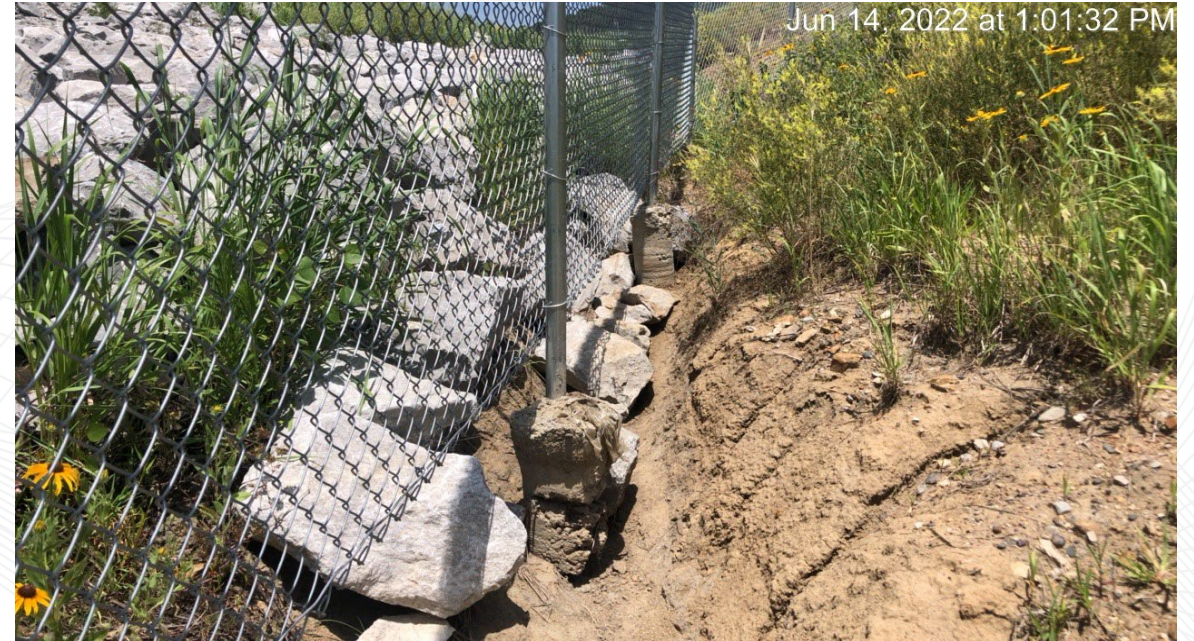
Close-up of exposed GTEC levee material.

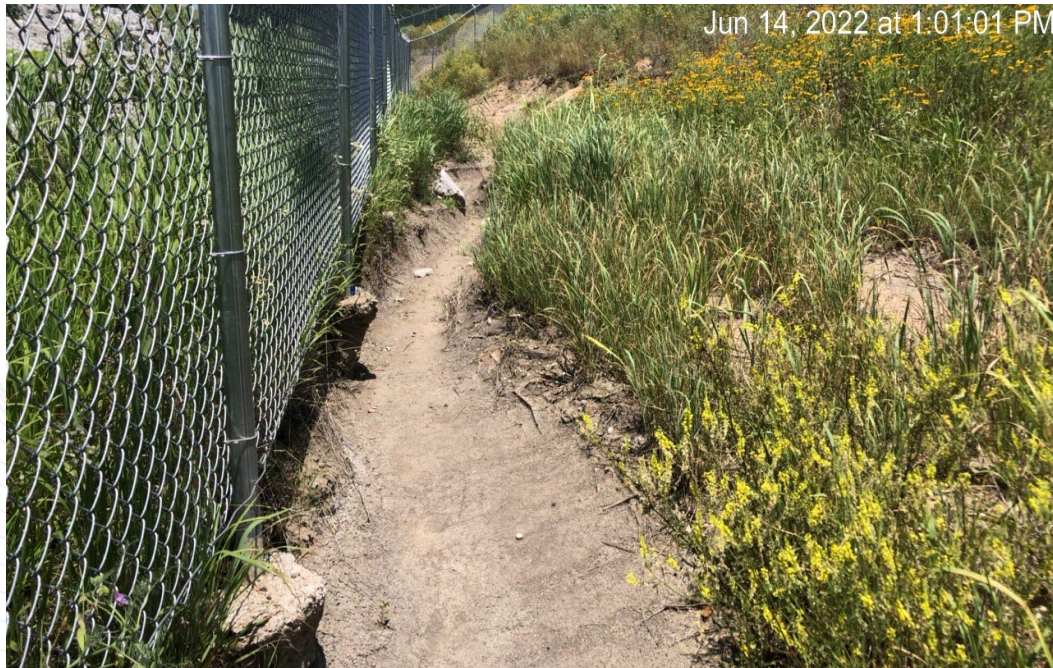
Undermined fenceline and riprap.

Fence Undermining on the SE Side of Closed CCR Impoundment Cap.

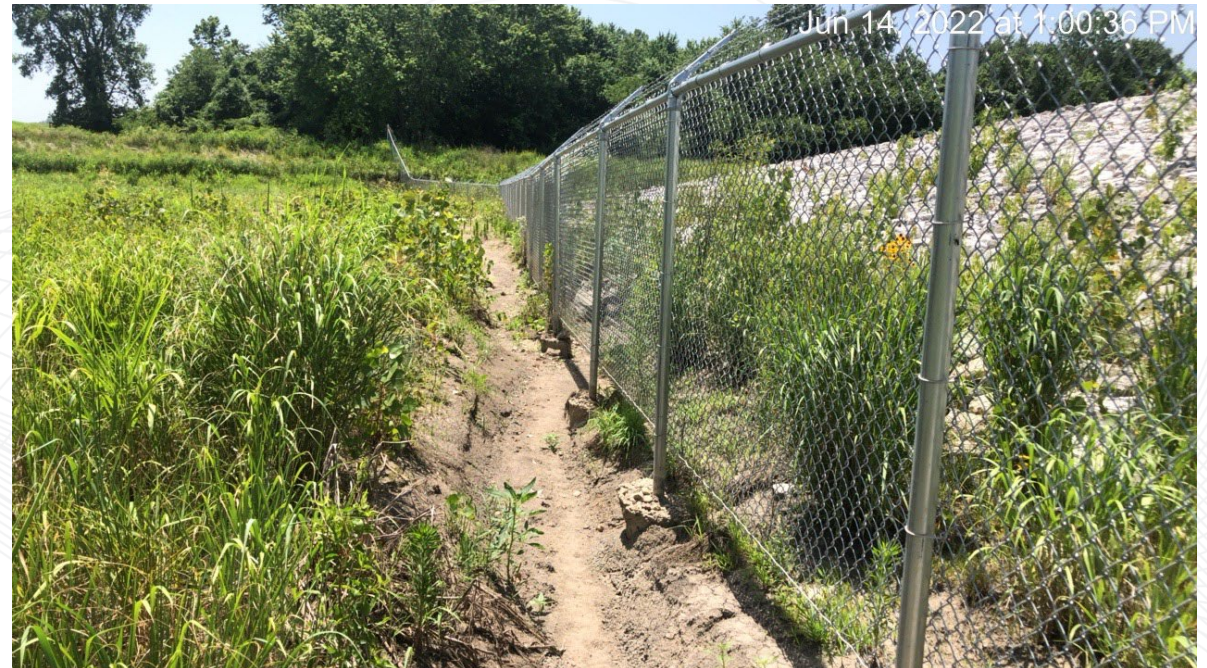
Facing north along fenceline.

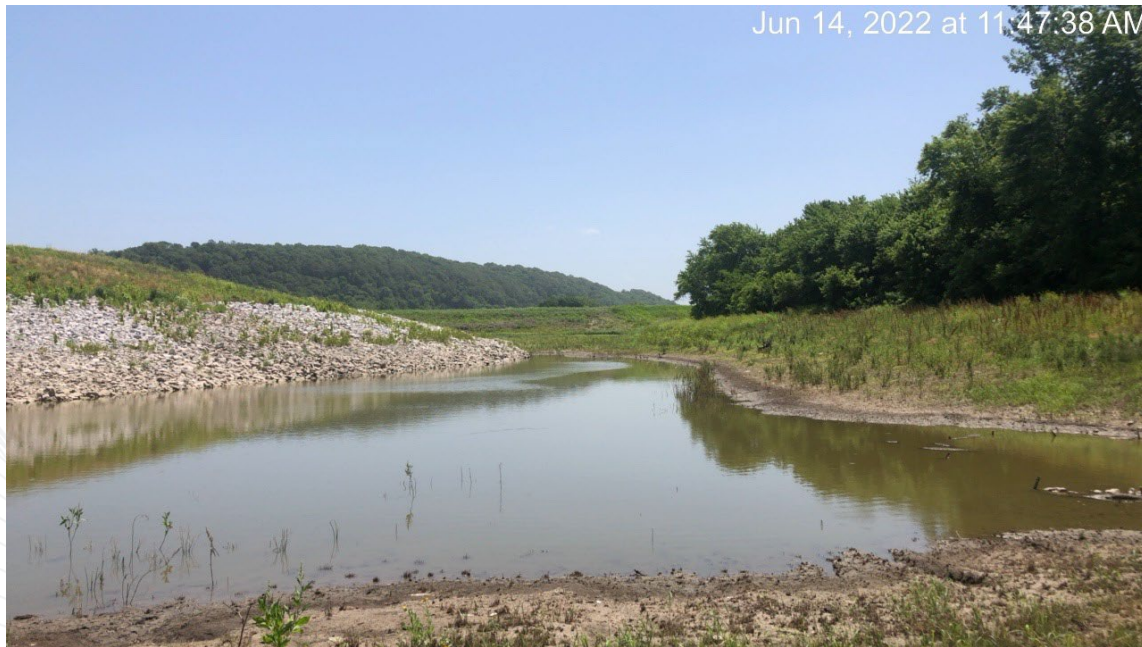
Mississippi River Backwater in the SW Corner of Site.

Mississippi River backwater in CCR impoundment drainage basin.

Note: Mississippi River backwater enters the GTEC CCR Impoundment Basin when the river level gage operated by the U.S. Army Corps of Engineers gage at Grand Tower, IL reaches a stage of approximately 27 ft.

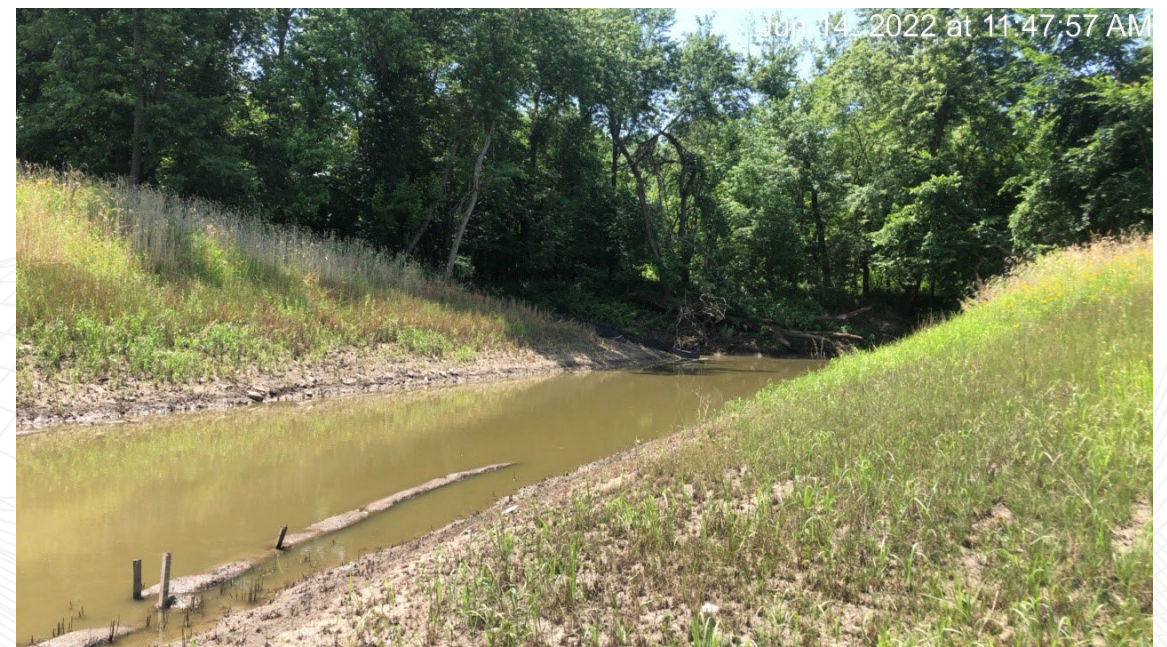
Mississippi River backwater connected to basin through drainage channel.

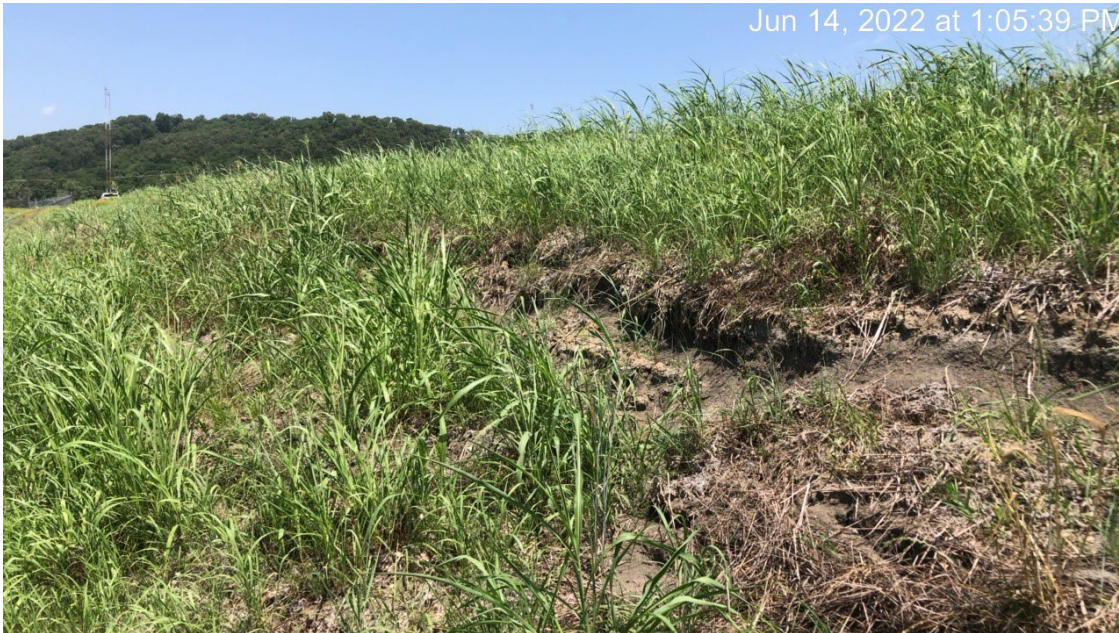
Army Corps of Engineers Levee Slump

Close-up of slumped area.

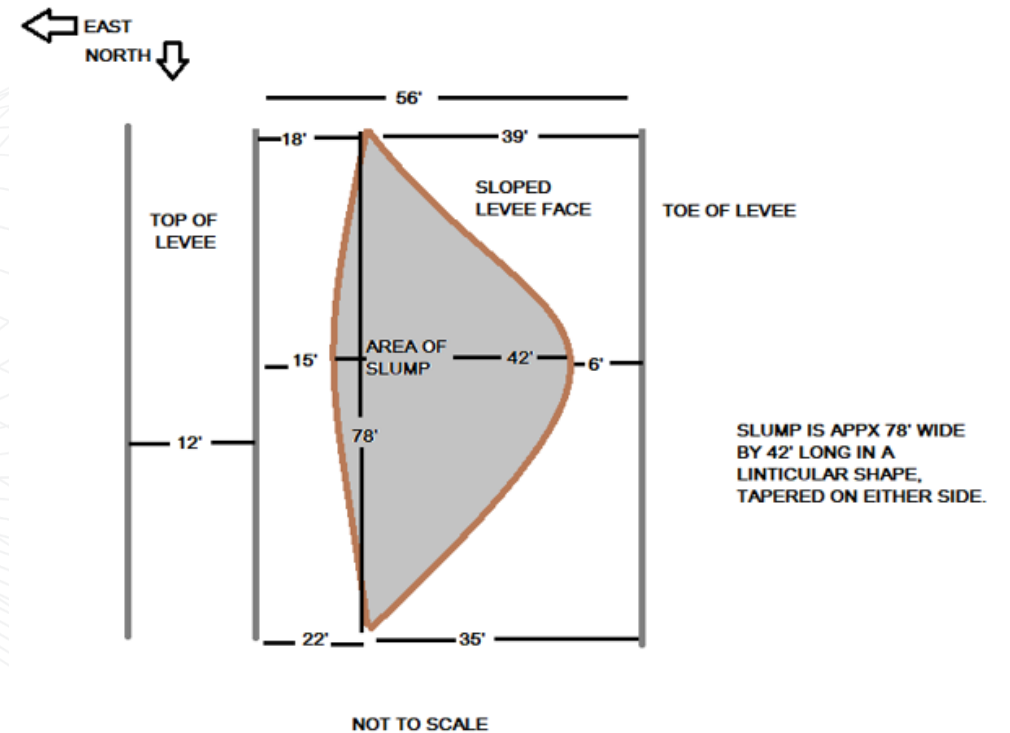
General dimensions of slumped area
