Rockland Capital, LLC

2022 Grand Tower Energy Center Annual Inspection Report

26 July 2023

Project No.: 0599247

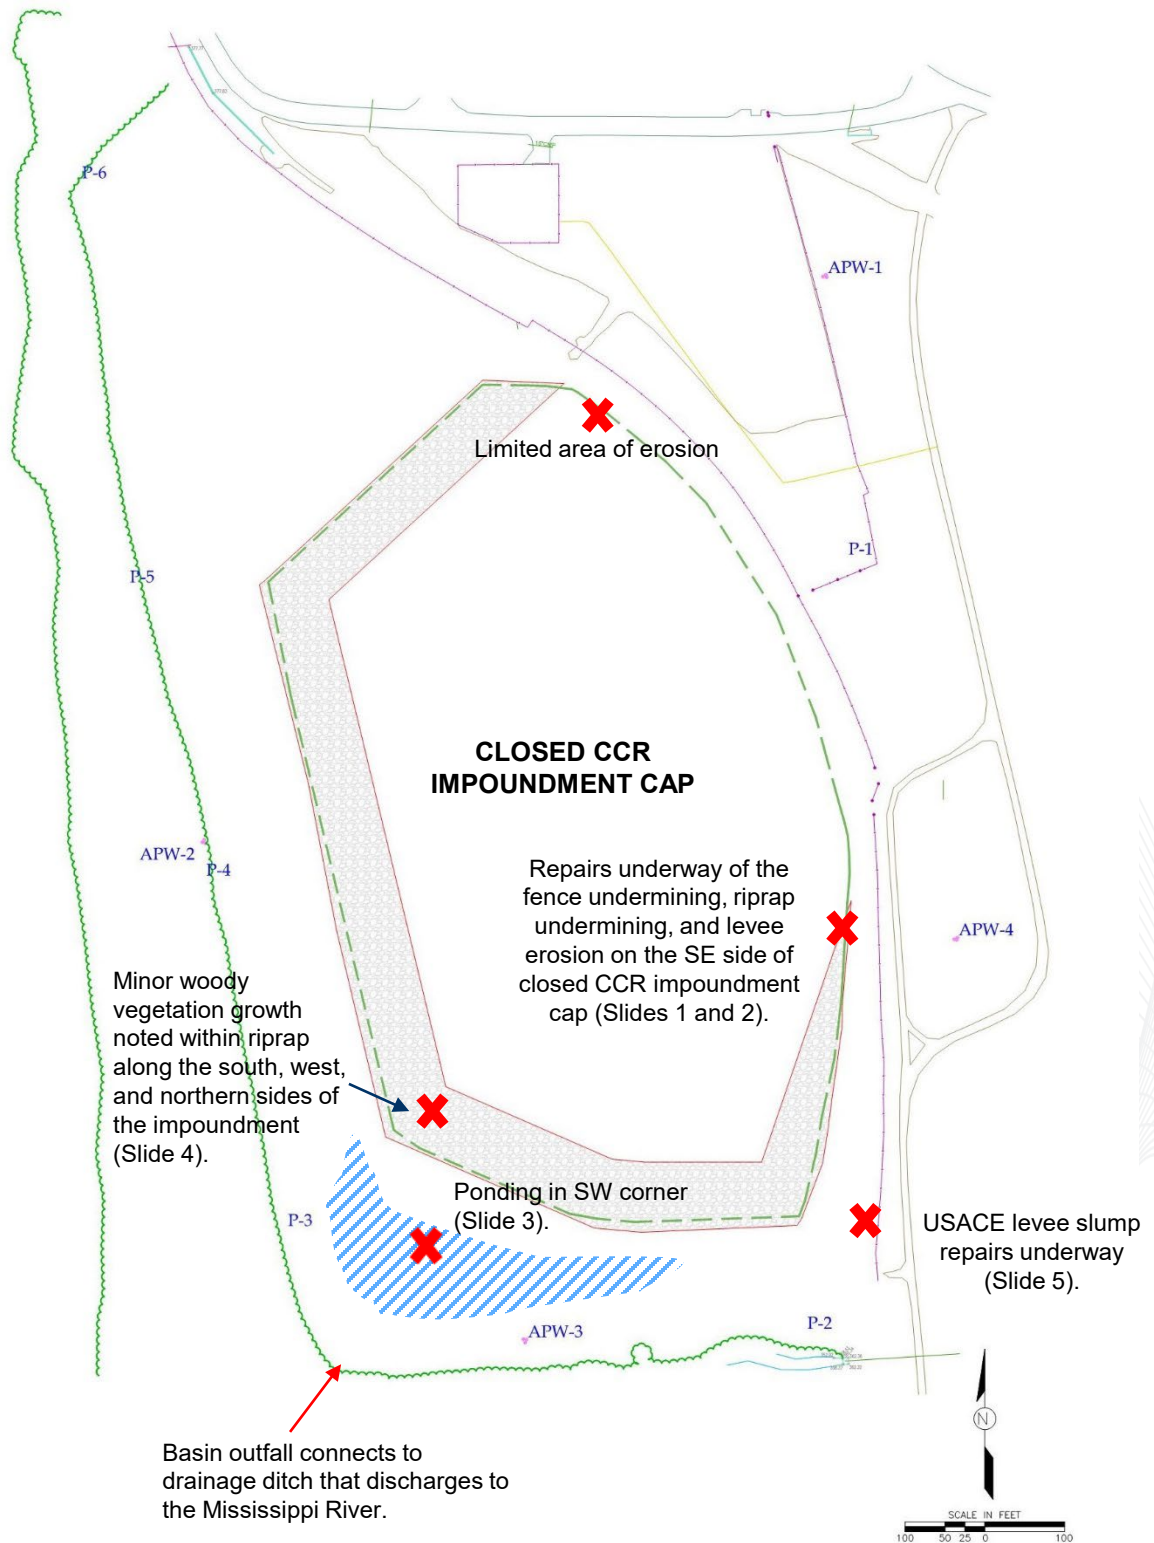
Observation Locations Map

- ERM onsite for the Q3 impoundment inspection and ground water sampling event.
- Repair of the U.S. Army Corps of Engineers (USACE) Levee to address slumping of the levee face noted in the Q1 and Q2 2022 inspection reports was underway as of 9/13/22 (see figure and photos).

- Repairs of the erosion and fence undermining on the east/SE side of site noted in the Q1 and Q2 2022 inspection reports was underway as of 9/13/22 (see figure and photos).

- Minor erosion noted across north, west, and southern CCR impoundment cap faces up to 6" deep.
- Growth of a limited amount of woody vegetation (under 1" diameter) within the riprap on the north, west, and southern impoundment cap faces was observed.

- Ponding noted in SW corner of the basin. Limited area of erosion at northern end of impoundment.
- Impoundment cap was mowed during Q3 of 2022 and found to be in generally good condition.

- Inspector recommends removal of woody vegetation growth and followup monitoring of repaired areas.

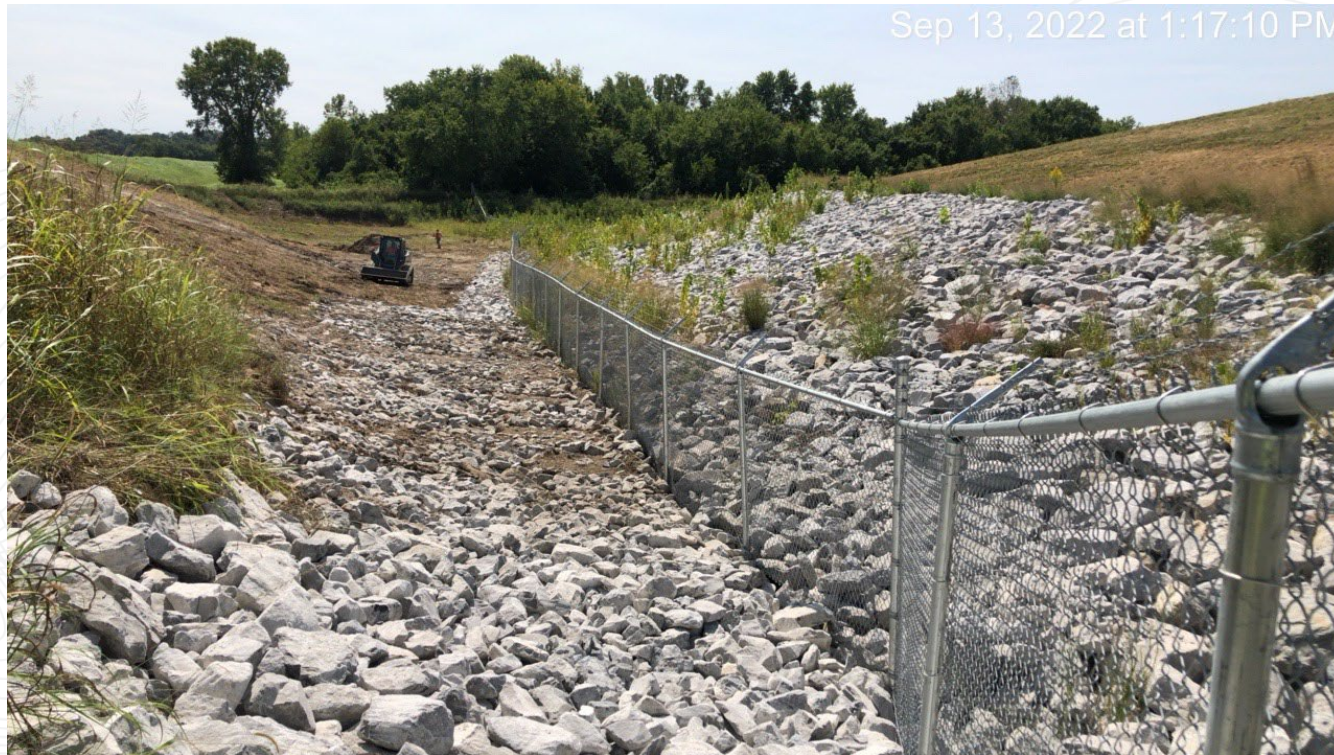
Repairs underway of the Fence Undermining, Riprap Undermining, and Levee Erosion on the SE Side of Closed CCR Impoundment Cap

Facing south along recently repaired fenceline area.

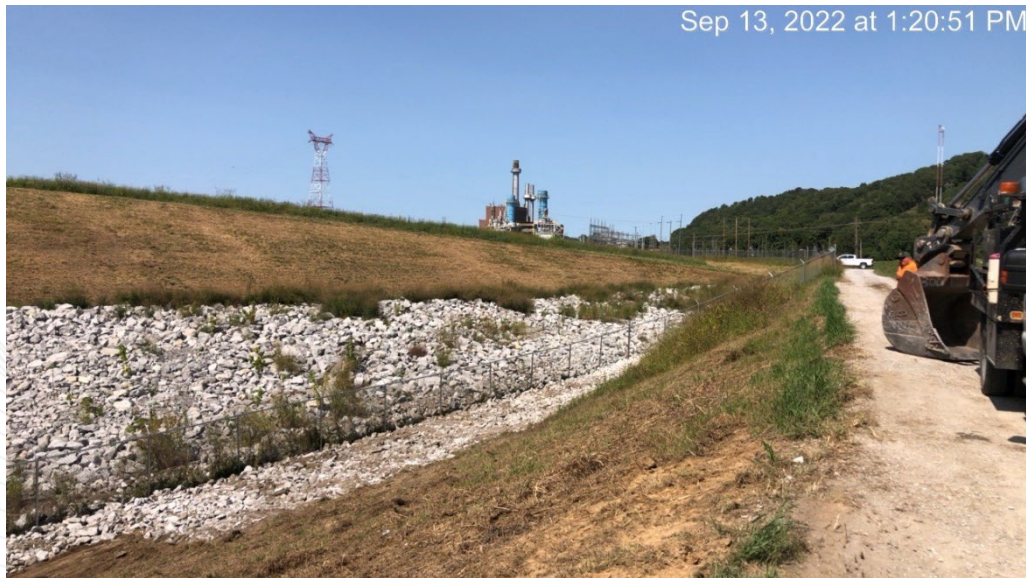
Facing north towards impoundment cap – repairs of fence undermining and riprap visible.

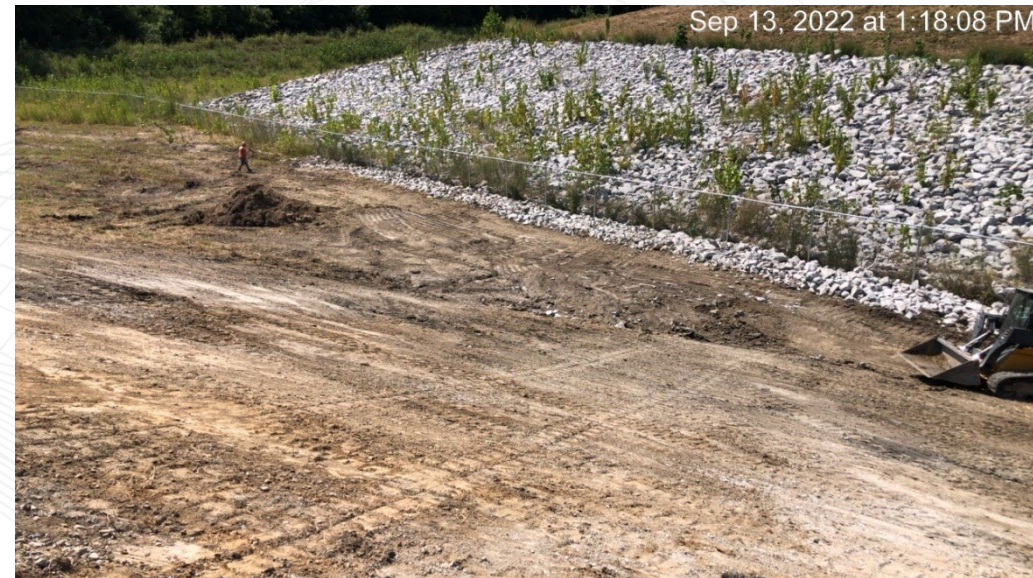
Facing southwest towards impoundment cap – repairs of fence undermining, levee, and riprap visible.

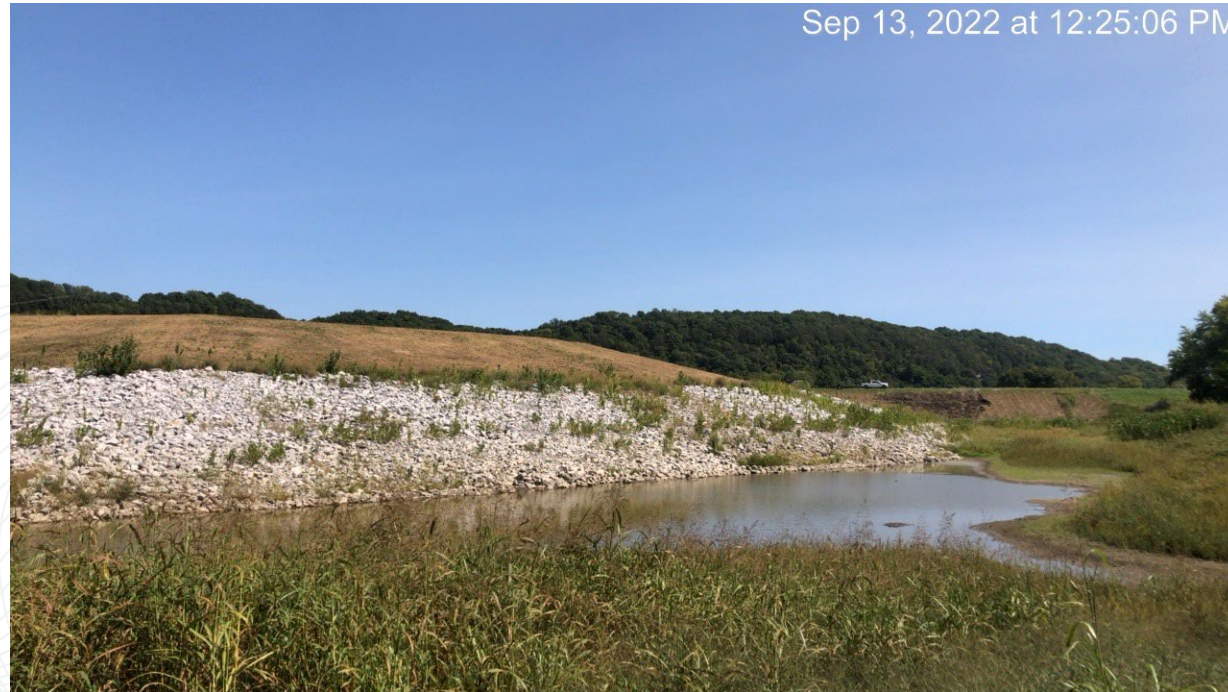
Ponding in the SW Corner of Site

Facing east from southwest corner of site across ponded area.

Note: Mississippi River backwater enters the GTEC CCR Impoundment Basin when the river level gage operated by the U.S. Army Corps of Engineers gage at Grand Tower, IL reaches a stage of approximately 27 ft.

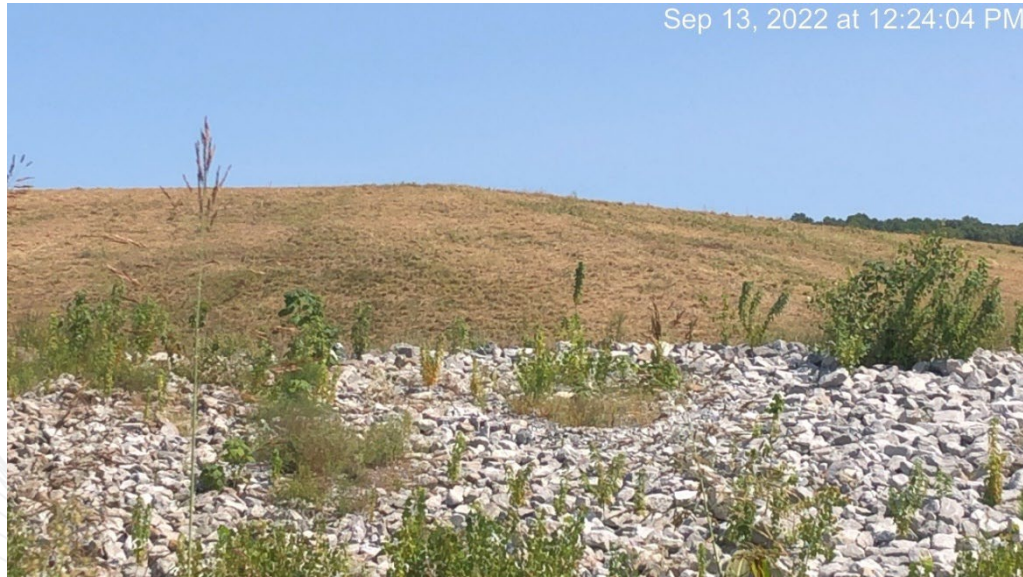
Southwest corner of the impoundment cap with limited woody growth (under 1" diameter) within riprap. Minor woody growth found within riprap along south, west, and northern sides of the impoundment.

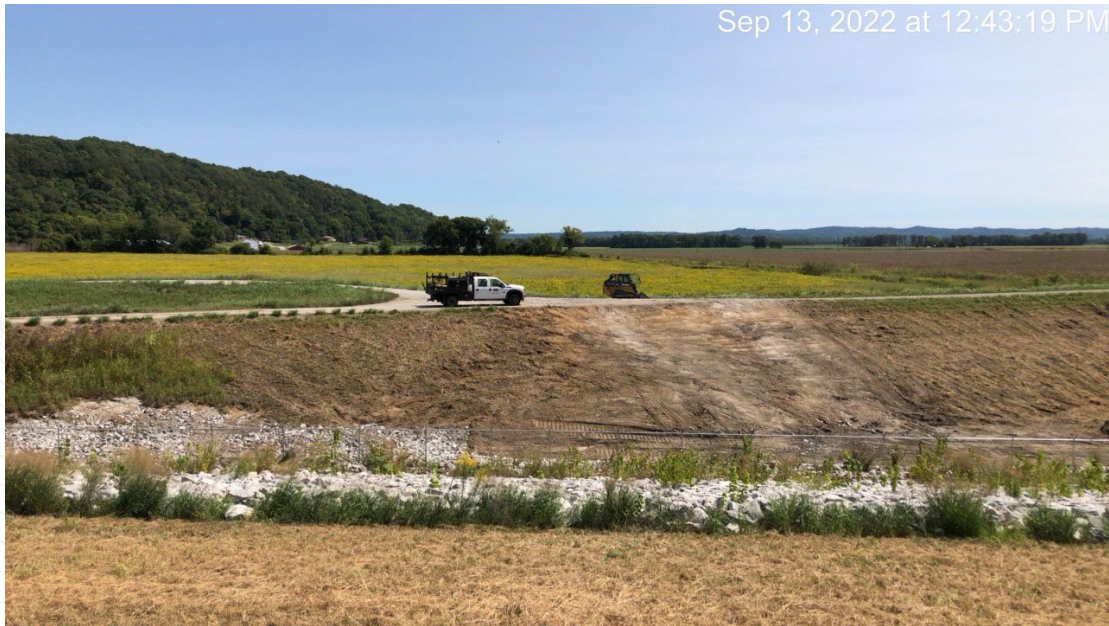
U.S. Army Corps of Engineers (USACE) Levee Slump Repair

Repair of levee (both USACE and GTEC sections) underway as of 9/13/22 (facing east).

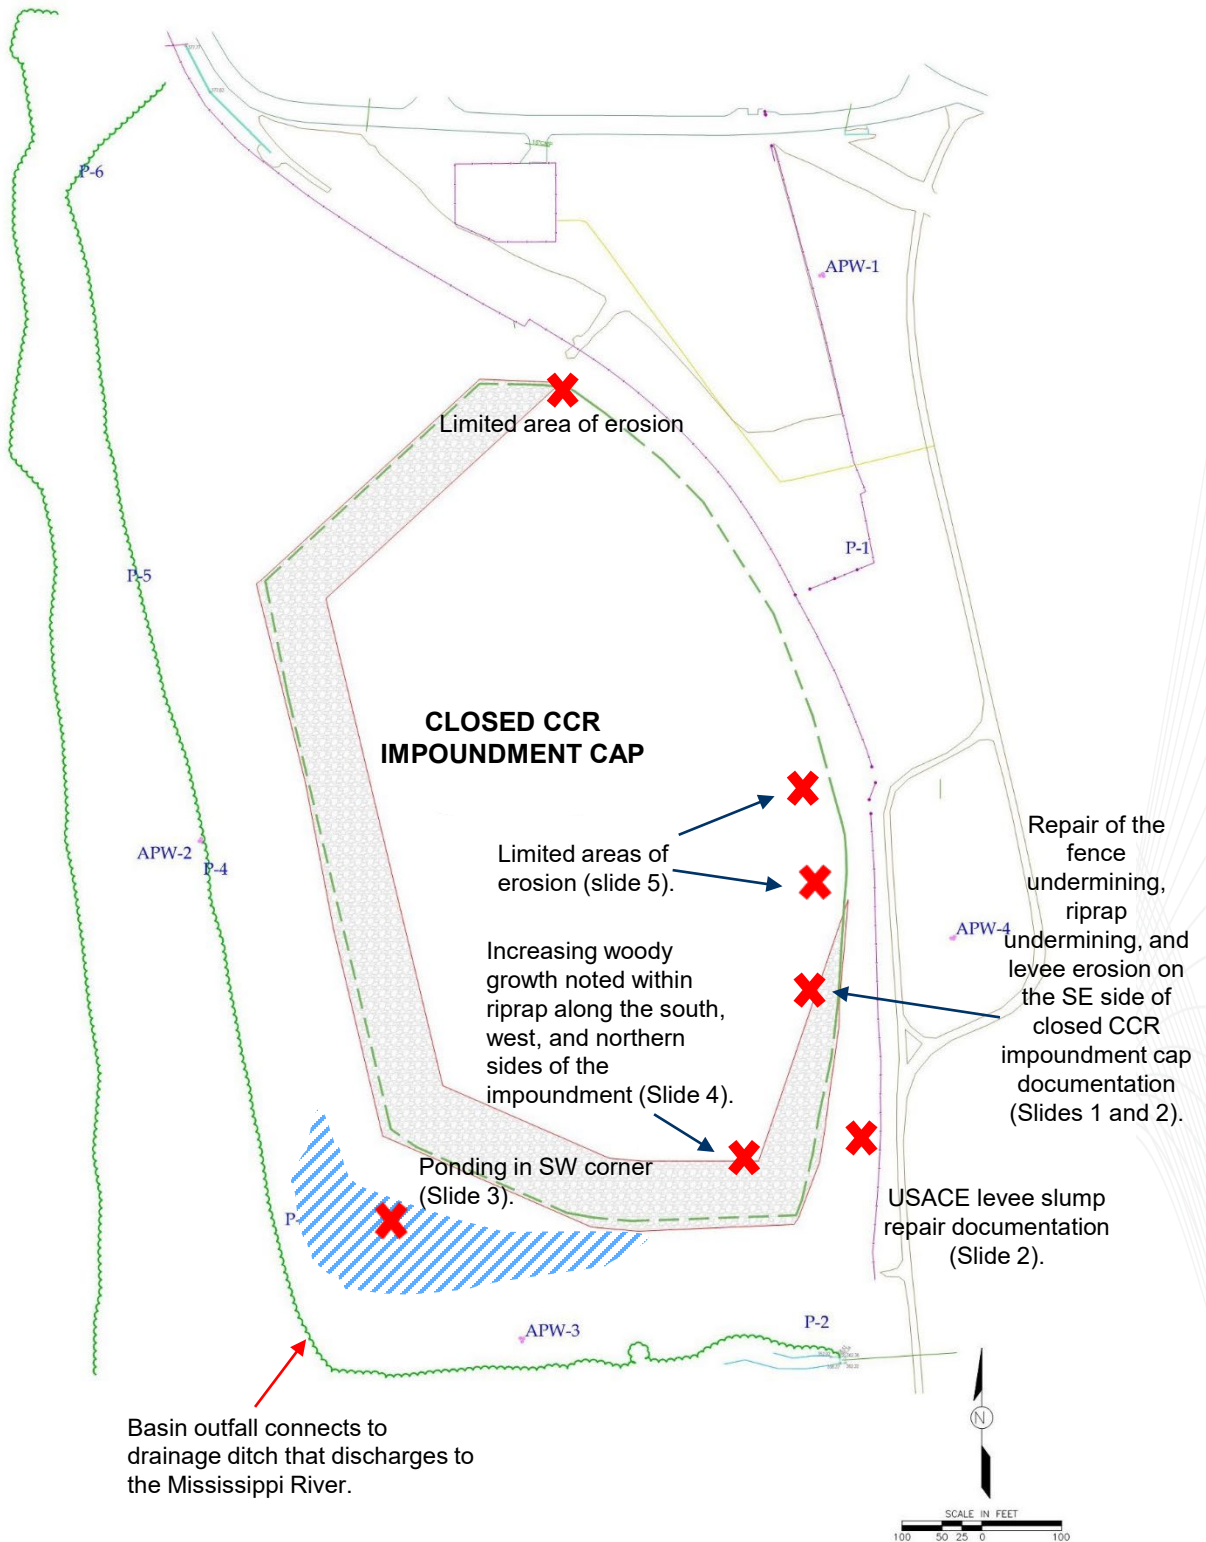
Observation Locations Map

- ERM onsite for the Q4 impoundment inspection and groundwater sampling event.
- Repair of the U.S. Army Corps of Engineers (USACE) Levee to address slumping of the levee face was documented (see figure and photos).

- Repairs of the erosion and fence undermining on the east/SE side was documented (see figure and photos).
- Post-repair erosion control measures (straw matting) on USACE levee has partially become detached.

- Limited erosion noted on eastern and northern CCR impoundment cap faces up to 9" deep.
- Growth of a limited but increasing amount of woody vegetation (up to 1" diameter) within the riprap on the north, west, and southern impoundment cap faces was observed.

- Ponding noted in SW corner of the basin.
- Impoundment cap was mowed during Q3 of 2022 and found to be in generally good condition.
- Inspector recommends removal of woody growth, repair of erosional channels, and re-installing straw matting.

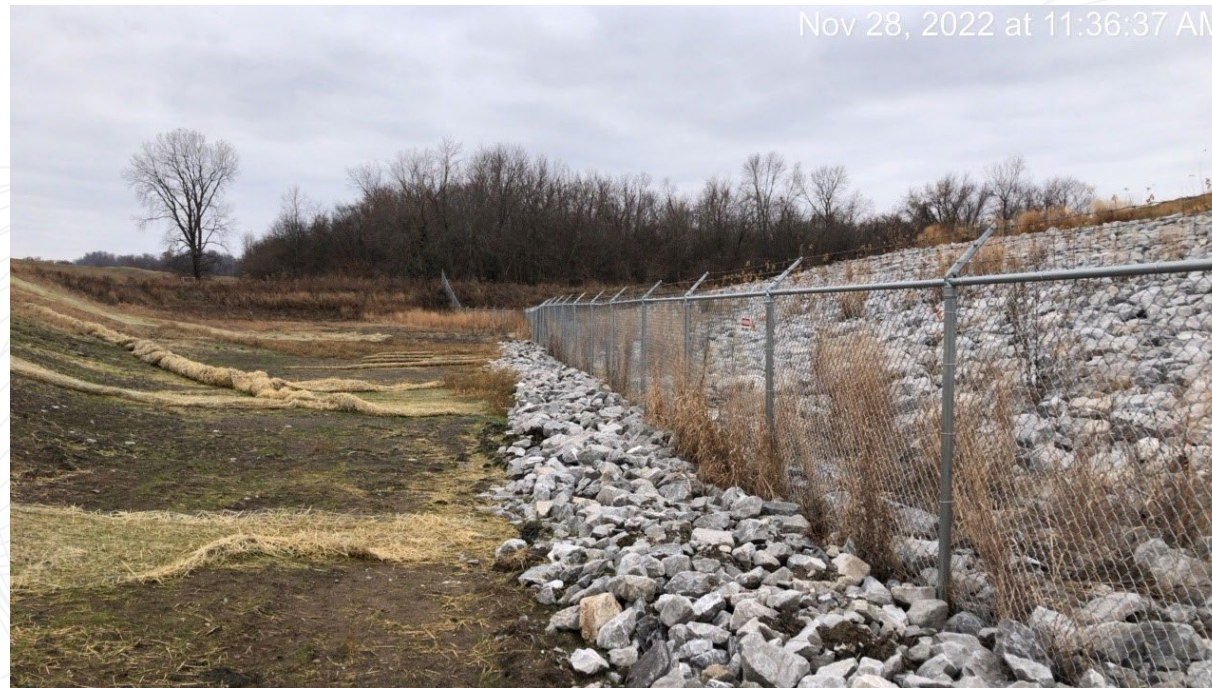
Repairs to the Fence Undermining, Riprap Undermining, and Levee Erosion on the SE Side of Closed CCR Impoundment Cap

Facing south along the repaired fenceline and levee area.
Note: straw matting from repaired levee face has become partially detached and deposited at the bottom of the slope.

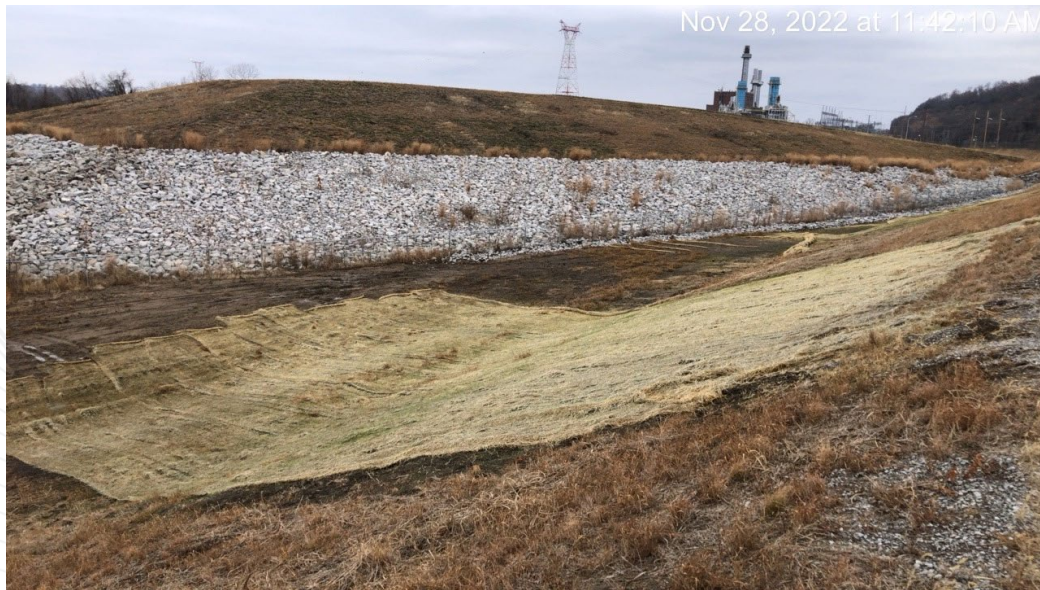
Facing north towards impoundment cap – repairs of fence undermining, riprap undermining, and United States Army Corps of Engineers (USACE) levee section are visible.

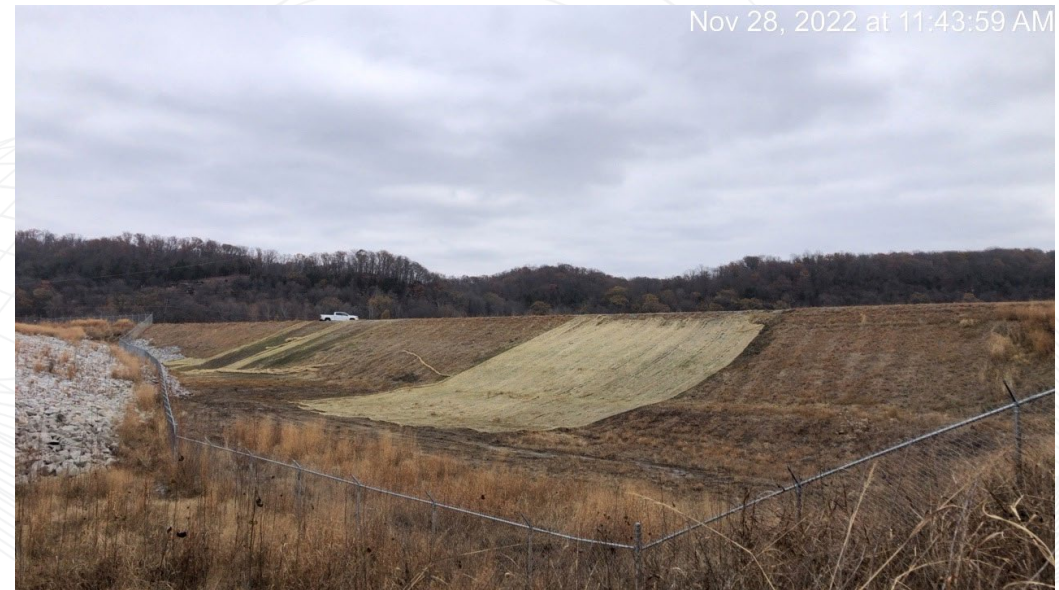
Facing northeast towards repaired section of USACE levee.

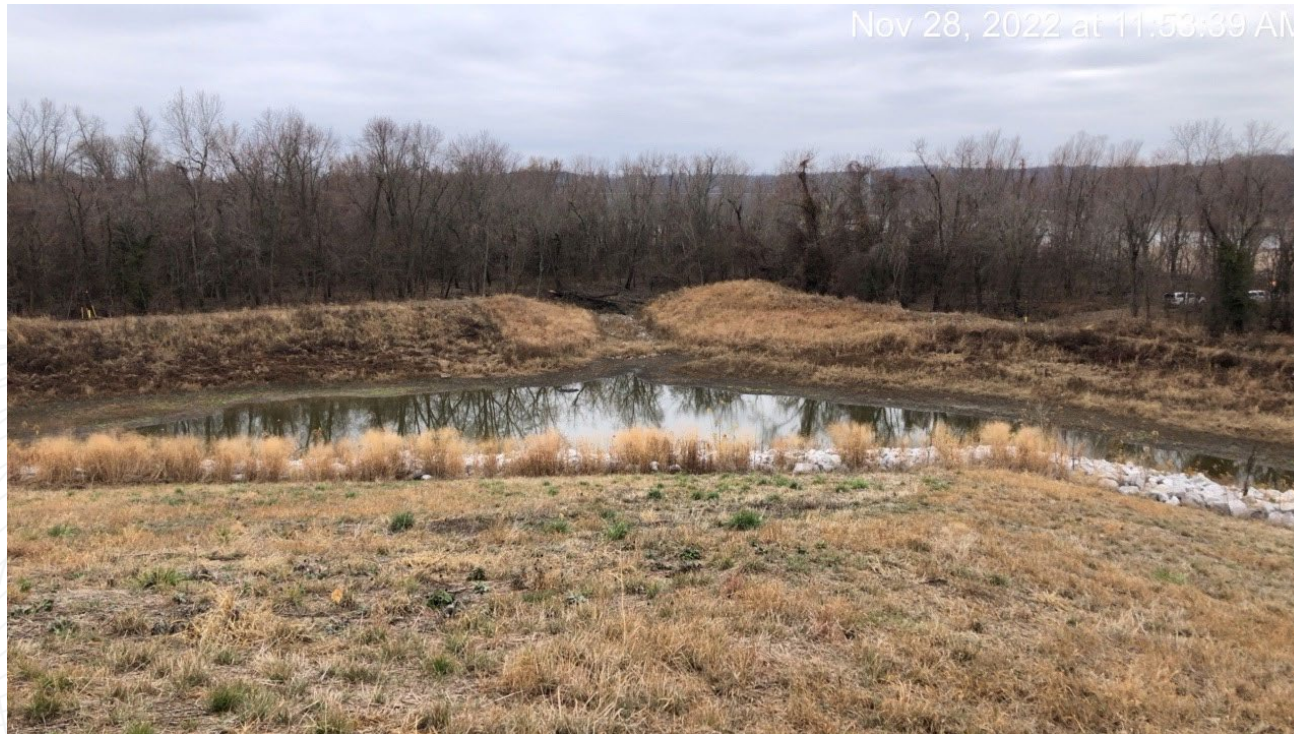
Ponding in the SW Corner of Site

Ponded area in southwest corner of site as viewed from mowed impoundment cap.

Note: Mississippi River backwater enters the GTEC CCR Impoundment Basin when the river level gage operated by the U.S. Army Corps of Engineers gage at Grand Tower, IL reaches a stage of approximately 27 ft.

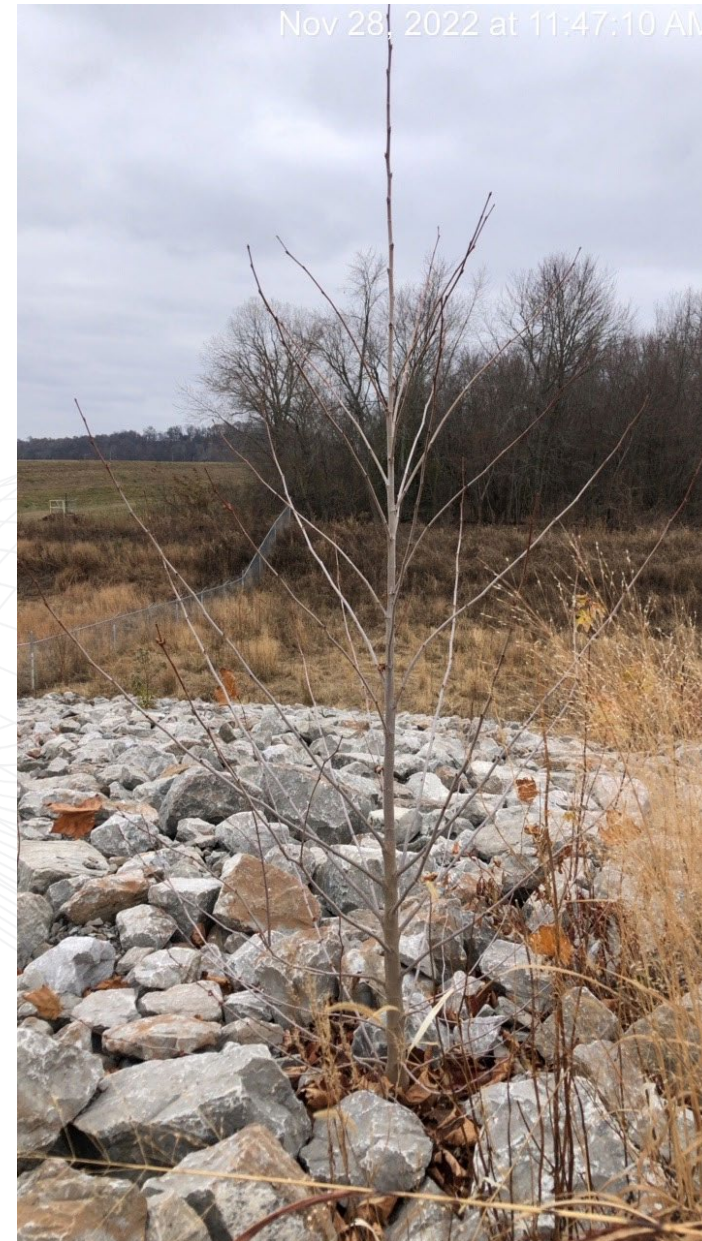
Woody Growth Observations

Southern face of impoundment cap with woody growth (up to 1" diameter) within riprap. Increasing woody growth found within riprap along south, west, and northern sides of the impoundment.

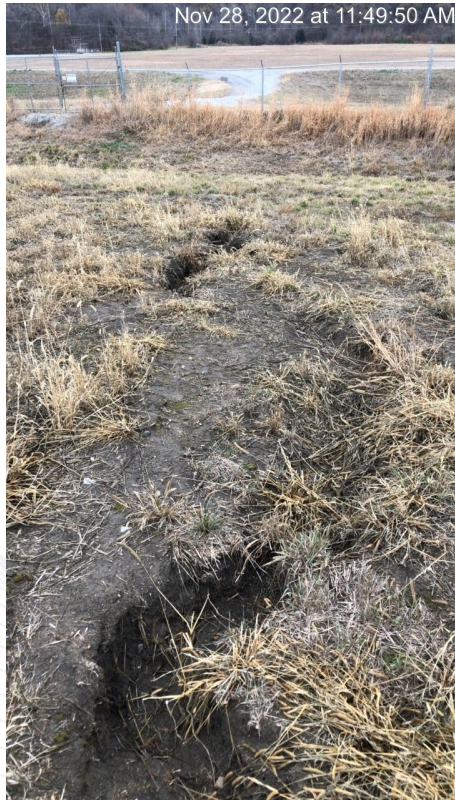
Erosional channel up to 9" deep. Facing east from center-east side of impoundment cap.

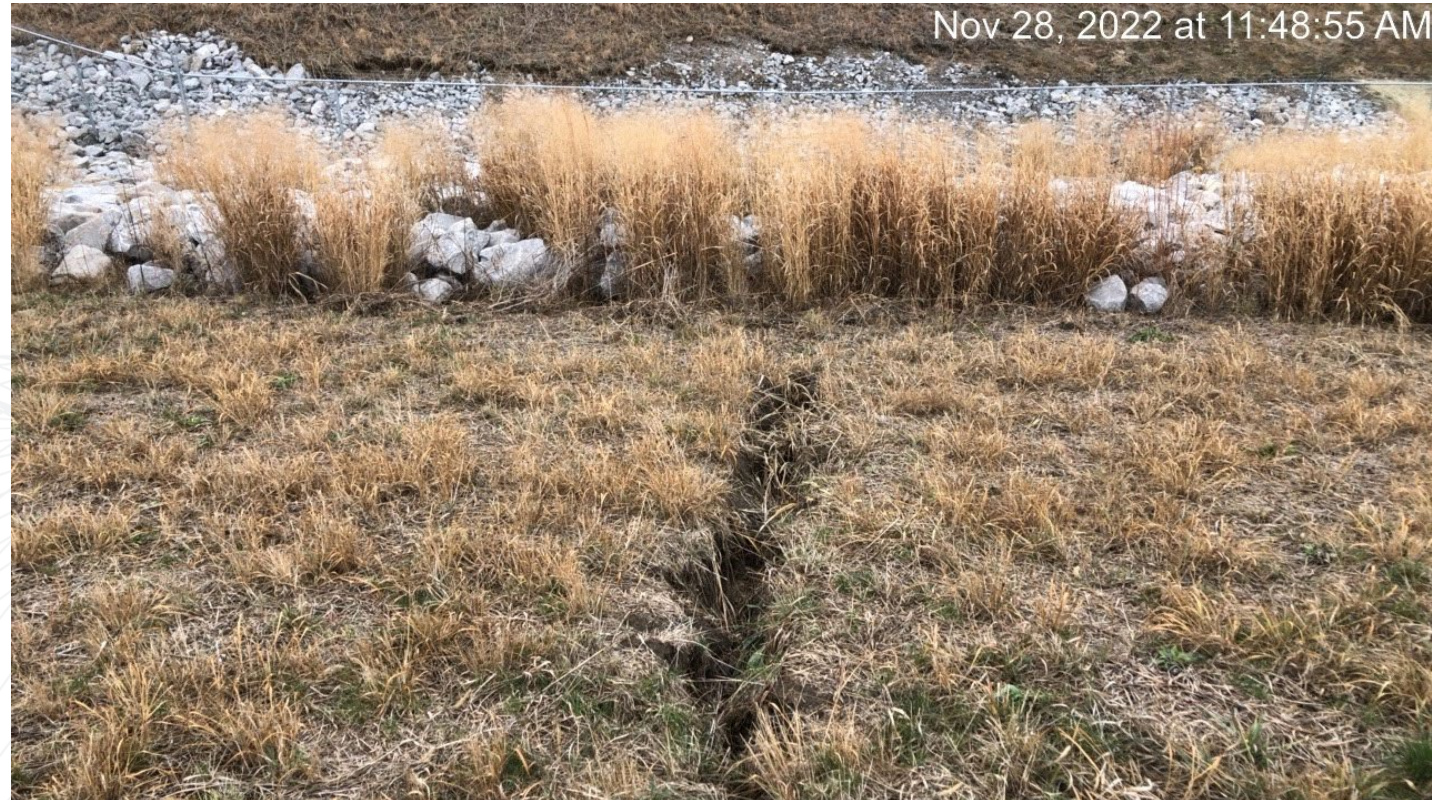
Erosional channel up to 9" deep. Facing east on southeast side of impoundment cap.
