Grand Tower Energy Center Closed CCR Impoundment Quarterly Inspection Form

Date: 6/26/2023

Grand Tower Energy Center Q2 2023 Closed CCR Impoundment Cap Inspection

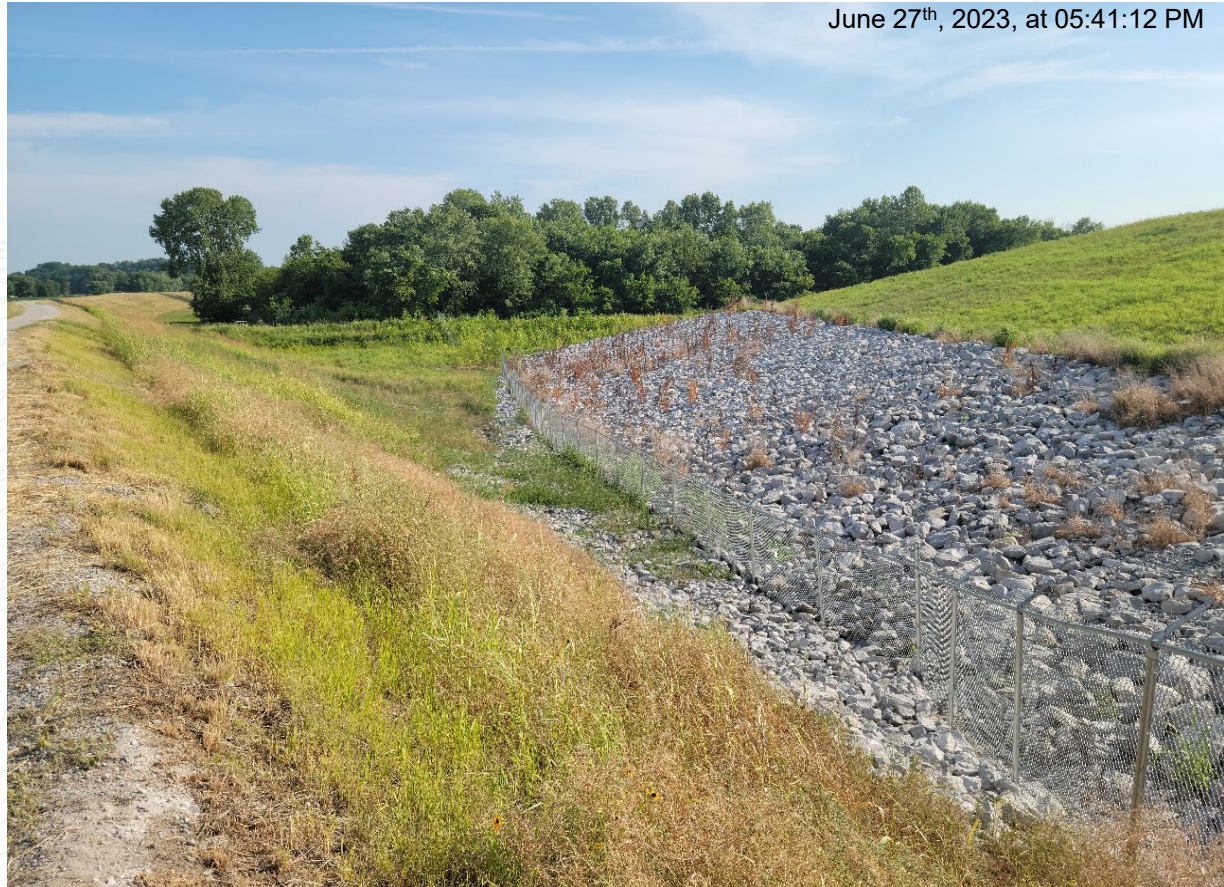
Repairs to the Fenceline and Levee area on the SE Side of Closed CCR Impoundment Cap

Facing south along the repaired fenceline, riprap, and levee area. Levee has successfully revegetated since repairs were initiated during 2022.

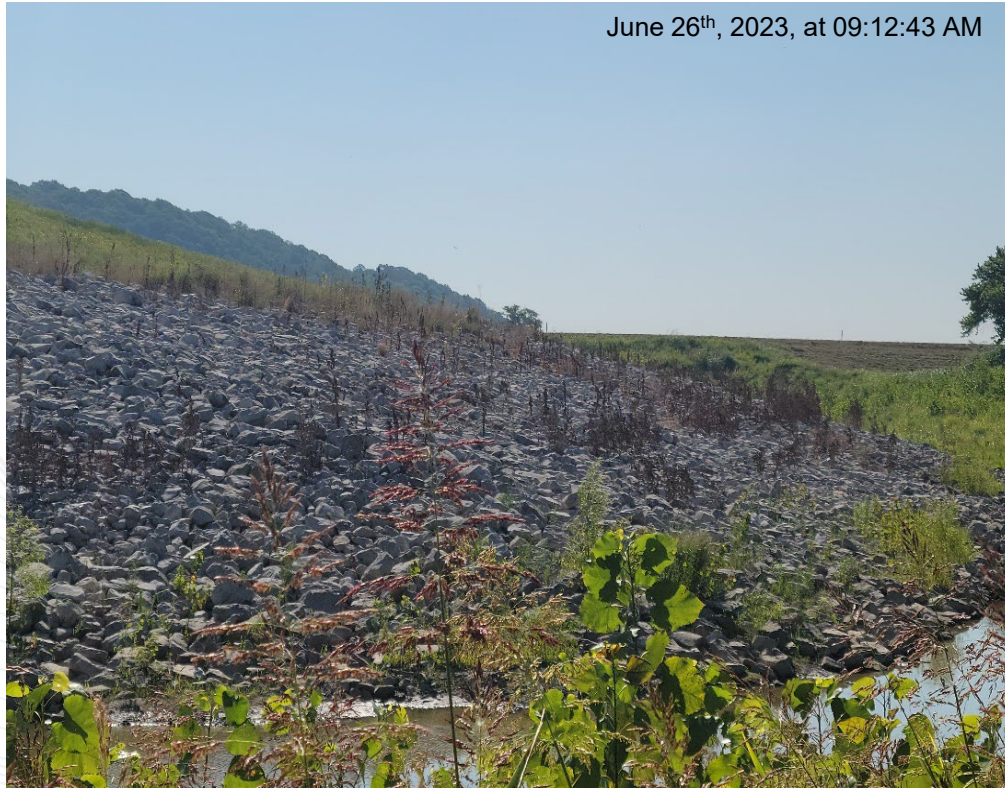
Repairs to the Levee erosion on the SE Side of Closed CCR Impoundment Cap and Woody Growth Observations

- Erosion noted across north, west, and southern CCR impoundment cap faces up to 9" deep.
- The woody vegetation (up to 1" diameter) noted to be within the riprap on the north, west, and southern impoundment cap faces during 2022 was treated with herbicide during Q1 2023. However, some live woody vegetation growth remains within the riprap.

Facing east towards impoundment cap – dead/herbicide treated woody vegetation noted within riprap up to 1” diameter. Limited amount of live woody growth remains.

- The Inspector recommends continued treatment of woody growth within the riprap with herbicide, and the filling of the erosional channels noted above.

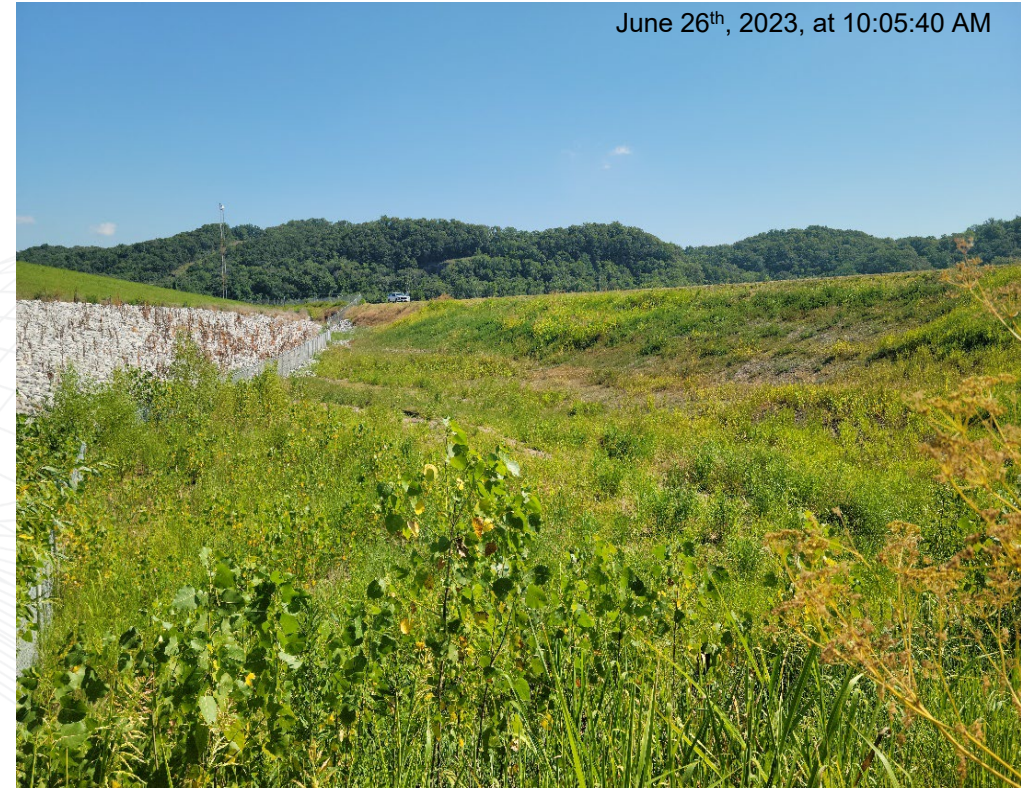
Facing northeast towards repaired section of USACE and GTEC levee sections.

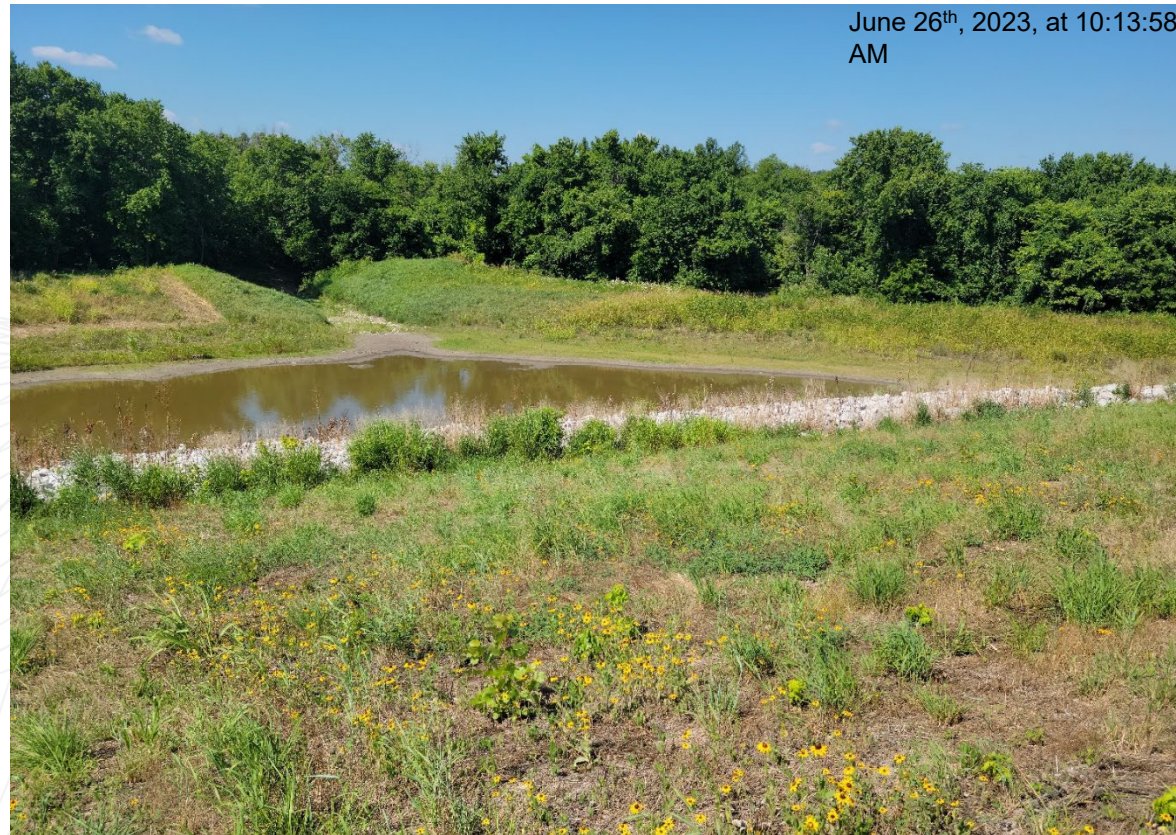
Ponding in the SW Corner of Site Basin Near the Outfall

Ponded area in southwest corner of site as viewed from mowed impoundment cap.

Note: Mississippi River backwater enters the GTEC CCR Impoundment Basin when the river level gage operated by the U.S. Army Corps of Engineers at Grand Tower, IL reaches a stage of approximately 27 ft.

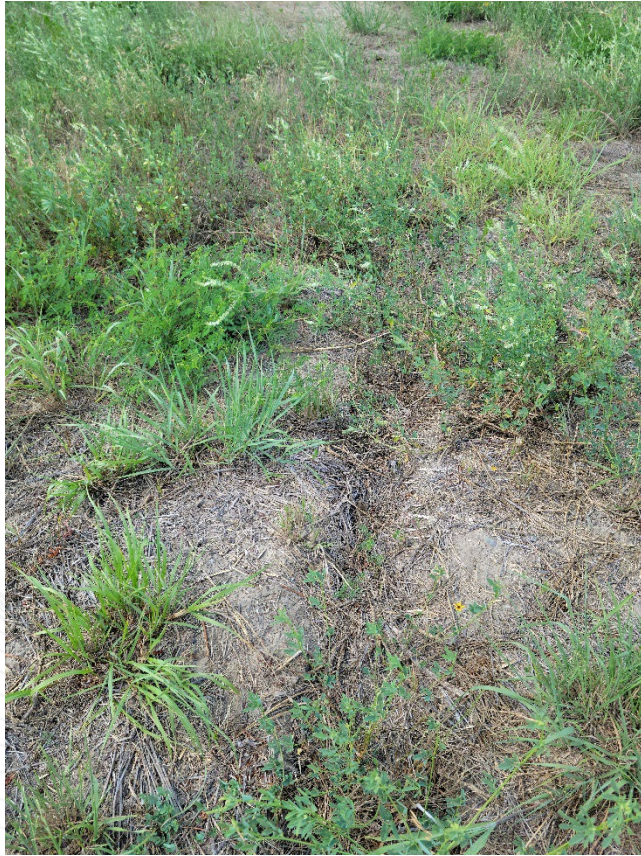
Erosion up to 9" deep - facing east from center-east side of impoundment cap.

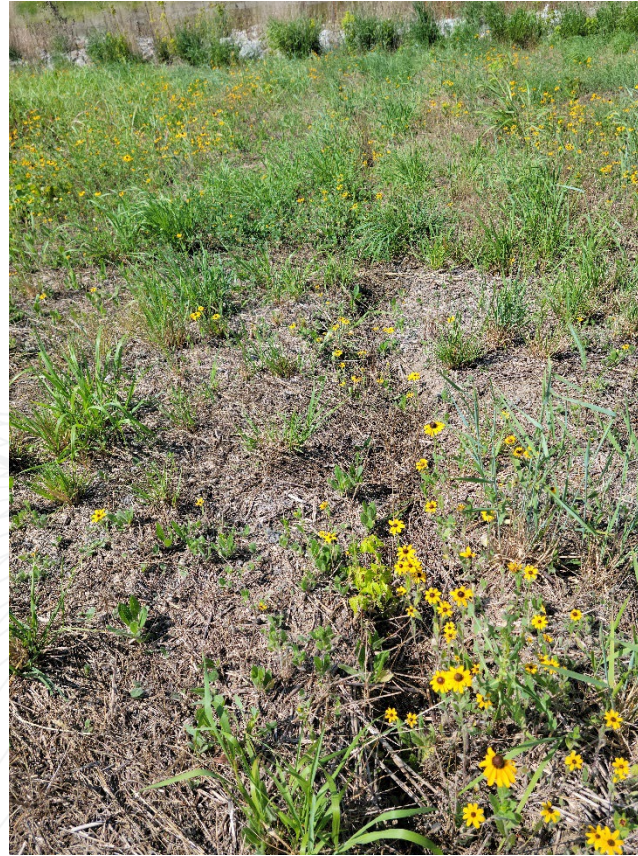
Erosion up to 9" deep - facing south from center-south side of impoundment cap.

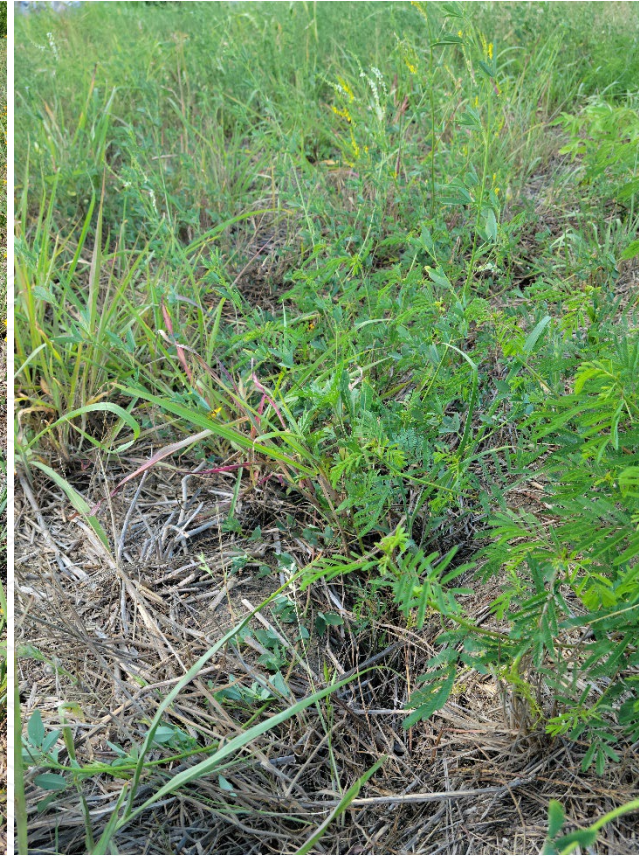
Erosion up to 9" deep - facing southwest from southern side of impoundment cap.
