Grand Tower Energy Center Closed CCR Impoundment Quarterly Inspection Form

Grand Tower Energy Center Q1 2023 Closed CCR Impoundment Cap Inspection - 3 March 2023

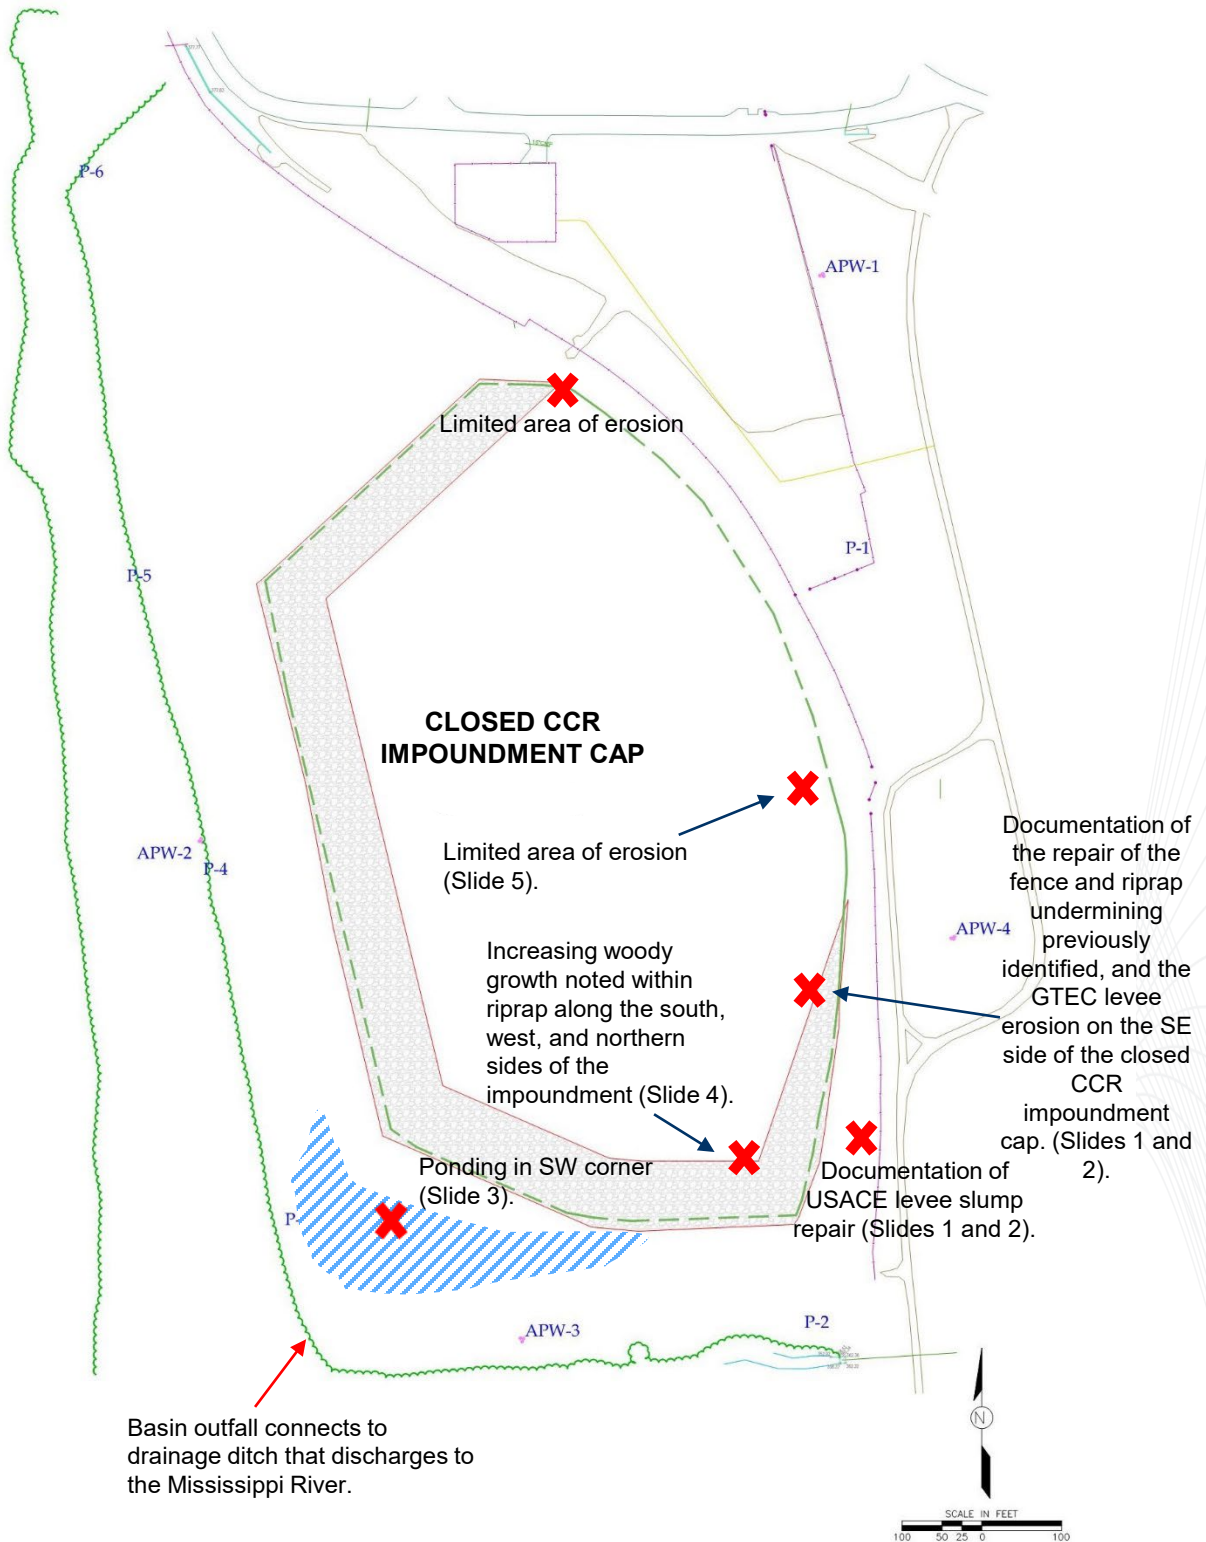
Observation Locations Map

Please see observation locations on figure on the following page.

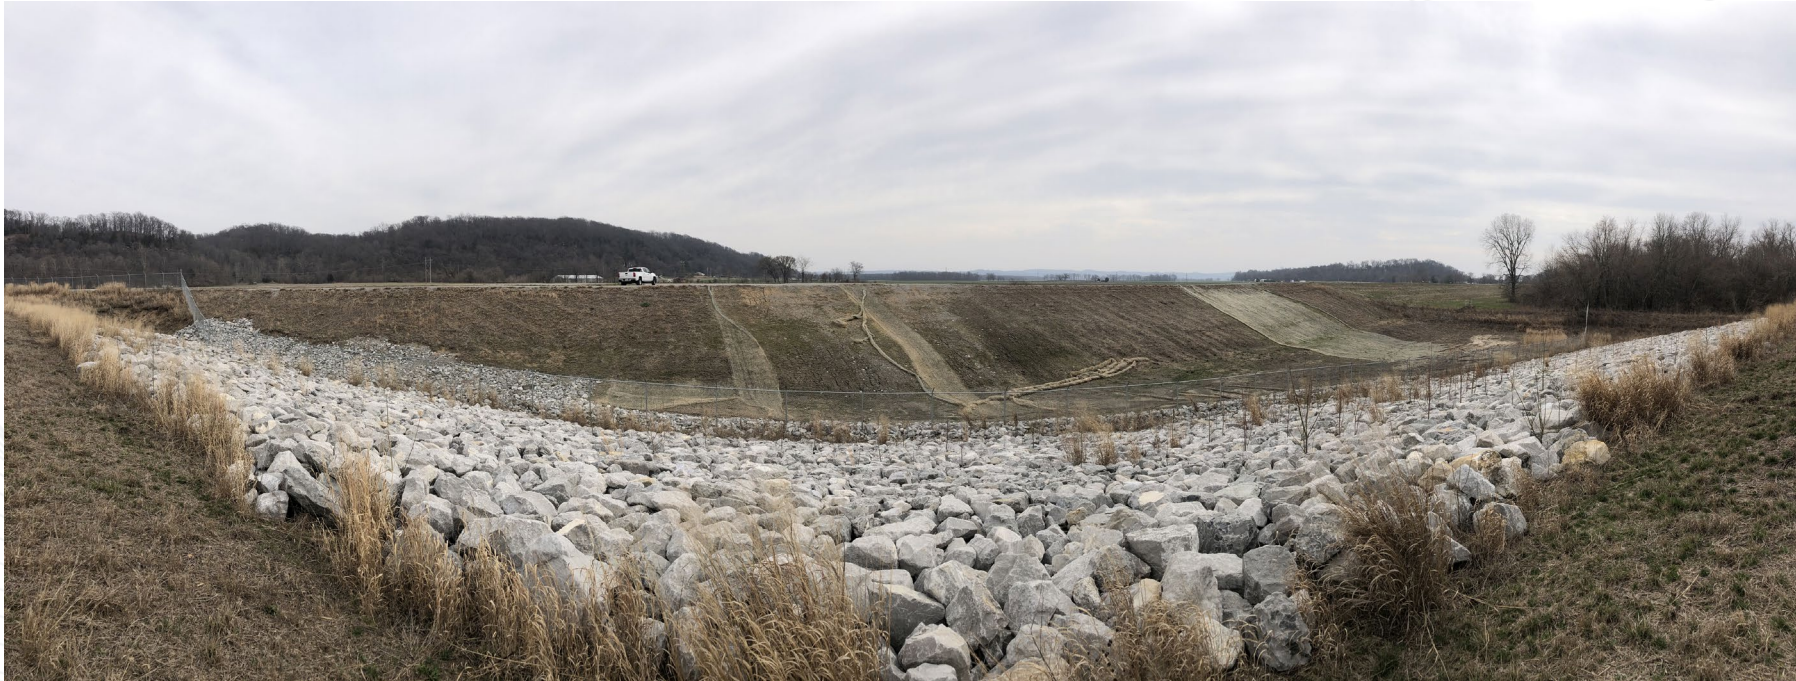
Repairs to the Levee and Fence Undermining on the SE Side of the Closed CCR Impoundment Cap

- Completed repairs to the fence undermining on the east/SE side documented (see figure and photos).
- Post-repair erosion control measures (straw matting) on USACE levee has partially become detached.

Facing east towards the repaired Grand Tower Energy Center (GTEC) and United States Army Corps of Engineers (USACE) levee area. Note: straw matting from repaired levee face has become partially detached and deposited at the bottom of the slope.

- Ponding noted in SW corner of the basin near the outfall.
- Inspector recommends removal of woody growth, repair of erosional channels, and re-installing straw matting on the USACE levee repair area.

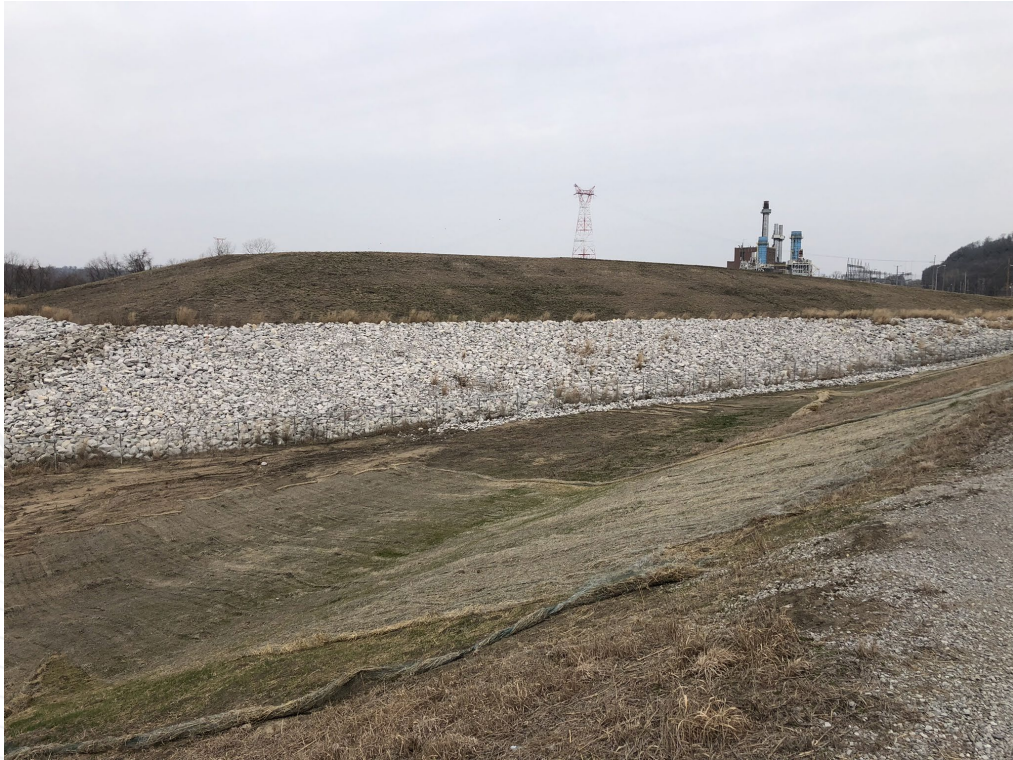
Repairs to the Fence and Riprap Undermining, and Levee erosion on the SE Side of Closed CCR Impoundment Cap

Facing north towards impoundment cap – repairs of fence and riprap undermining, and USACE levee section are visible.

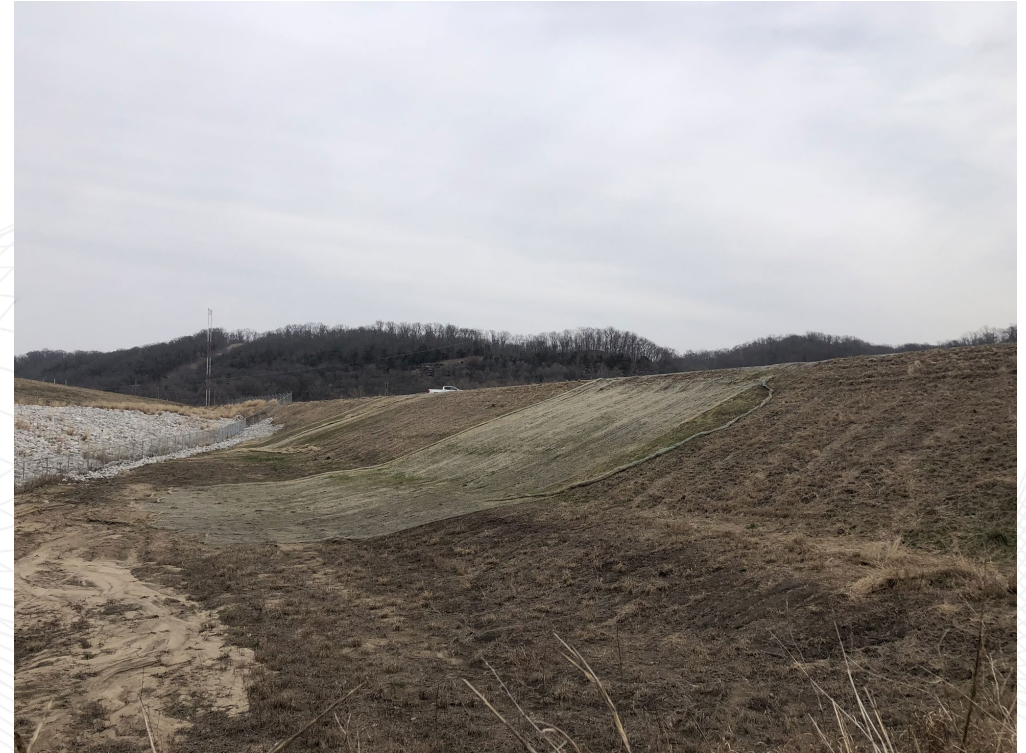
Facing northeast towards repaired section of USACE levee.

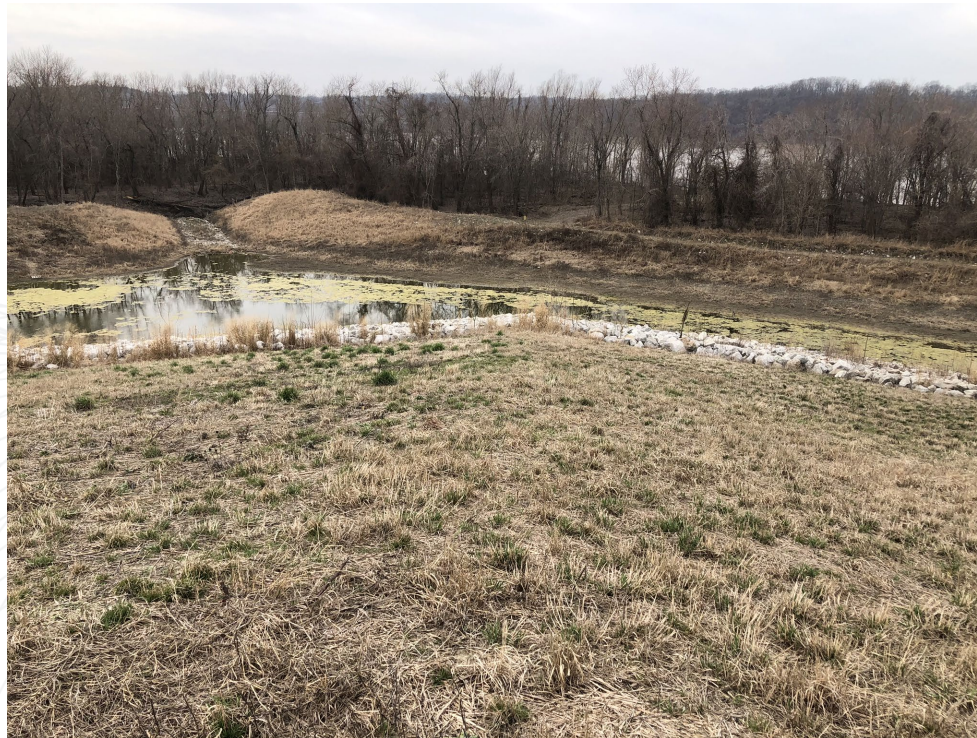
Ponding in the SW Corner of Site Basin Near the Outfall

Ponded area in southwest corner of site as viewed from impoundment cap.

Note: Mississippi River backwater enters the GTEC CCR Impoundment Basin when the river level gage operated by the U.S. Army Corps of Engineers gage at Grand Tower, IL reaches a stage of approximately 27 ft.

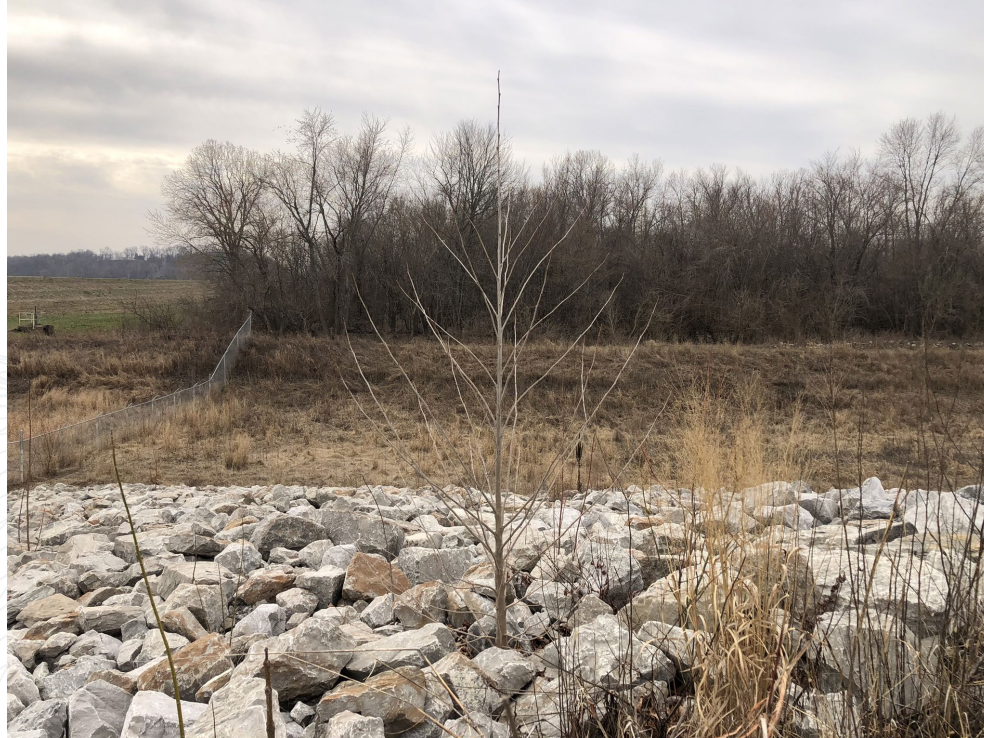
Woody Growth Observations

Southern face of impoundment cap with woody growth (up to 1" diameter) within riprap. Increased woody growth since the third quarter 2022 found within riprap along south, west, and northern sides of the impoundment.

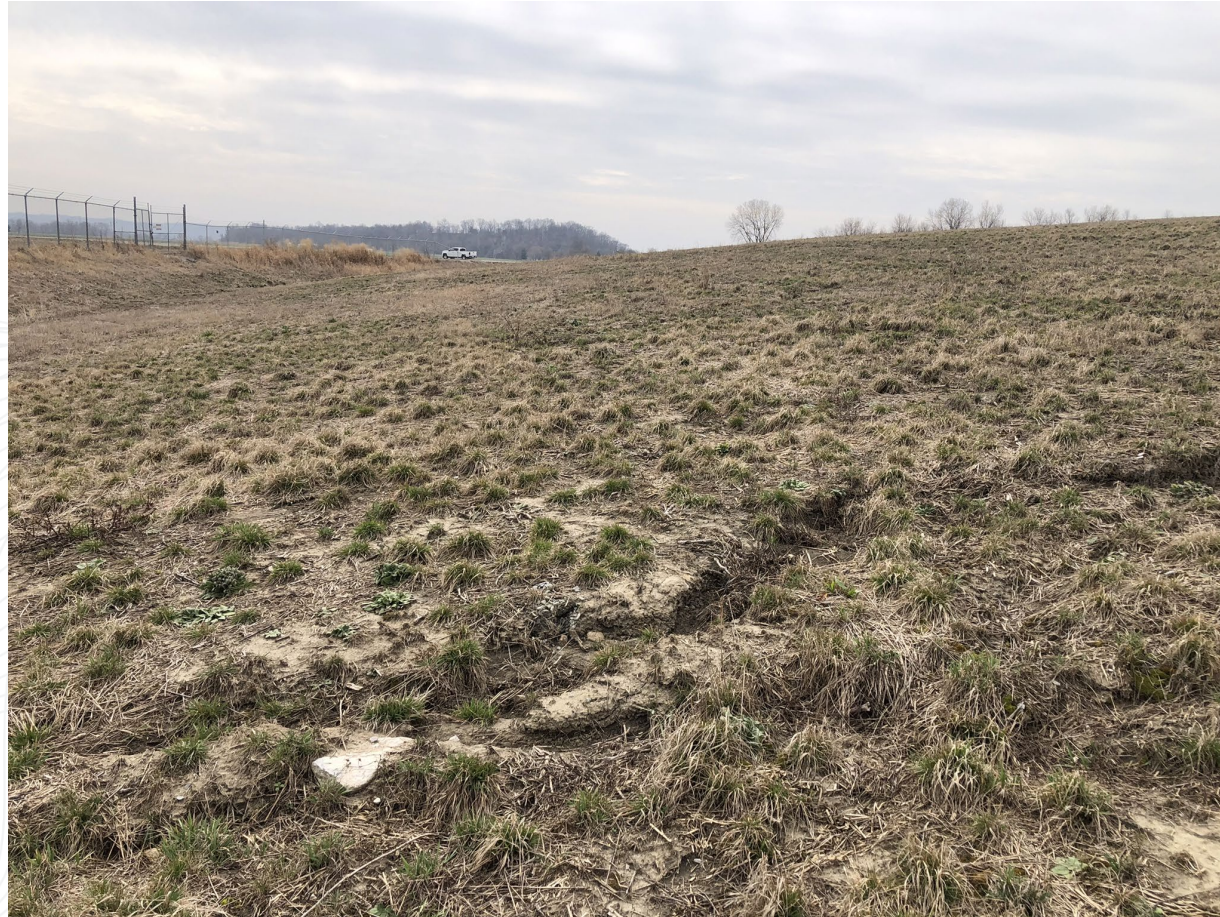
Erosional Channel Observations

- Erosion noted across north, west, and southern CCR impoundment cap faces up to 9" deep.
- Growth of a limited but increased amount of woody vegetation (up to 1" diameter) within the riprap on the north, west, and southern impoundment cap faces was observed.

Facing south on east side of impoundment cap.
