2023 Grand Tower Energy Center Annual Inspection Report

PREPARED FOR
Rockland Capital, LLC

DATE
January 2024

REFERENCE
0599247

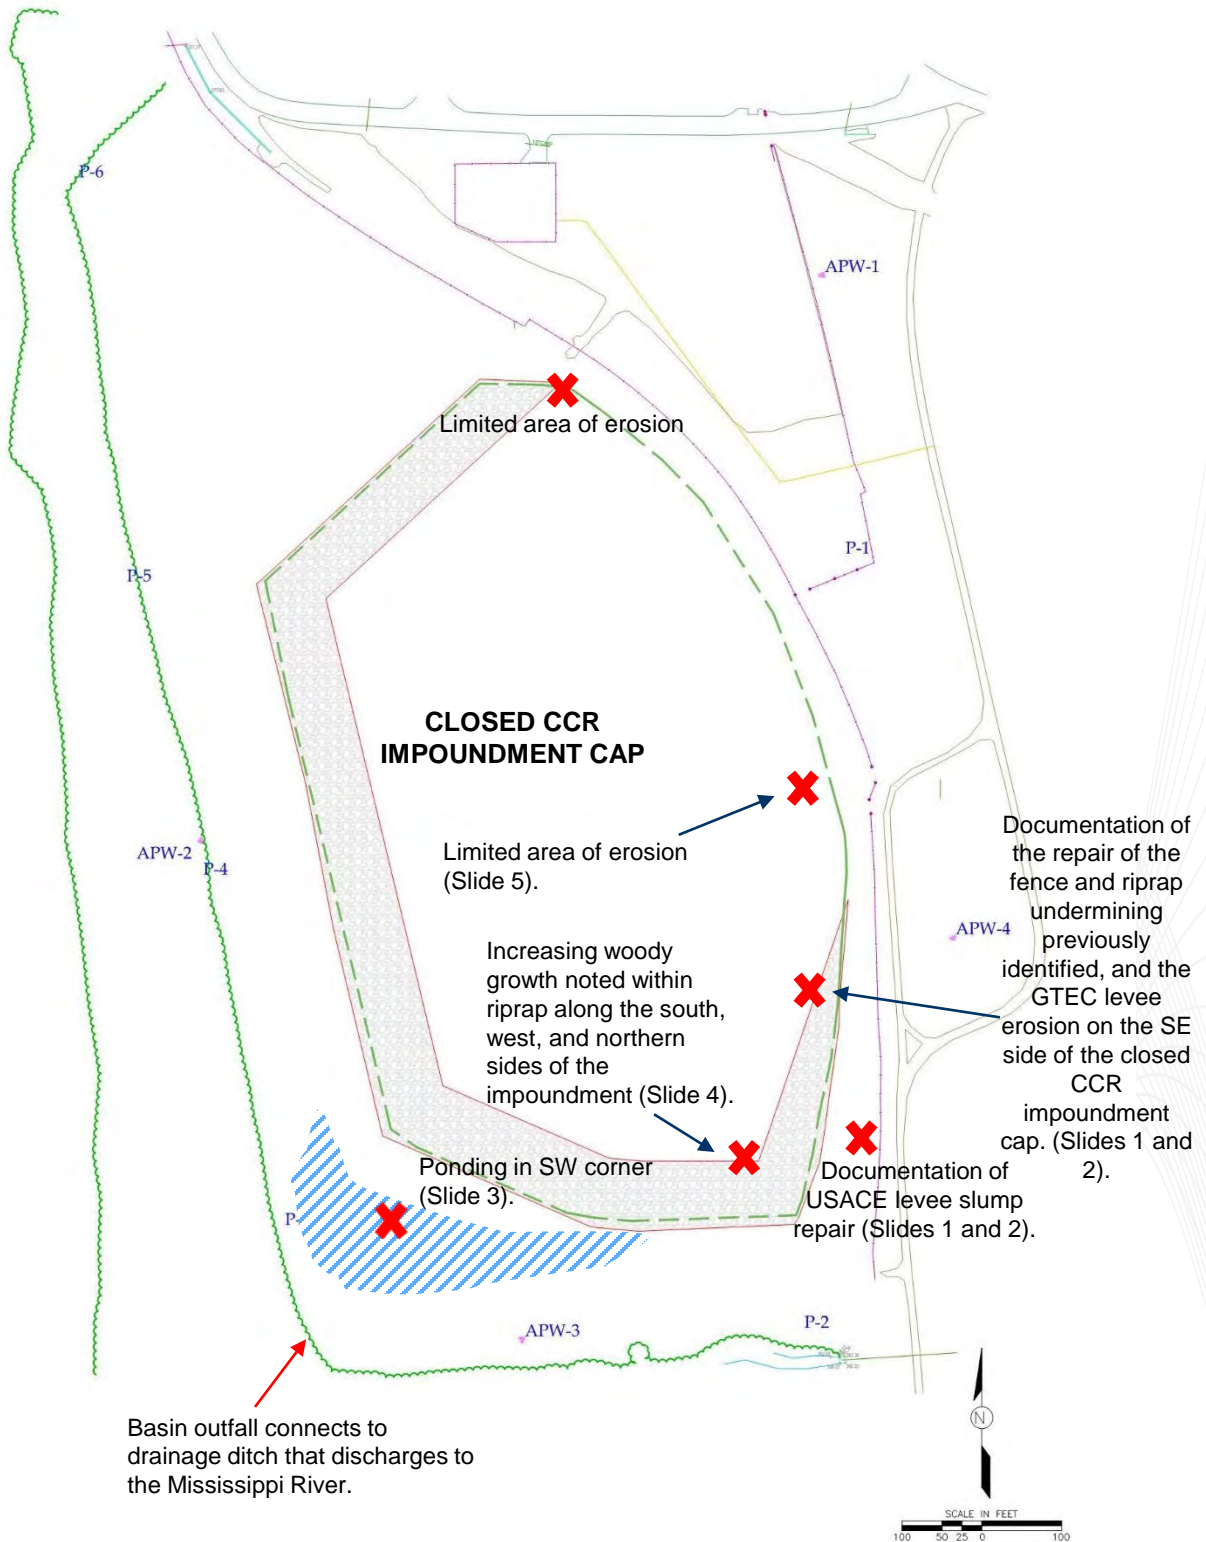
Observation Locations Map

- ERM onsite for the Q1 inspection of the closed CCR impoundment and groundwater sampling event.
- Completed repairs to the U.S. Army Corps of Engineers (USACE) Levee by Grand Tower Energy Center (GTEC) continues to be documented by ERM (see figure and photos).

- Completed repairs to the fence undermining on the east/SE side documented (see figure and photos).
- Post-repair erosion control measures (straw matting) on USACE levee has partially become detached.

- Erosion noted across north, west, and southern CCR impoundment cap faces up to 9" deep.
- Growth of a limited but increased amount of woody vegetation (up to 1" diameter) within the riprap on the north, west, and southern impoundment cap faces was observed.

- Ponding noted in SW corner of the basin near the outfall.
- Inspector recommends removal of woody growth, repair of erosional channels, and re-installing straw matting on the USACE levee repair area.

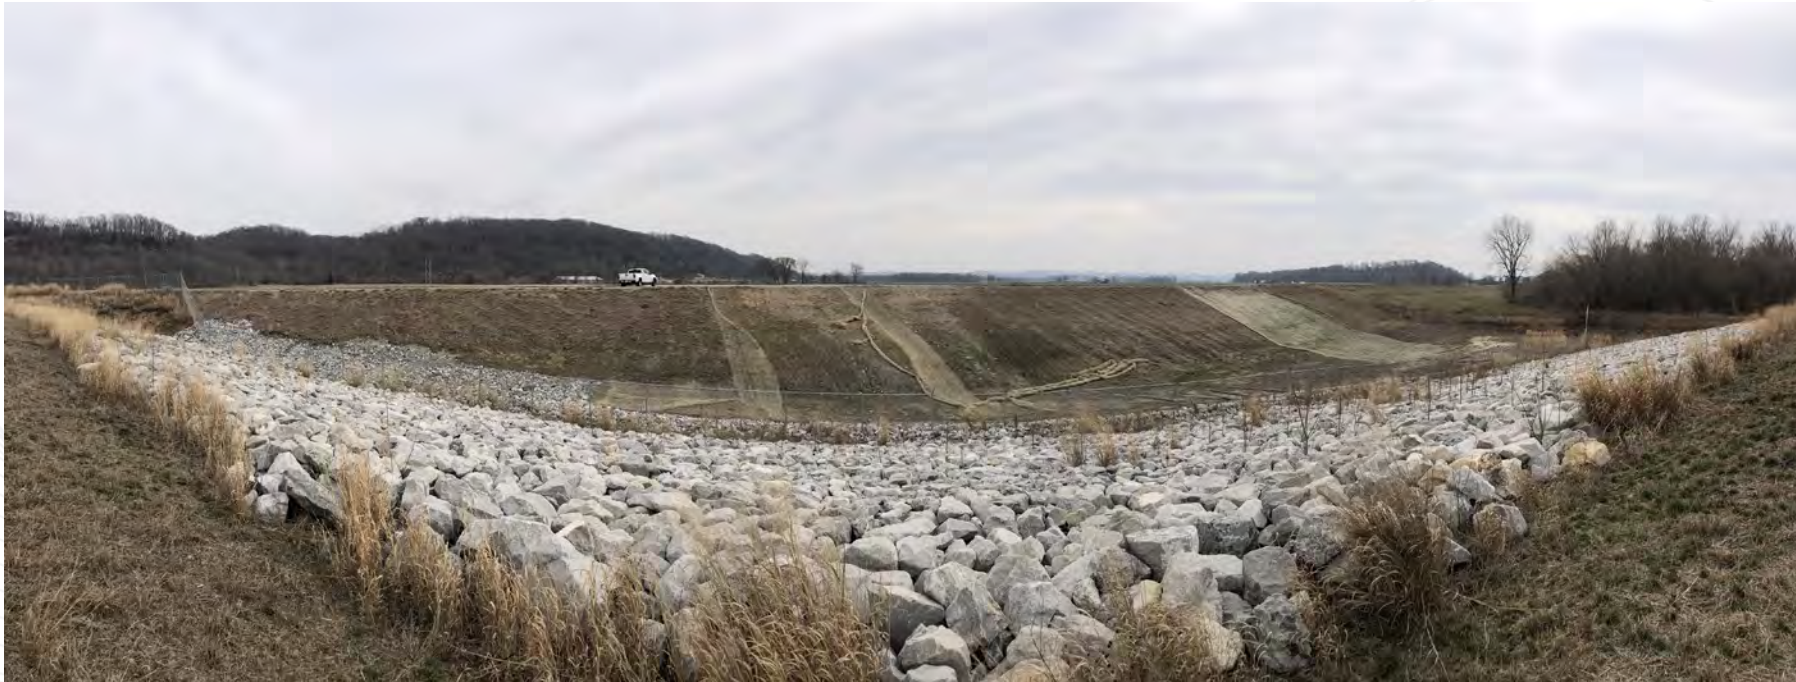
Repairs to the Levee and Fence Undermining on the SE Side of the Closed CCR Impoundment Cap

Facing east towards the repaired Grand Tower Energy Center (GTEC) and United States Army Corps of Engineers (USACE) levee area. Note: straw matting from repaired levee face has become partially detached and deposited at the bottom of the slope.

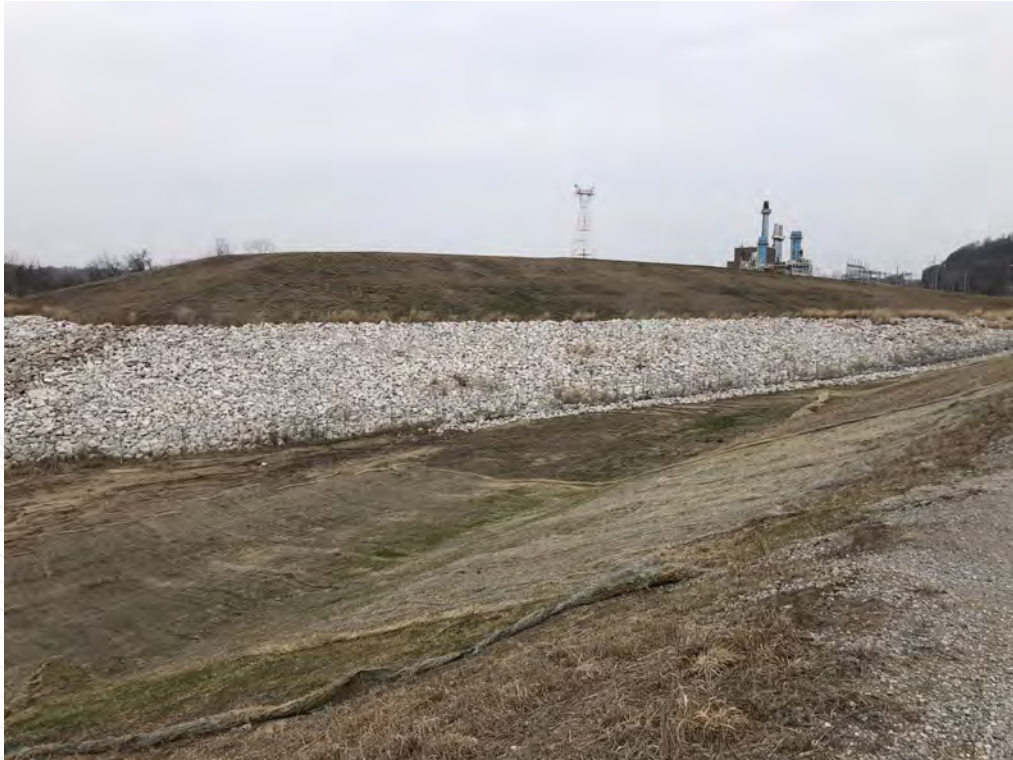
Repairs to the Fence and Riprap Undermining, and Levee erosion on the SE Side of Closed CCR Impoundment Cap

Facing north towards impoundment cap – repairs of fence and riprap undermining, and USACE levee section are visible.

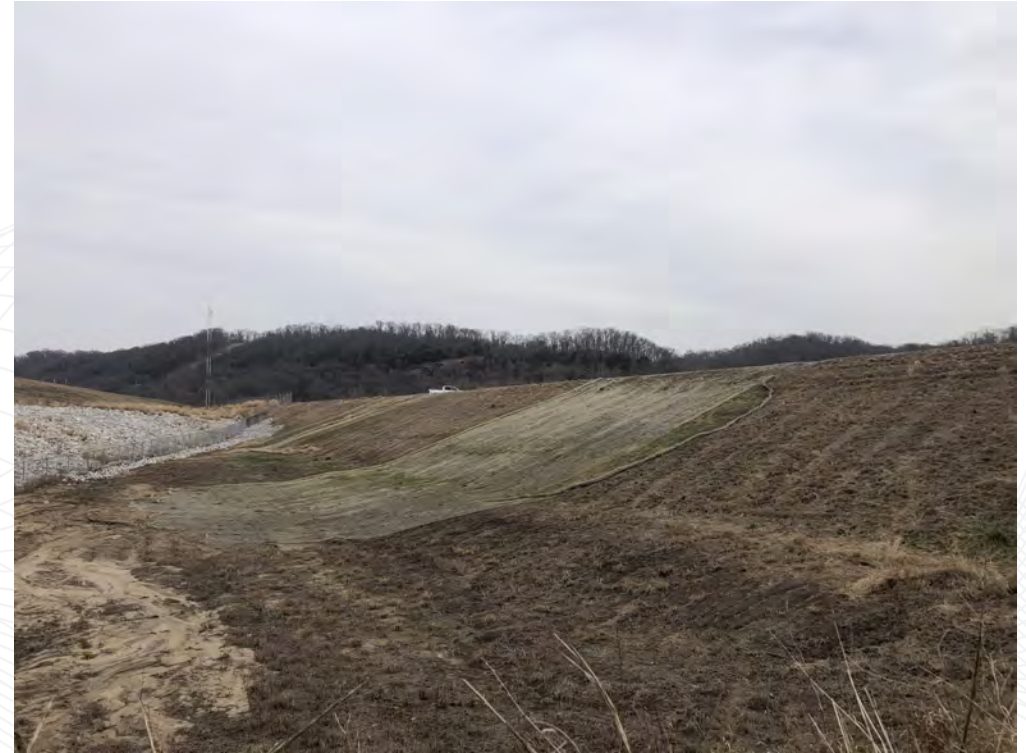
Facing northeast towards repaired section of USACE levee.

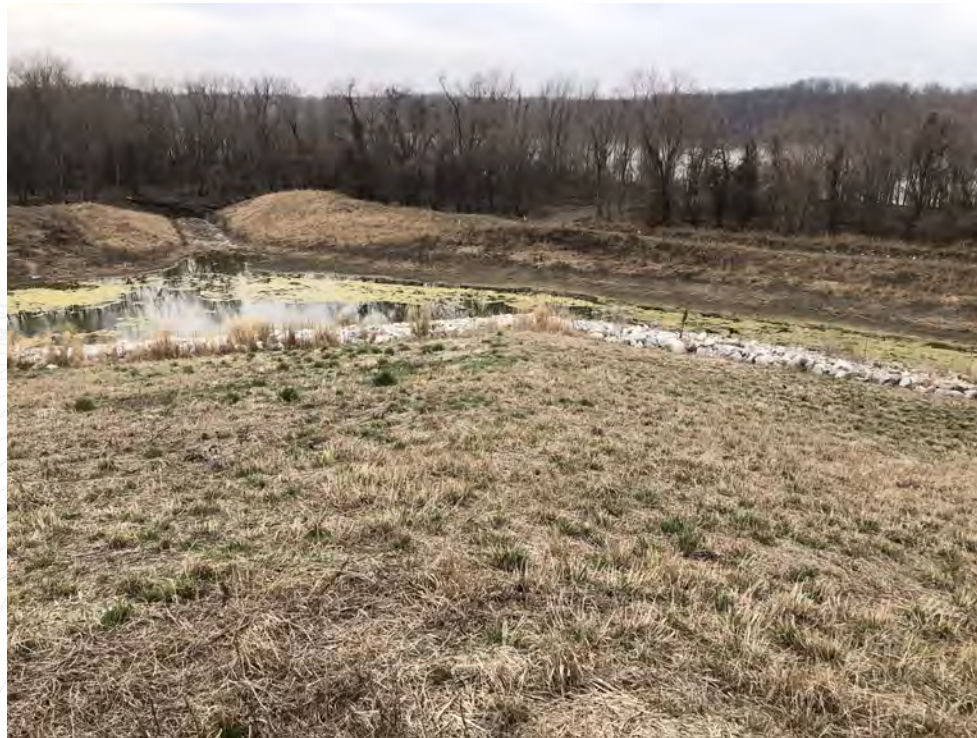
Ponding in the SW Corner of Site Basin Near the Outfall

Ponded area in southwest corner of site as viewed from impoundment cap.

Note: Mississippi River backwater enters the GTEC CCR Impoundment Basin when the river level gage operated by the U.S. Army Corps of Engineers gage at Grand Tower, IL reaches a stage of approximately 27 ft.

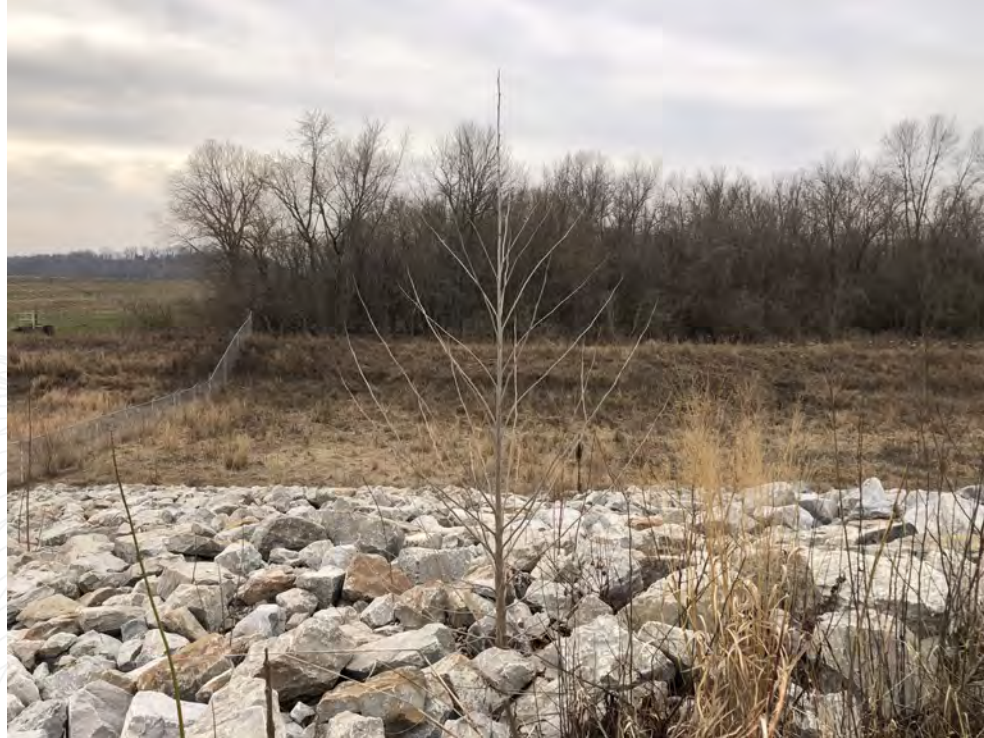
Woody Growth Observations

Southern face of impoundment cap with woody growth (up to 1" diameter) within riprap. Increased woody growth since the third quarter 2022 found within riprap along south, west, and northern sides of the impoundment.

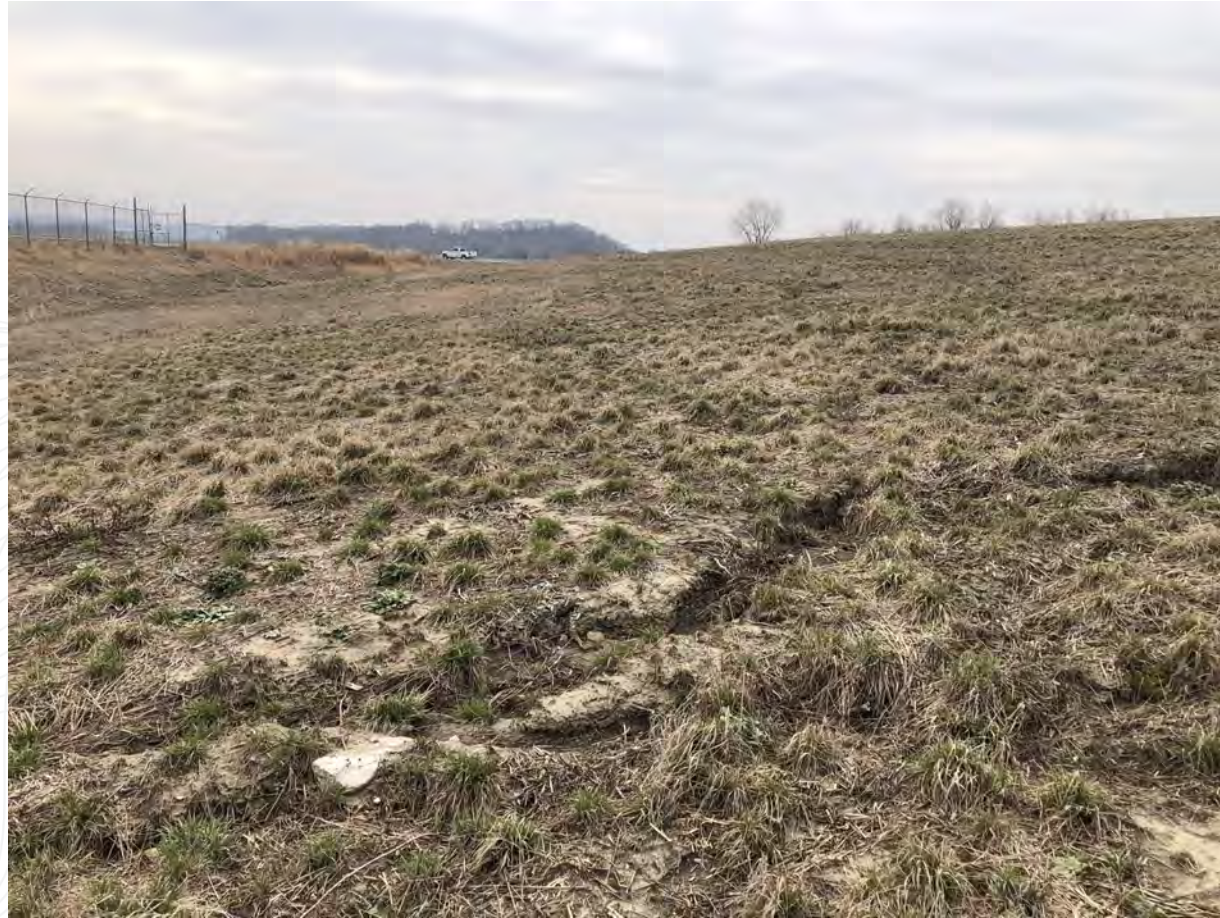
Erosional Channel Observations

Facing south on east side of impoundment cap.

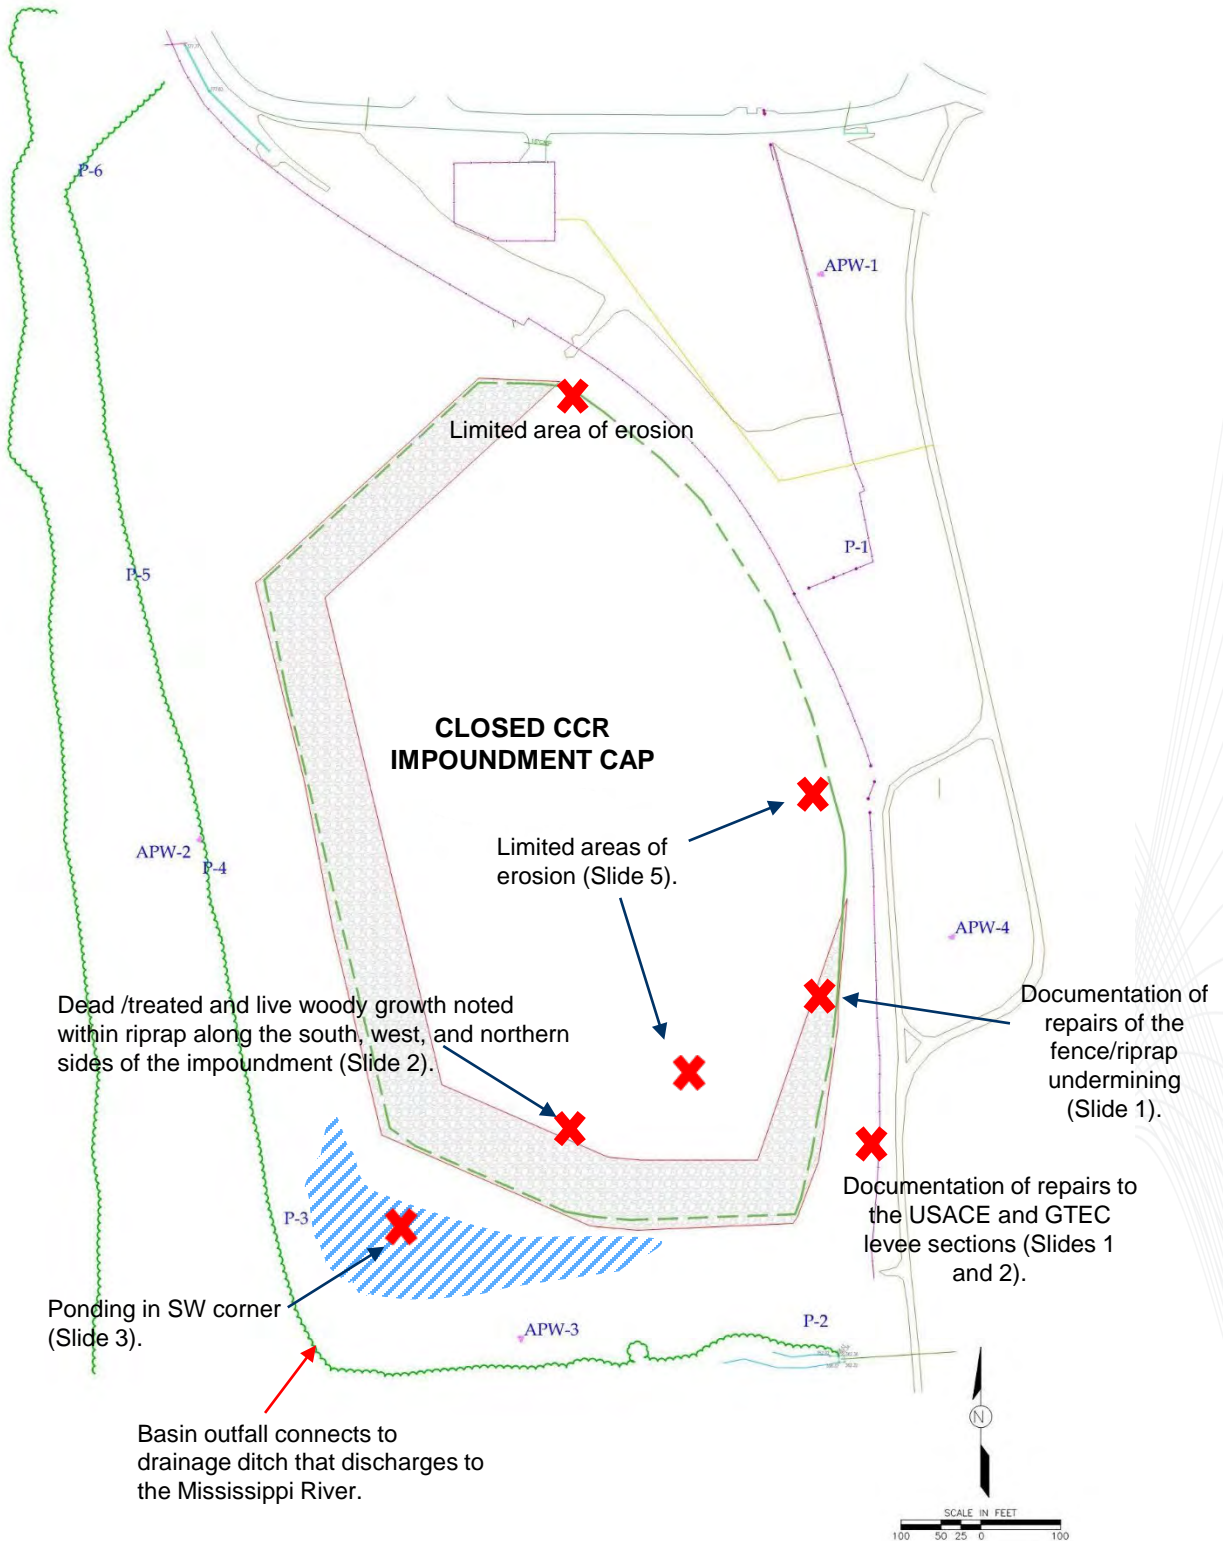
Observation Locations Map

- ERM onsite for the Q2 2023 inspection of the CCR impoundment and groundwater sampling event.
- Repairs to the United States Army Corps of Engineers (USACE) and GTEC levees continue to hold, and successful revegetation of levee face continues to progress.

- Erosion noted across north, west, and southern CCR impoundment cap faces up to 9" deep.
- The woody vegetation (up to 1" diameter) noted to be within the riprap on the north, west, and southern impoundment cap faces during 2022 was treated with herbicide during Q1 2023. However, some live woody vegetation growth remains within the riprap.

- Ponding continues to be noted in the SW corner of the basin near the outfall.
- The impoundment cap was mowed during Q2 of 2023 and found to be in generally good condition.

- The Inspector recommends continued treatment of woody growth within the riprap with herbicide, and the filling of the erosional channels noted above.

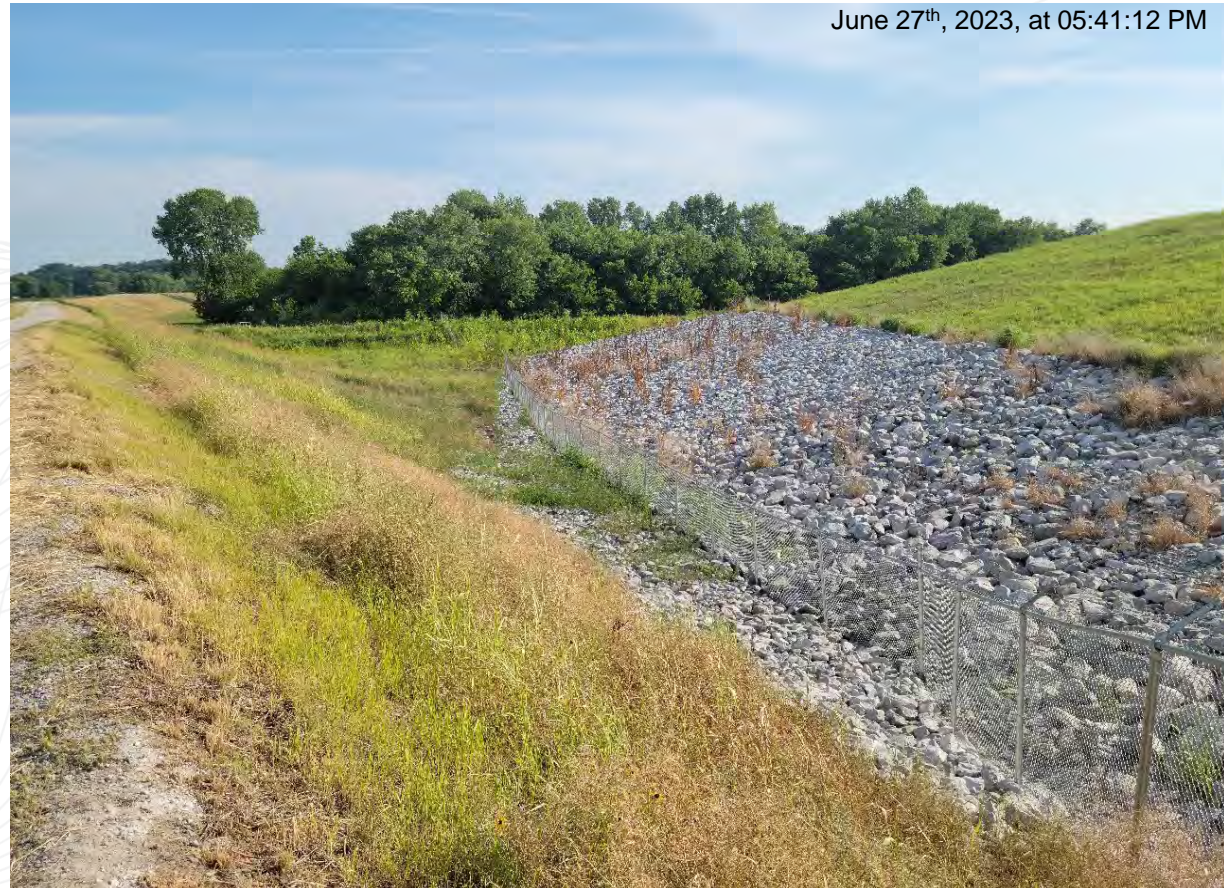
Repairs to the Fenceline and Levee area on the SE Side of Closed CCR Impoundment Cap

Facing south along the repaired fenceline, riprap, and levee area. Levee has successfully revegetated since repairs were initiated during 2022.

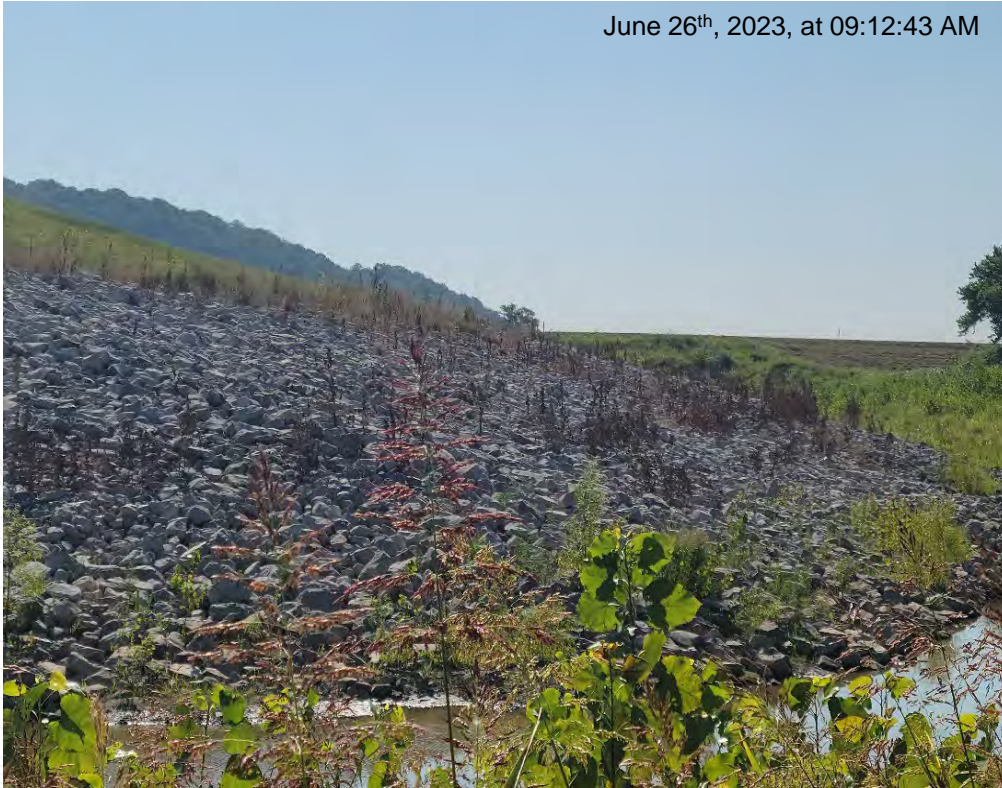
Facing east towards impoundment cap – dead/herbicide treated woody vegetation noted within riprap up to 1” diameter. Limited amount of live woody growth remains.

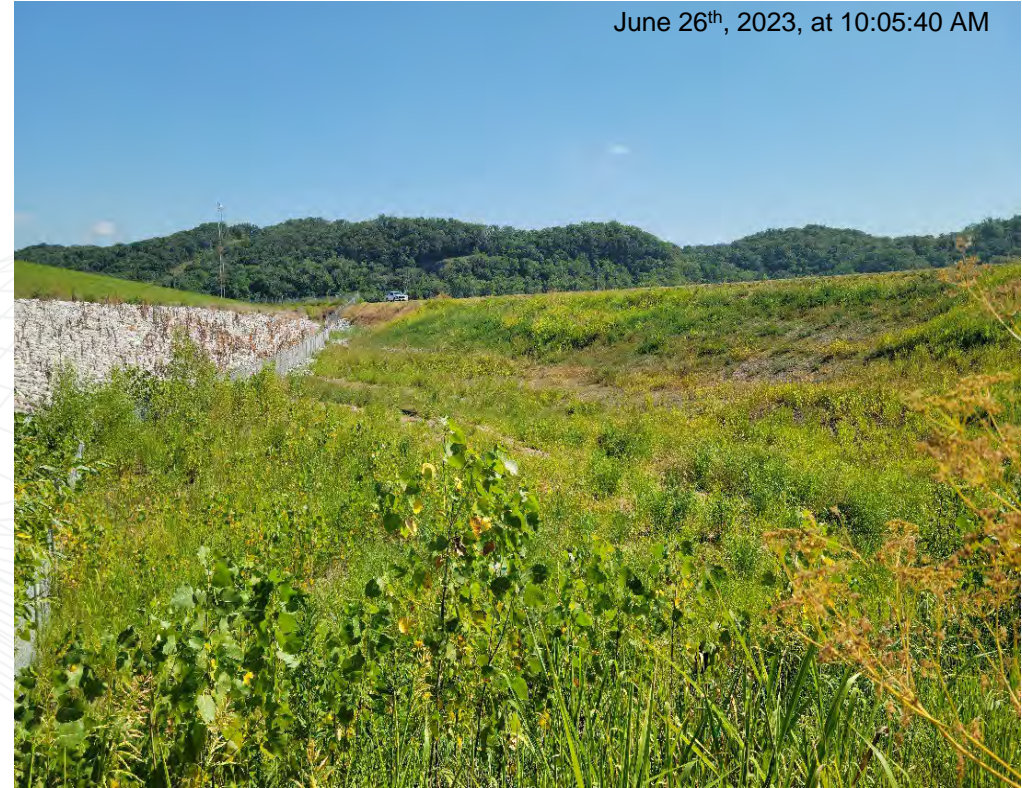
Facing northeast towards repaired section of USACE and GTEC levee sections.

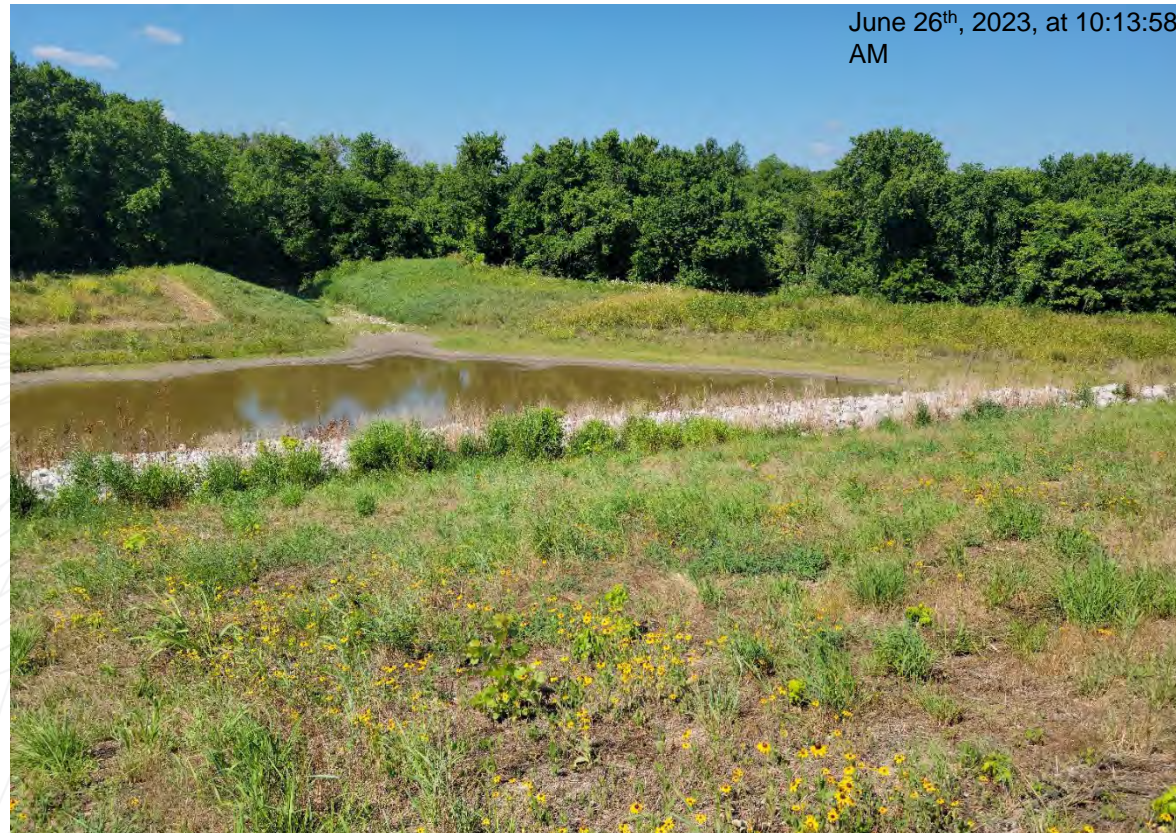
Ponding in the SW Corner of Site Basin Near the Outfall

Ponded area in southwest corner of site as viewed from mowed impoundment cap.

Note: Mississippi River backwater enters the GTEC CCR Impoundment Basin when the river level gage operated by the U.S. Army Corps of Engineers at Grand Tower, IL reaches a stage of approximately 27 ft.

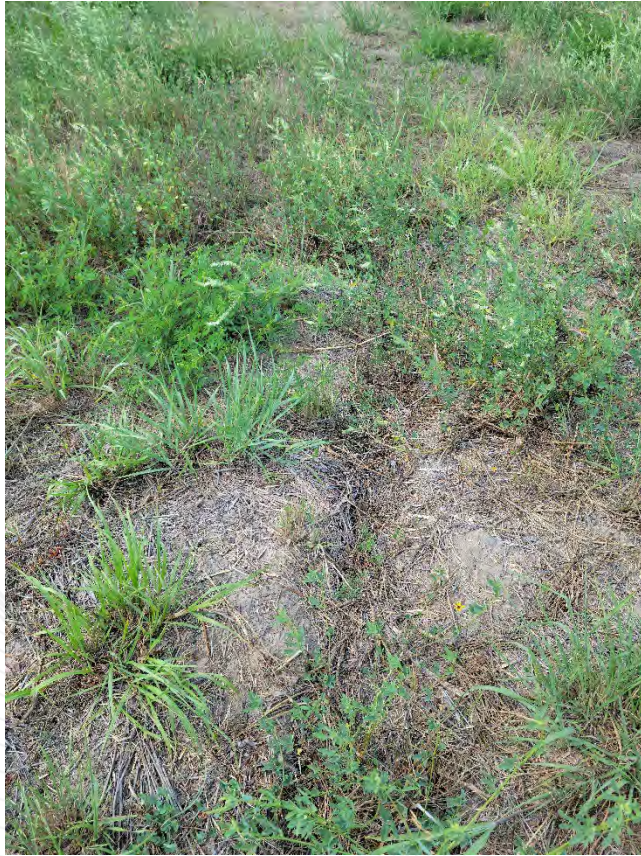
Erosion up to 9" deep - facing east from center-east side of impoundment cap.

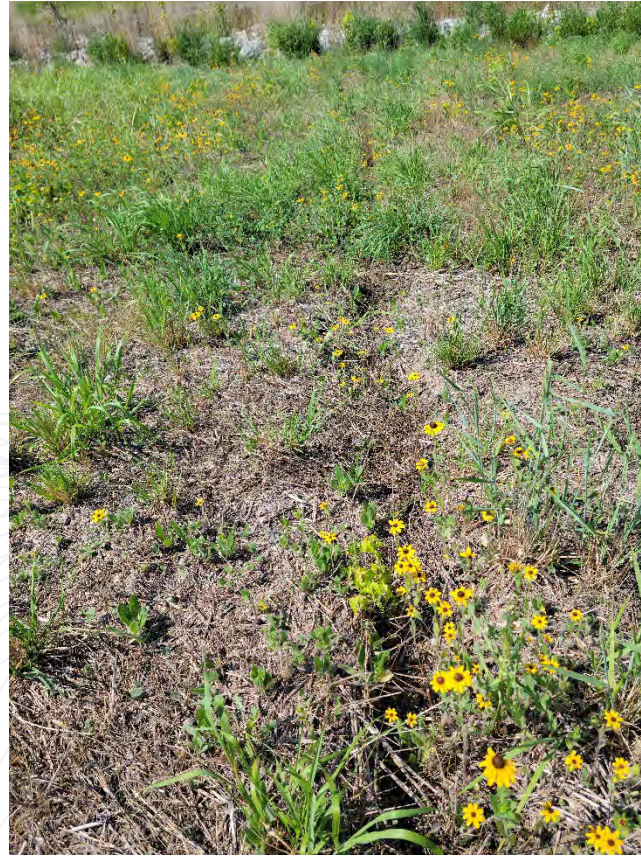
Erosion up to 9" deep - facing south from center-south side of impoundment cap.

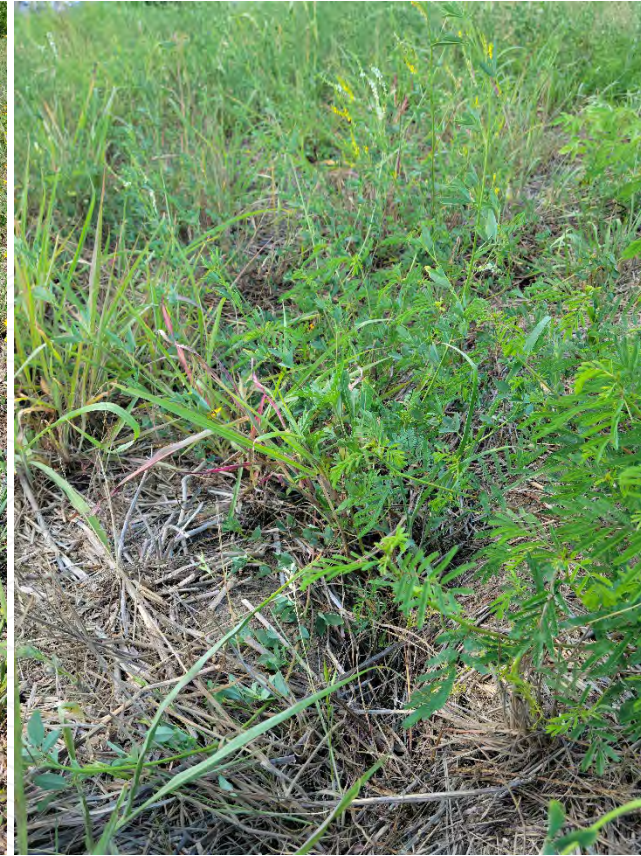
Erosion up to 9" deep - facing southwest from southern side of impoundment cap.

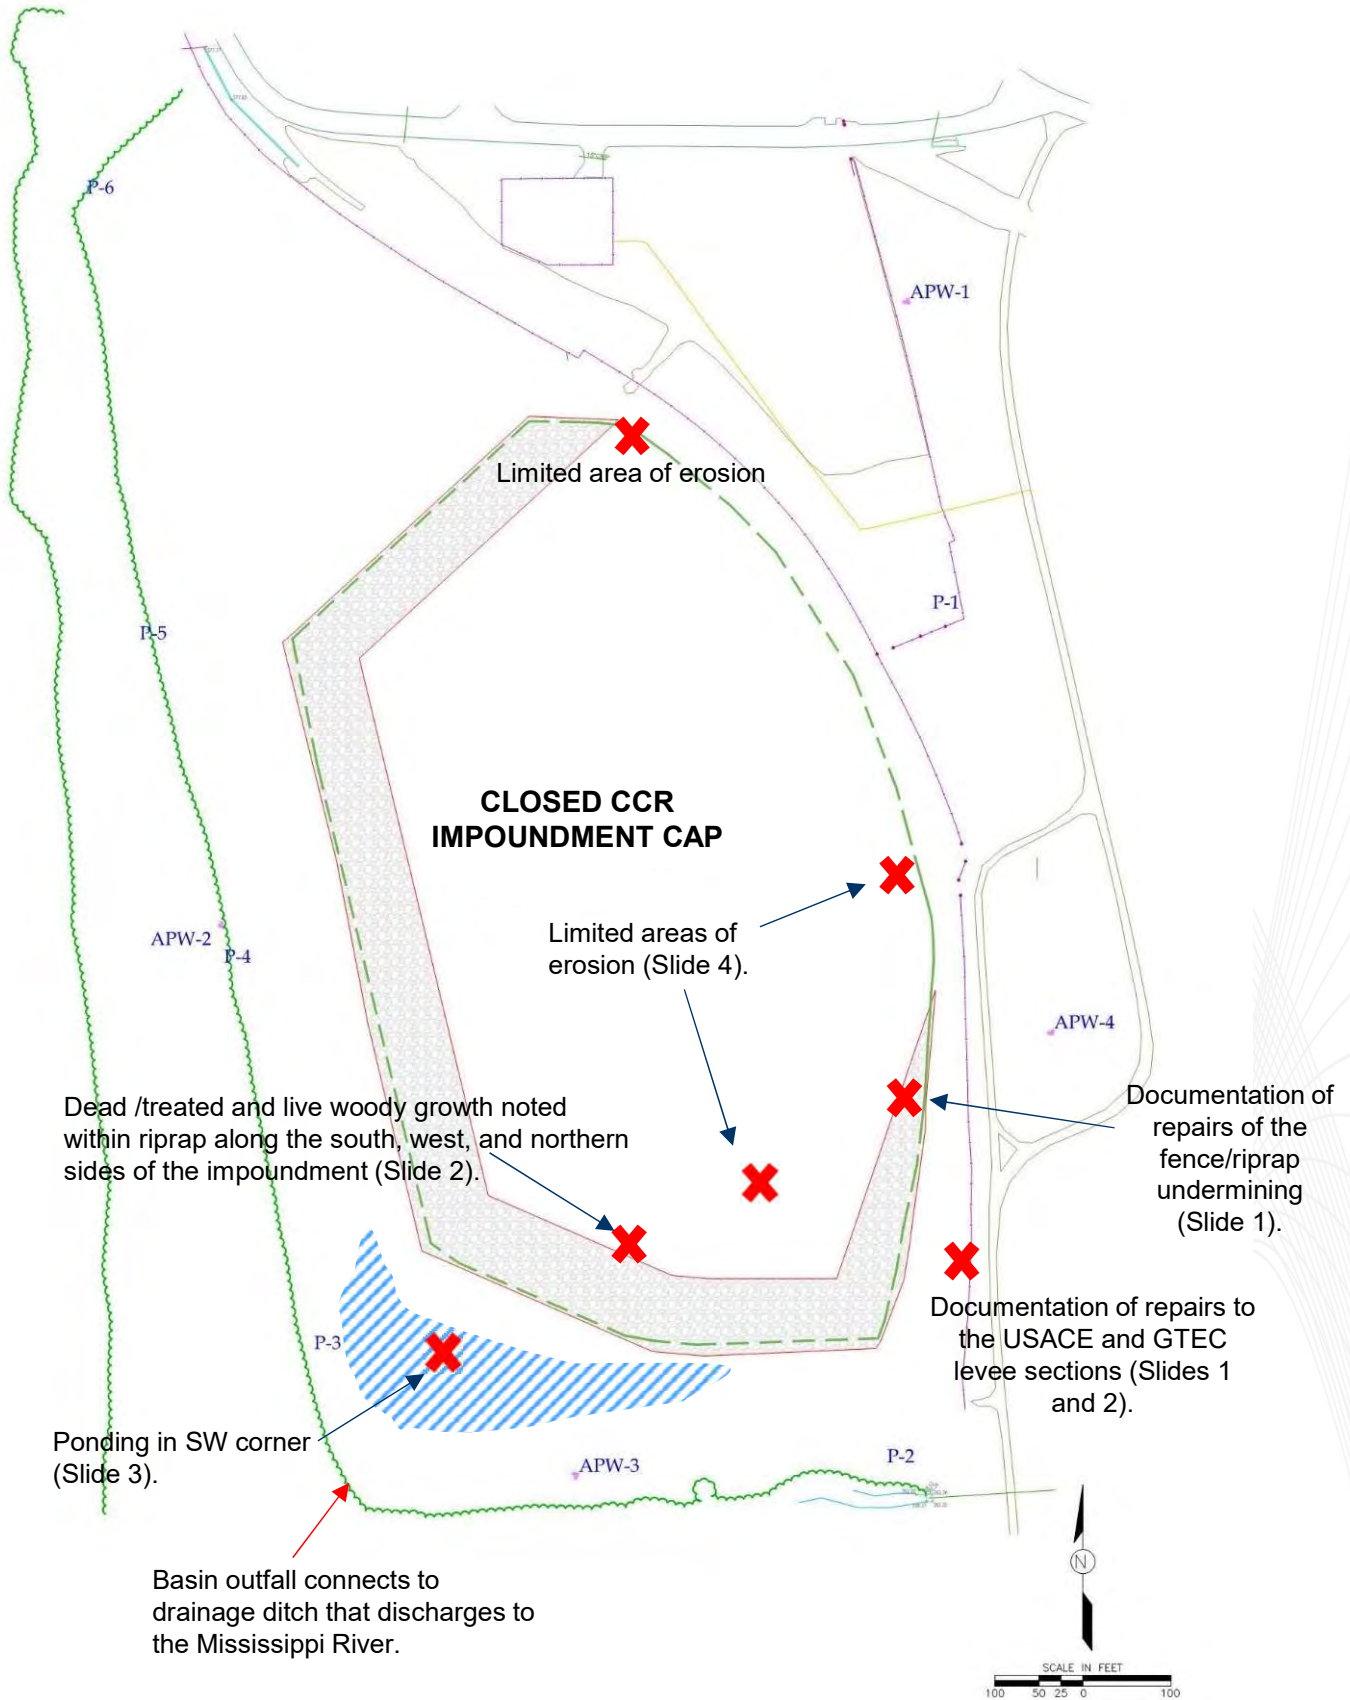
Observation Locations Map

- ERM onsite for the Q3 2023 inspection of the CCR impoundment and groundwater sampling event.
- Repairs to the United States Army Corps of Engineers (USACE) and GTEC levees continue to hold, and successful re-vegetation of levee face continues to progress.
- Erosion noted across north, west, and southern CCR impoundment cap faces up to 9" deep.
- Ponding continues to be noted in the SW corner of basin around the toe of the slope of the impoundment cap near the outfall.
- The impoundment cap was mowed during Q2 2023 and found to be in generally good condition.
- The inspector recommends continued treatment of woody growth within the riprap on the impoundment cap with appropriate management methods such as brushhogging, mowing, cutting, herbicide applications, and the filling of the erosional channels noted above.

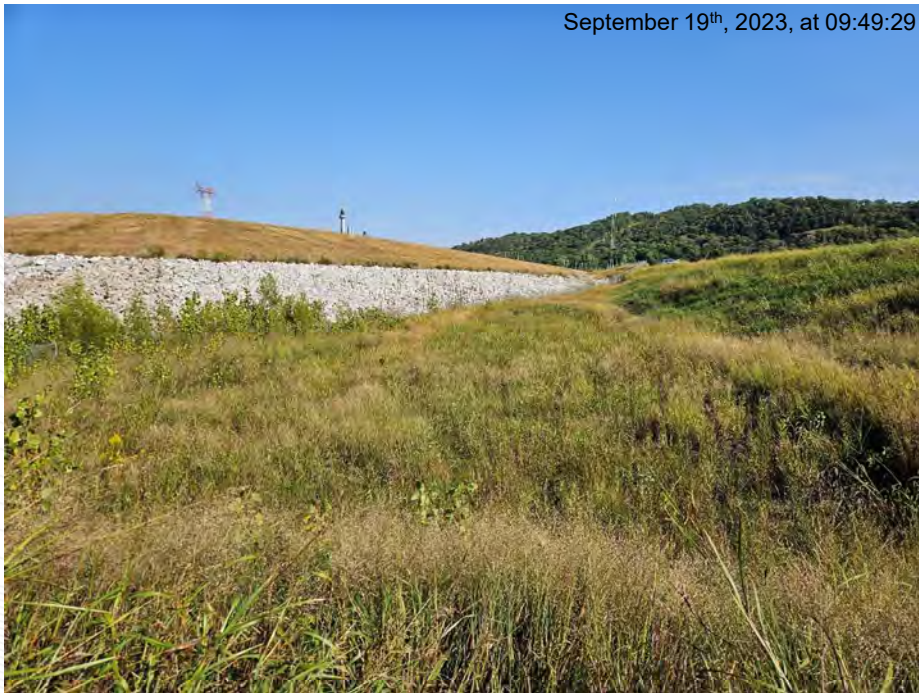
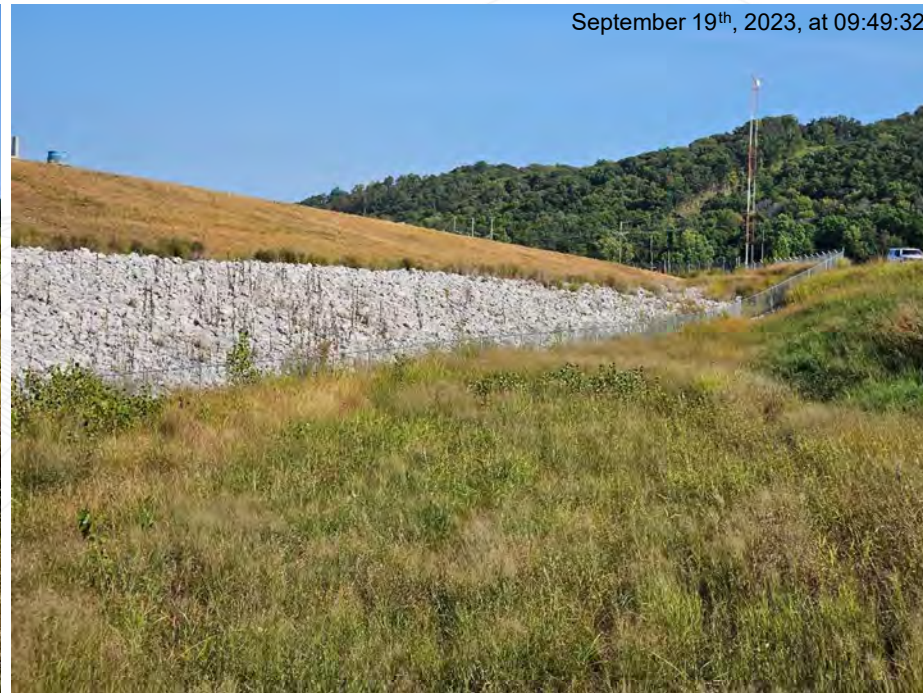
Repairs to the Fenceline and Levee area on the SE Side of Closed CCR Impoundment Cap

Facing north along the repaired fence-line, riprap, and levee area. Levee has successfully revegetated since repairs were initiated during 2022.

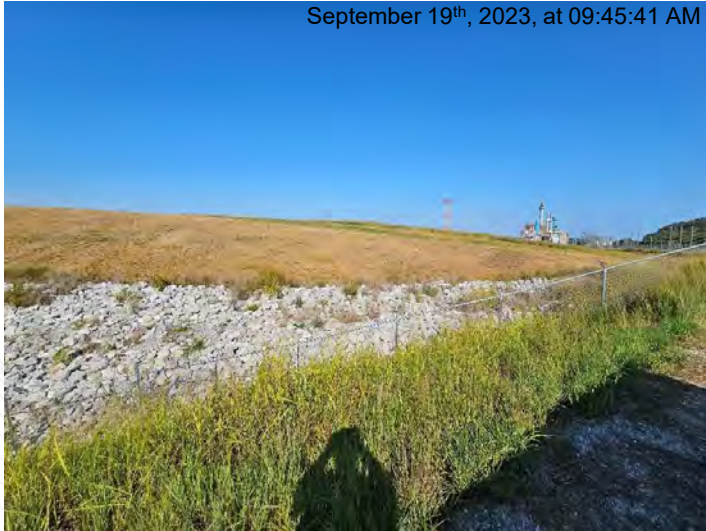
Facing west towards impoundment cap.

Dead/herbicide treated woody vegetation noted within riprap up to 1" diameter. Limited amount of live woody growth remains.

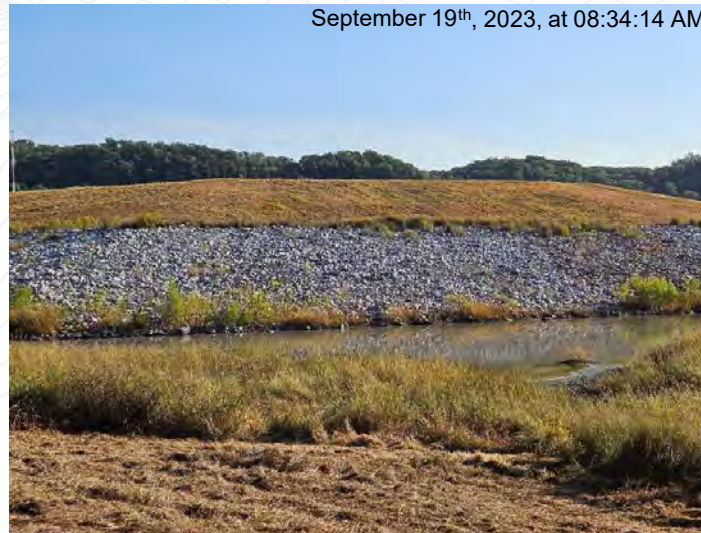
Facing north towards impoundment cap.

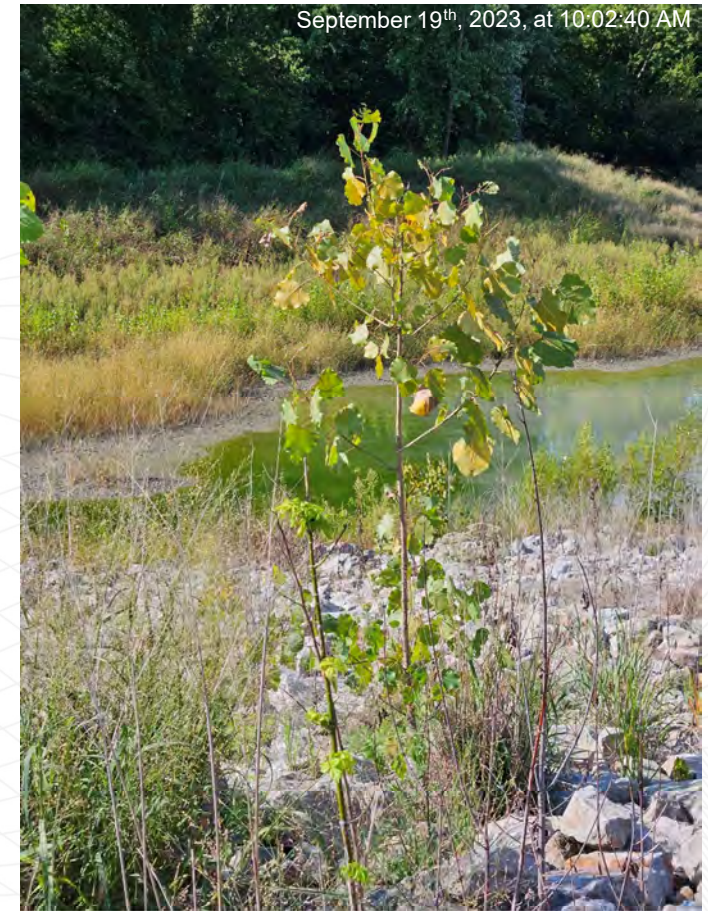
Southern portion of the impoundment cap in foreground facing the southern berm and pond.

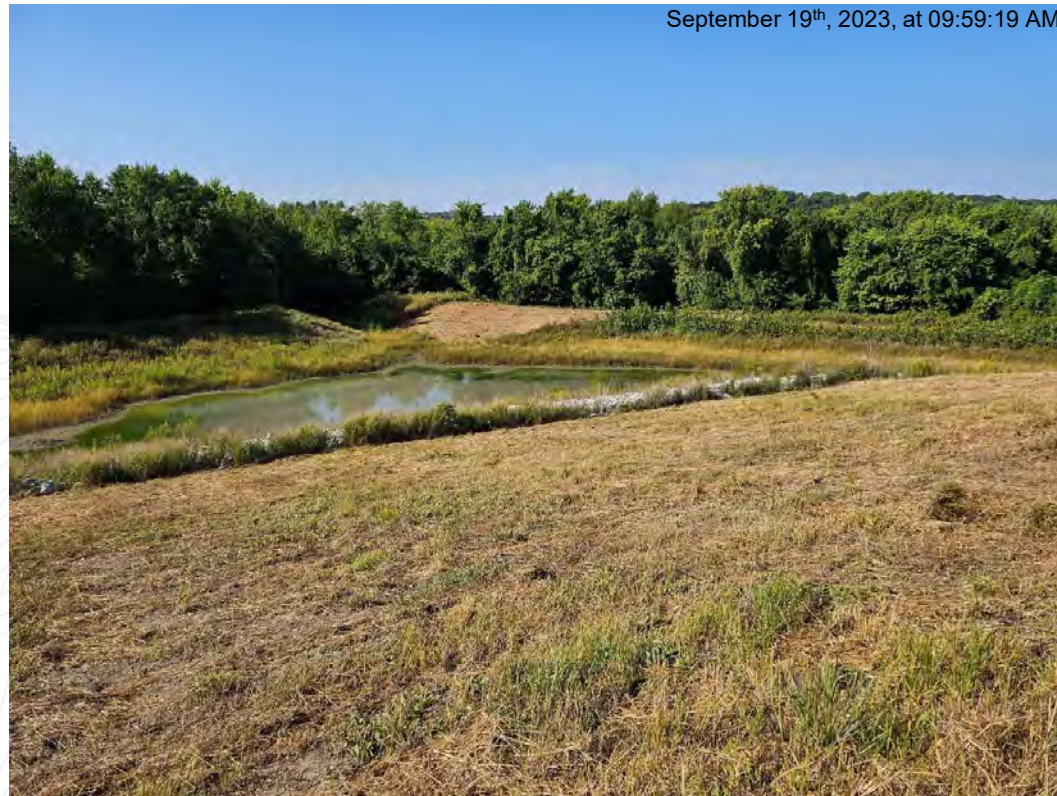
Ponding in the SW Corner of Site Basin Near the Outfall

Ponded area in southwest corner of basin near the outfall, as viewed from mowed impoundment cap.

Note: Mississippi River backwater enters the GTEC CCR Impoundment Basin when the river level gage operated by the U.S. Army Corps of Engineers at Grand Tower, IL reaches a stage of approximately 27 ft.
