2023 Grand Tower Energy Center Annual Inspection Report

PREPARED FOR
Rockland Capital, LLC

DATE
January 2024

REFERENCE
0599247

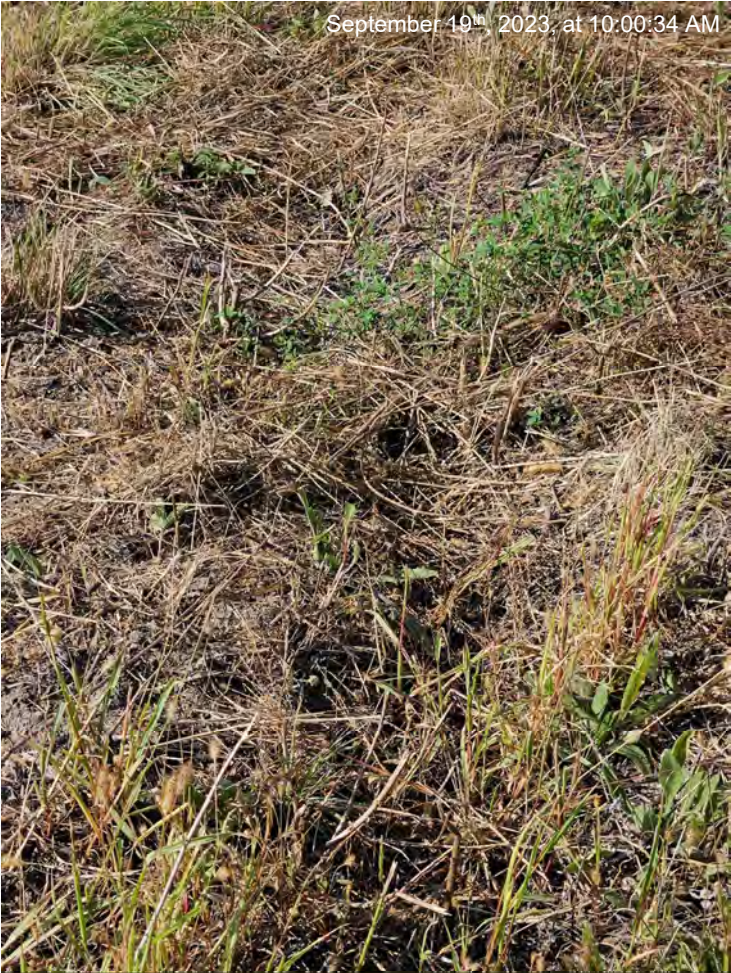
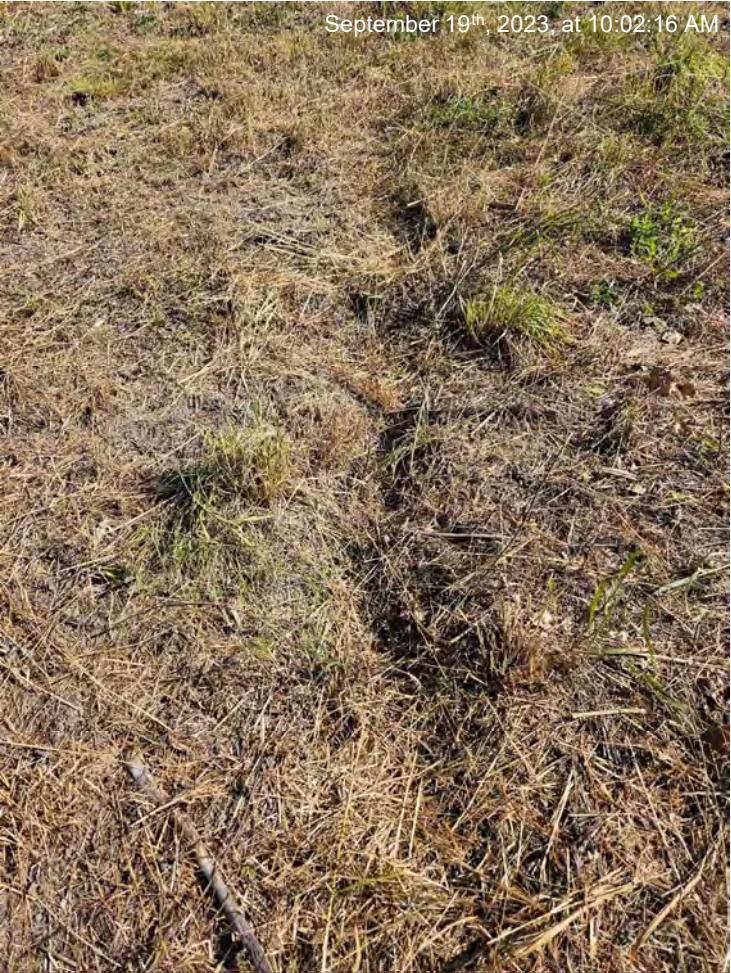
Erosional Channel Observations

Erosion facing southwest from southern side of impoundment cap.

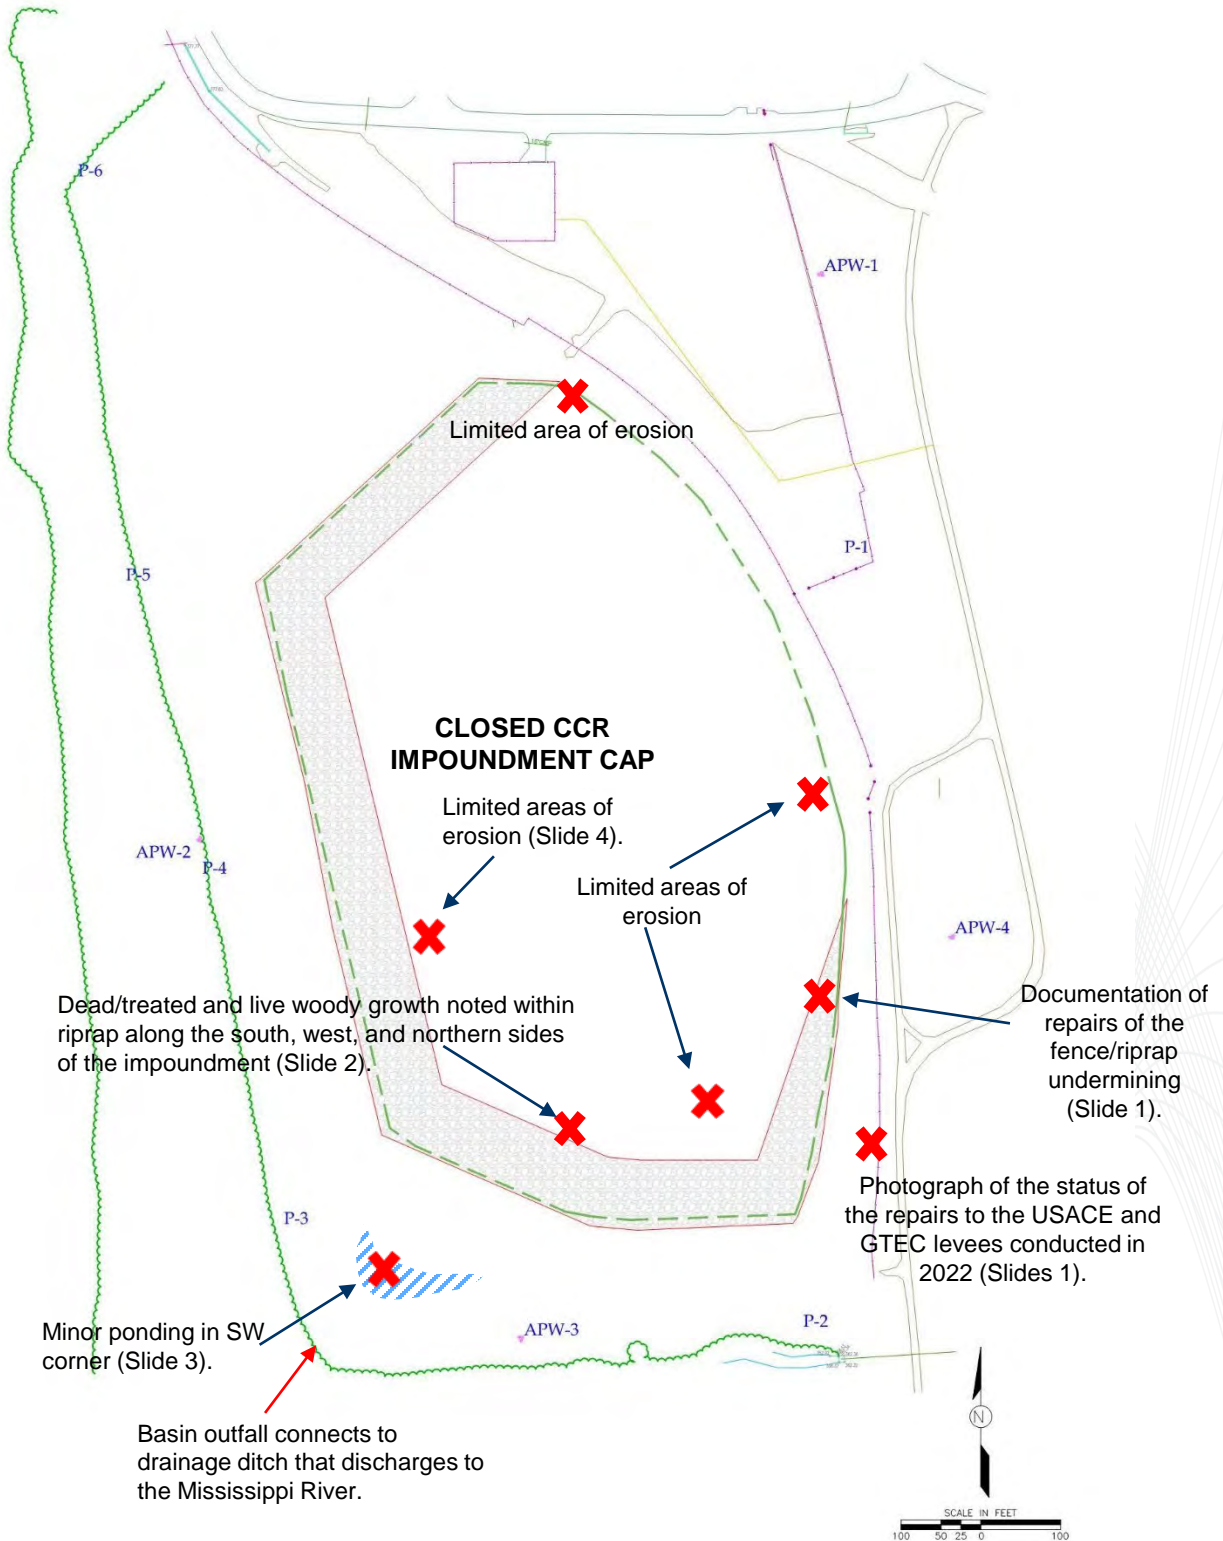
Observation Locations Map

- ERM onsite for the Q4 2023 inspection of the CCR impoundment and groundwater sampling event.
- Repairs to the United States Army Corps of Engineers (USACE) and GTEC levees continue to hold, and successful revegetation of levee face continues to progress.

- Erosion noted across north, west, and southern CCR impoundment cap faces up to 10" deep. This is an increase from 9" deep noted in previous inspection events.

- Ponding continues to be noted in the SW corner of the basin near the outfall albeit considerably reduced compared to Q3 2023 observations.
- The impoundment cap was mowed during Q3 2023 and found to be in generally good condition.

- The inspector recommends continued treatment of woody growth within the riprap on the impoundment cap with appropriate management methods such as brushhogging, mowing, cutting, herbicide applications, and the filling of the erosional channels noted above.

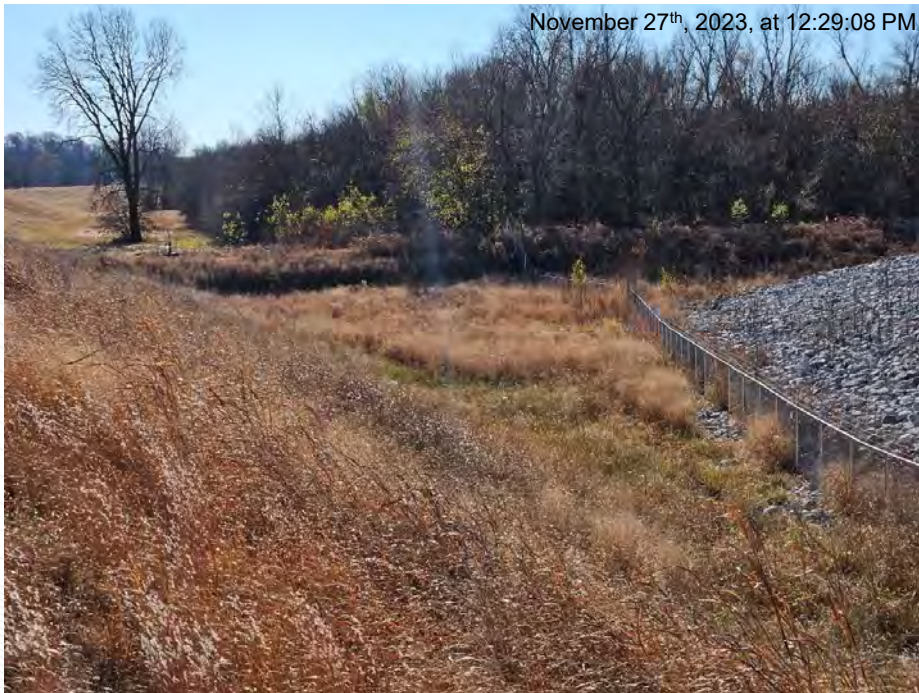
Facing south along the repaired fence-line, riprap, and levee area.

Levee has successfully revegetated since repairs were initiated during 2022.

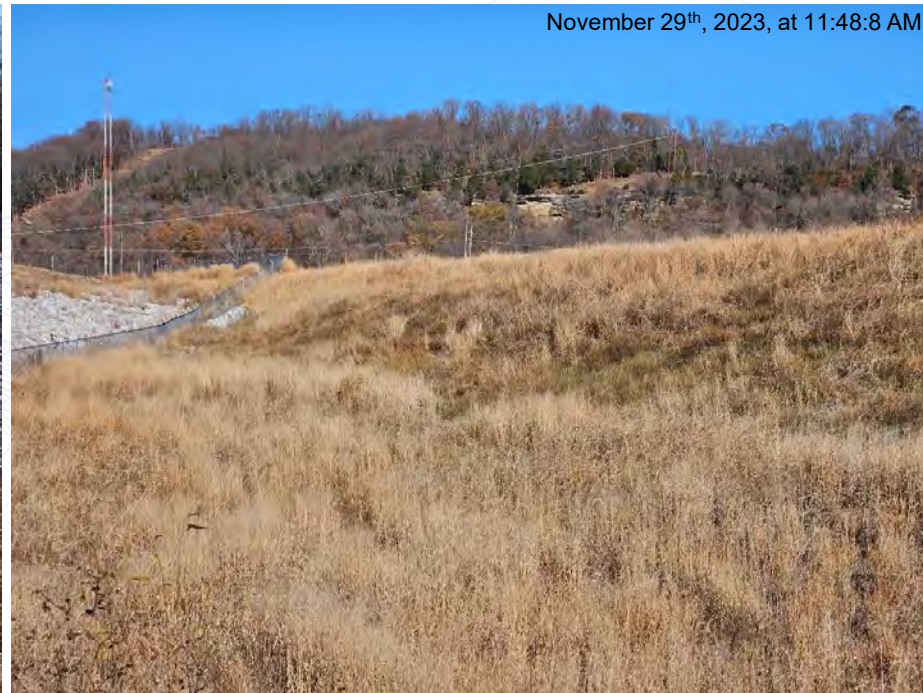
Facing northeast along the repaired fence-line, riprap, and levee area.

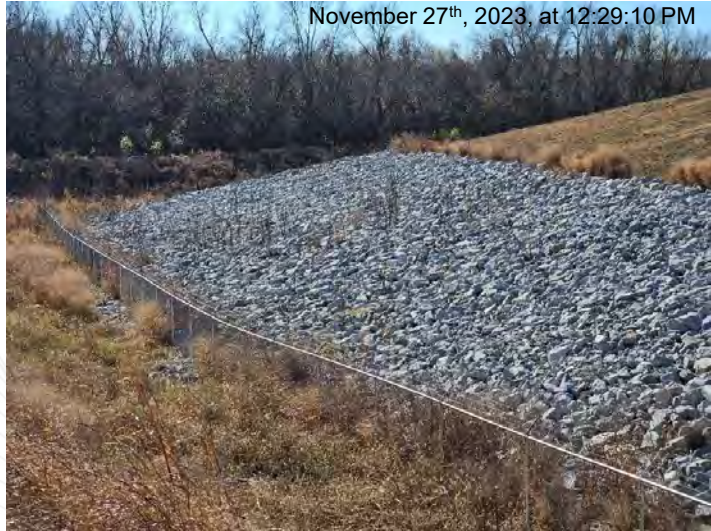
Facing southwest towards impoundment cap.

Dead/herbicide treated woody vegetation noted within riprap up to 1" diameter. Limited amount of live woody growth remains.

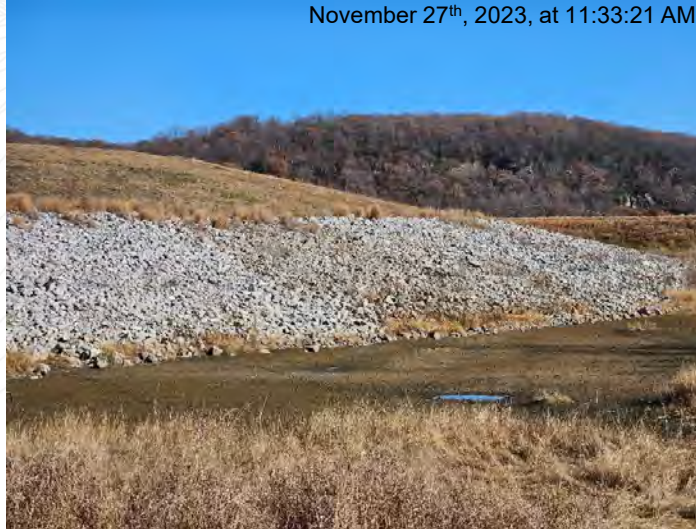
Facing northeast towards impoundment cap.

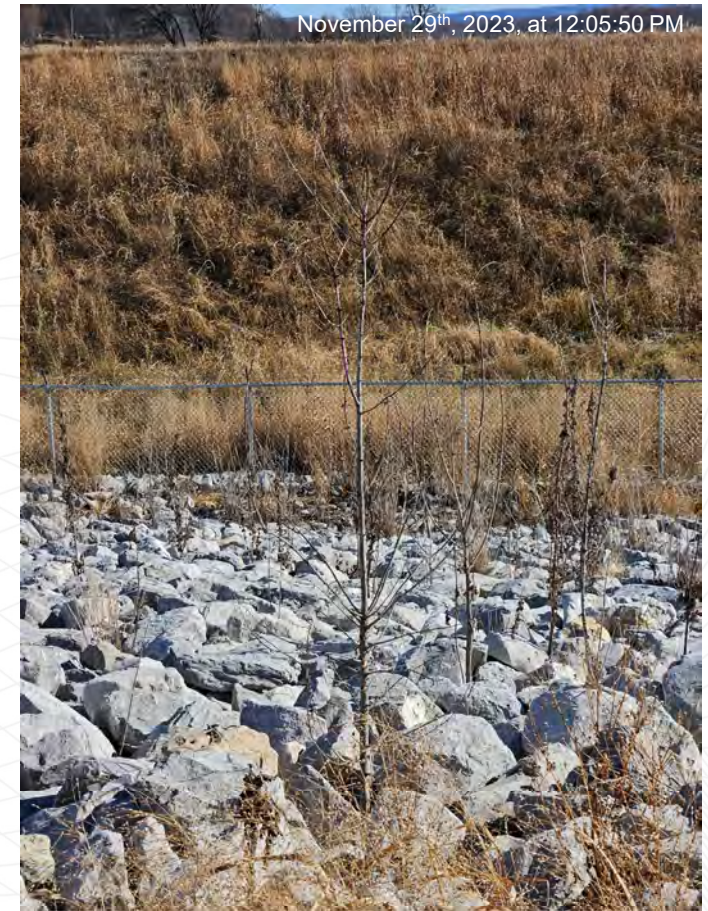
Facing east away from impoundment cap.

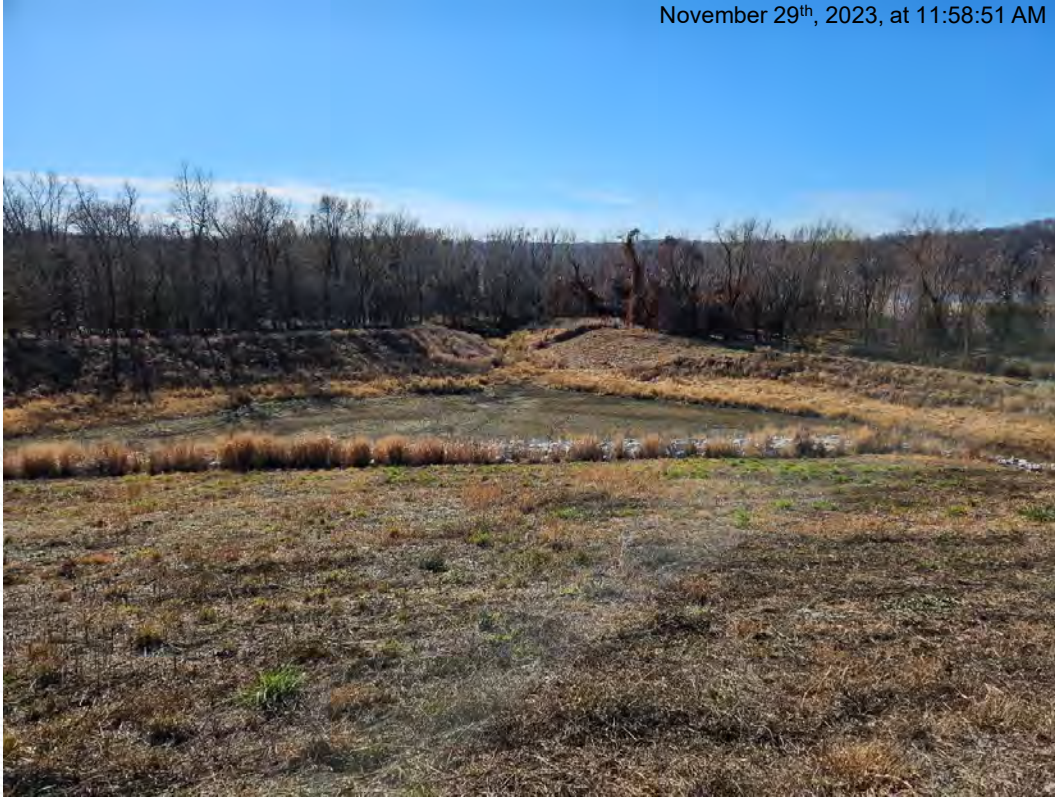
Minor Ponding in the SW Corner of Site Basin Near the Outfall

Minor ponded area in southwest corner of basin near the outfall, as viewed from mowed impoundment cap. Note that ponding is much less than that noted in Q3 2023.

Note: Mississippi River backwater enters the GTEC CCR Impoundment Basin when the river level gage operated by the U.S. Army Corps of Engineers at Grand Tower, IL reaches a stage of approximately 27 ft.

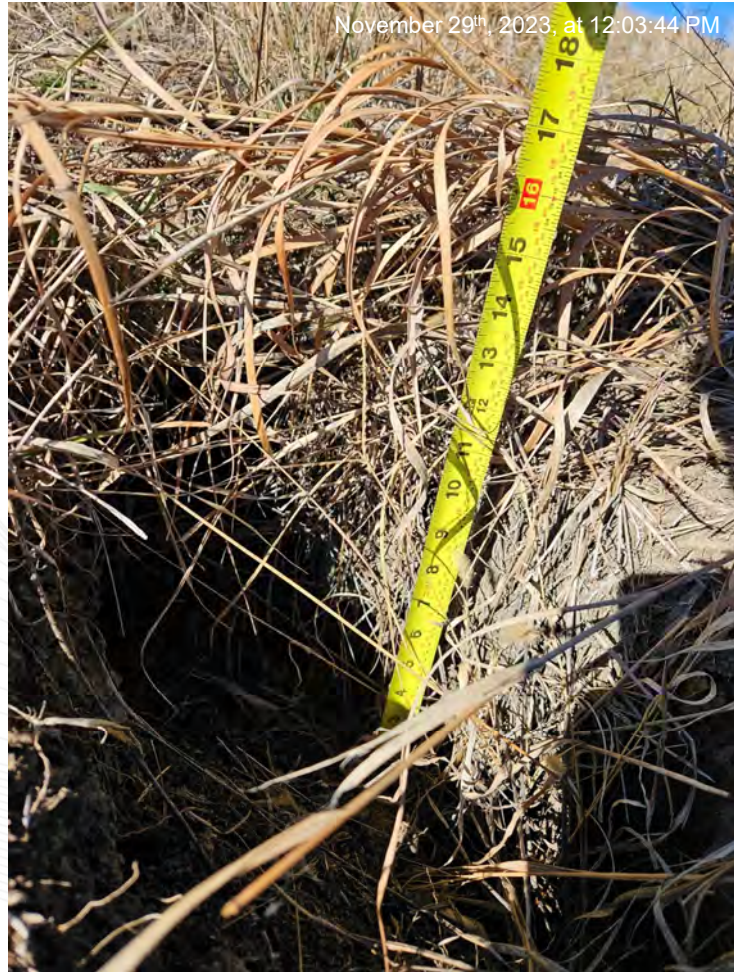
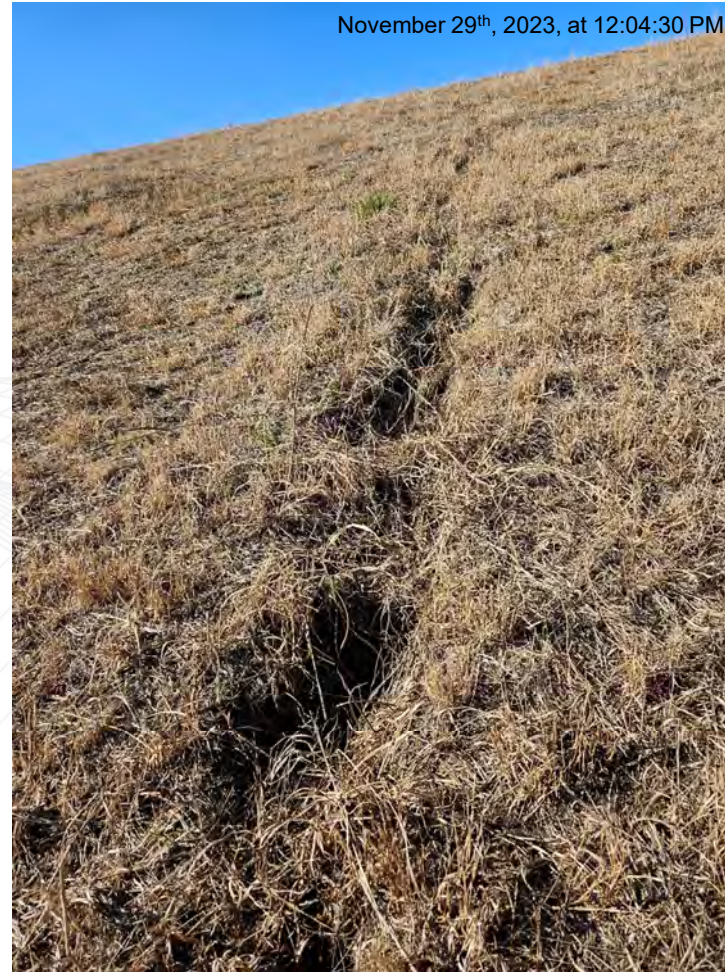
Erosional Channel Observations

Erosion from western side of impoundment cap.
