**Grand Tower Energy Center
Closed CCR Impoundment
Quarterly Inspection Form**

Date: 9/19/2023
Time: 9:00-10:30
Name: Marshall Arendell
(Inspector)

Grand Tower Energy Center Q3 2023 Closed CCR Impoundment Cap Inspection

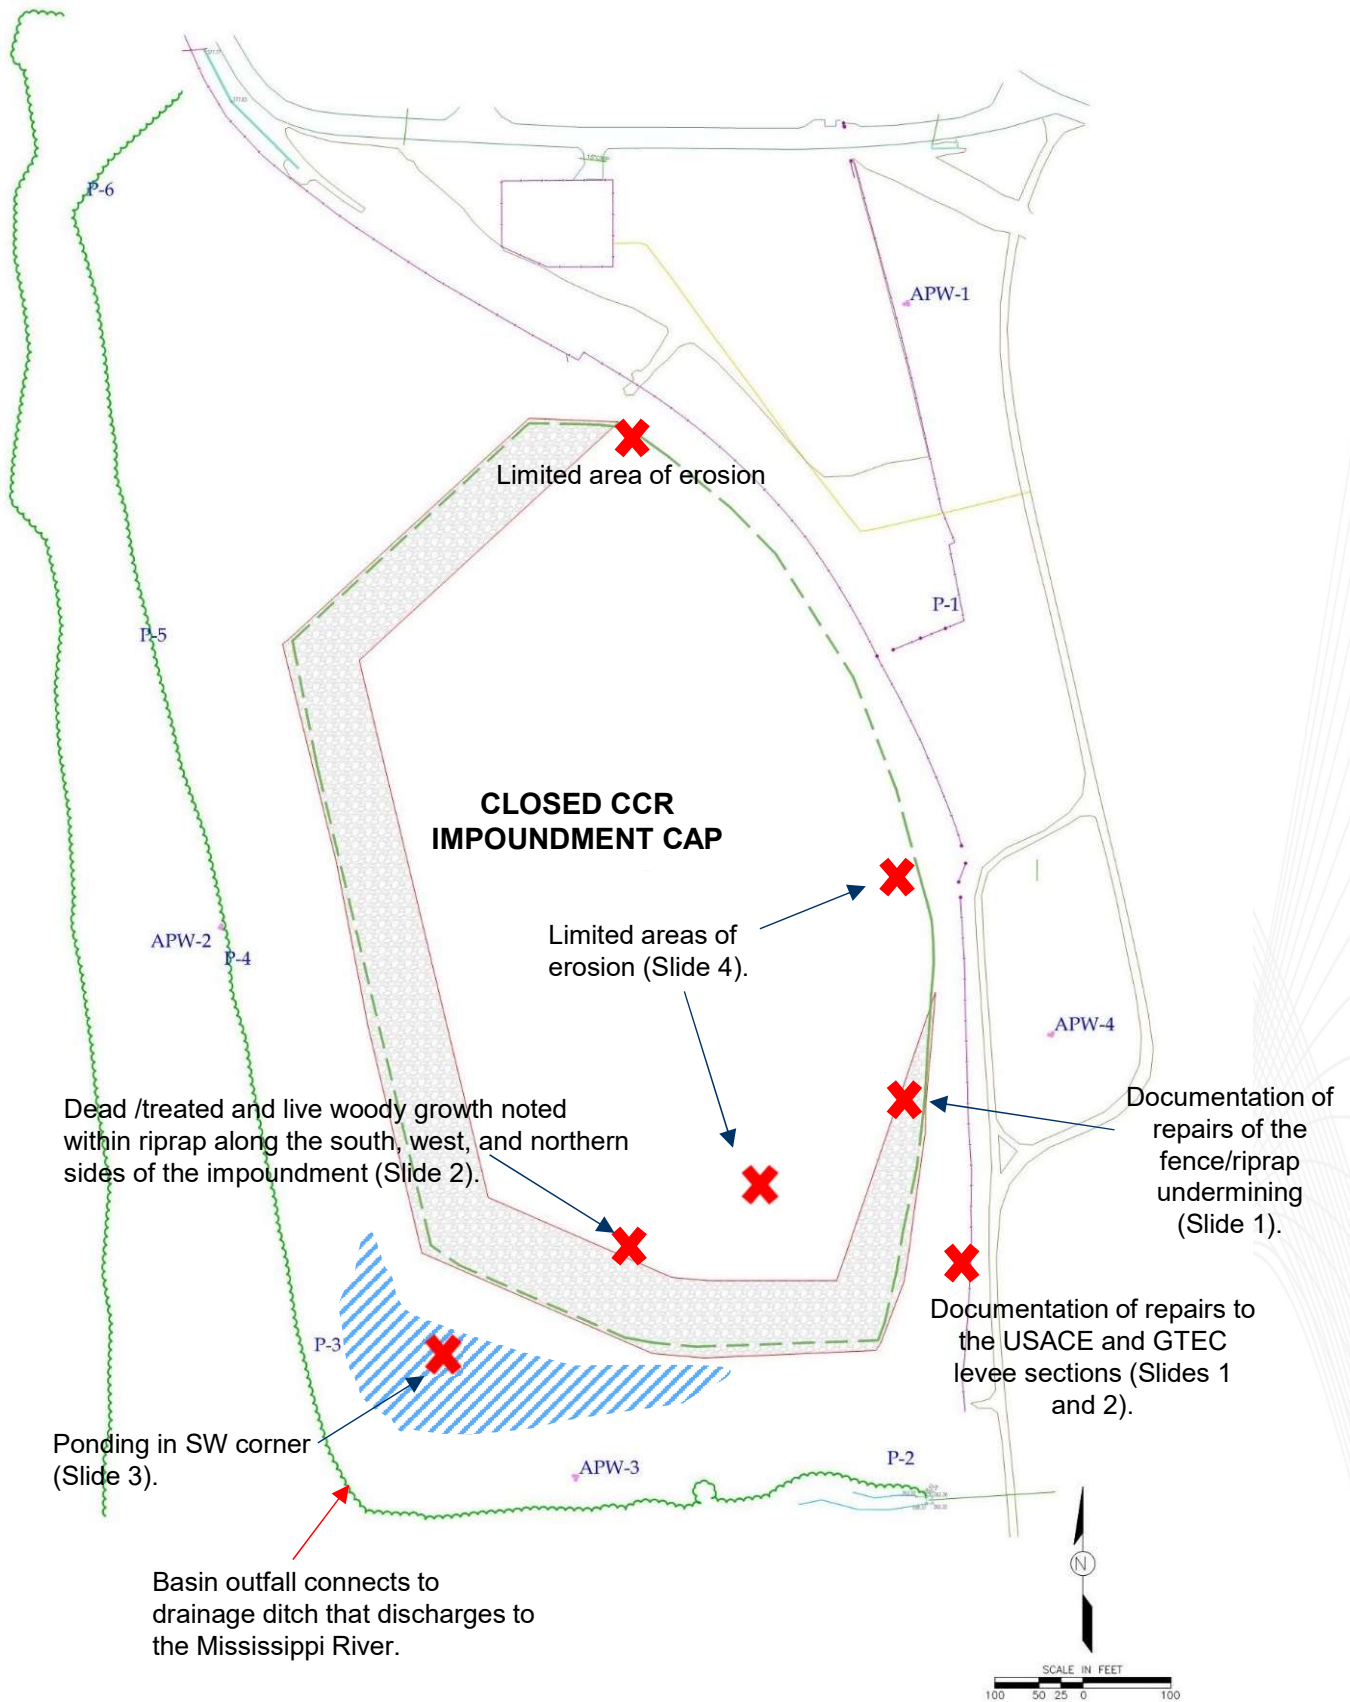
Observation Locations Map

Please see observation locations on figure on the following page.

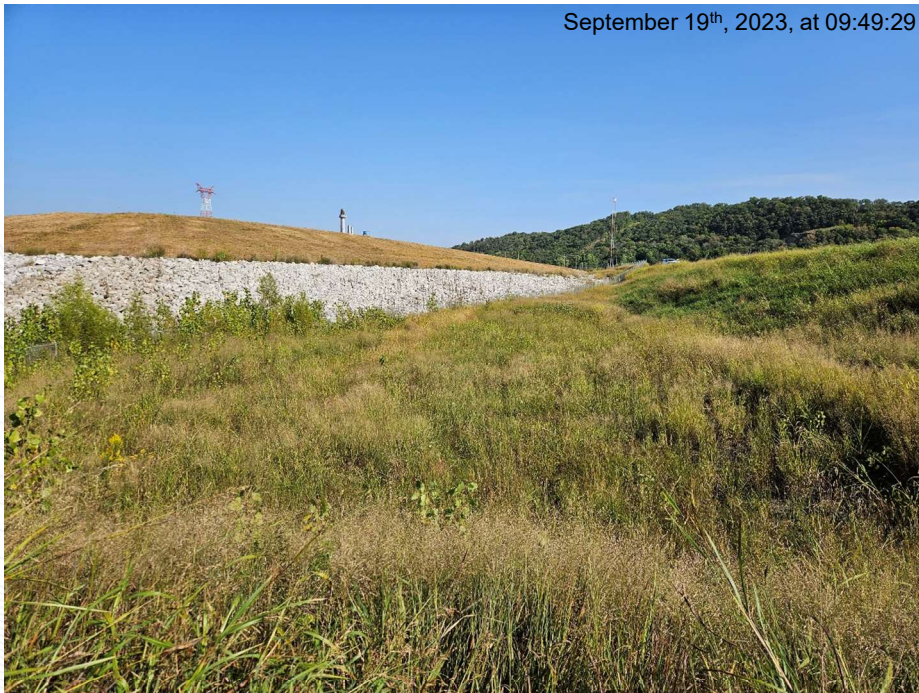
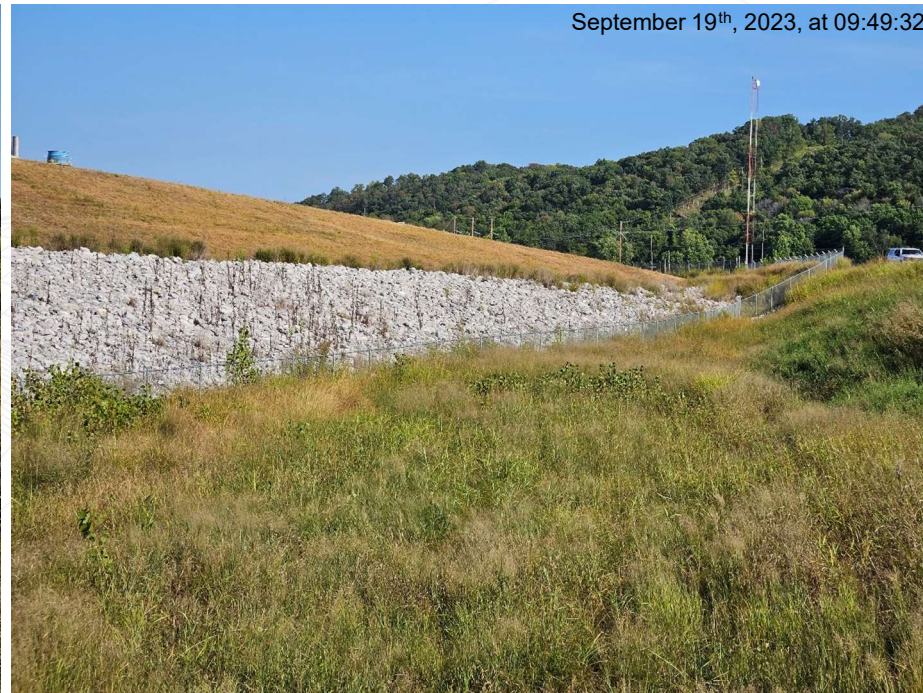
Repairs to the Fenceline and Levee area on the SE Side of Closed CCR Impoundment Cap

Facing north along the repaired fence-line, riprap, and levee area. Levee has successfully revegetated since repairs were initiated during 2022.

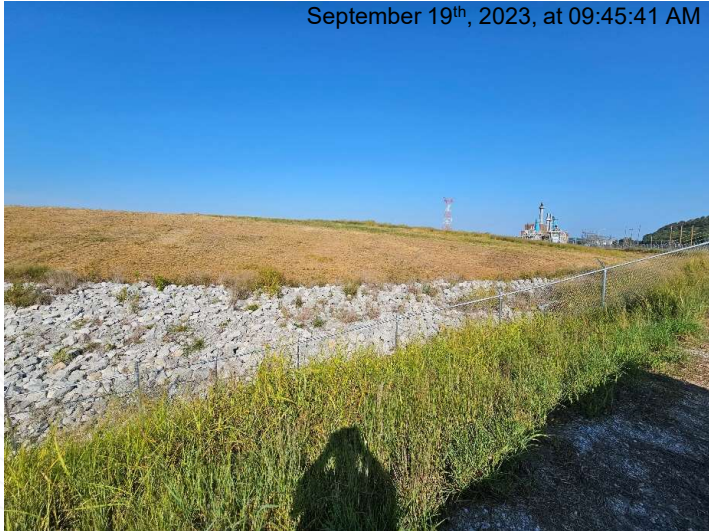
September 19th, 2023, at 09:45:41 AM

Facing west towards impoundment cap.

Dead/herbicide treated woody vegetation noted within riprap up to 1" diameter. Limited amount of live woody growth remains.

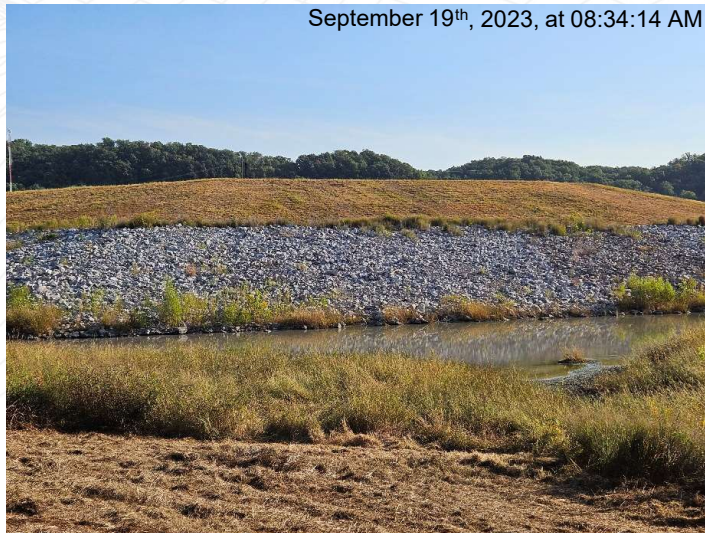
September 19th, 2023, at 08:34:14 AM

Facing north towards impoundment cap.

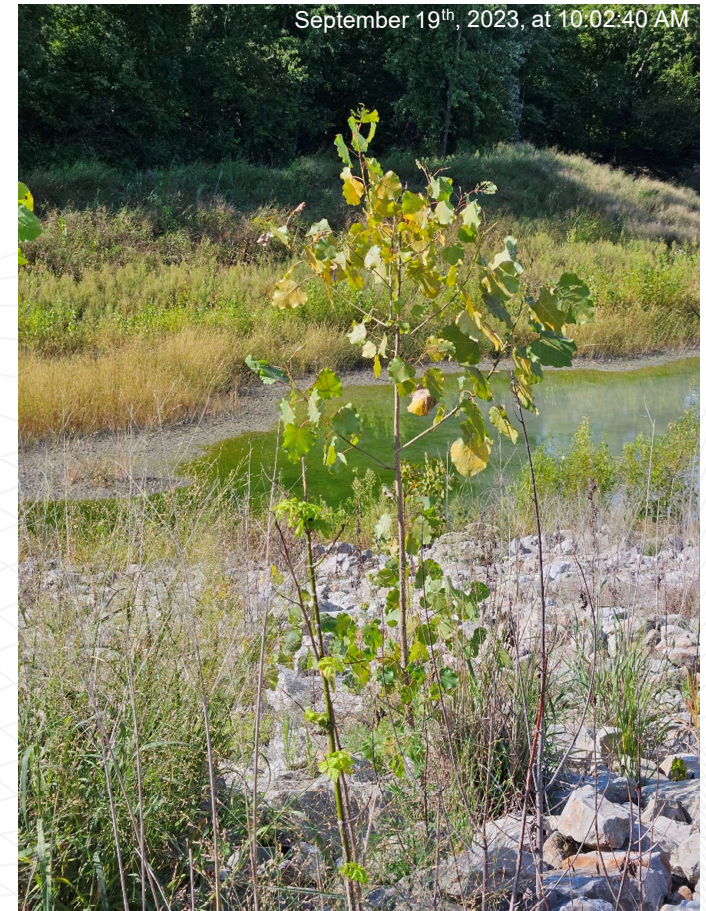
September 19th, 2023, at 10:02:40 AM

Southern portion of the impoundment cap in foreground facing the southern berm and pond.

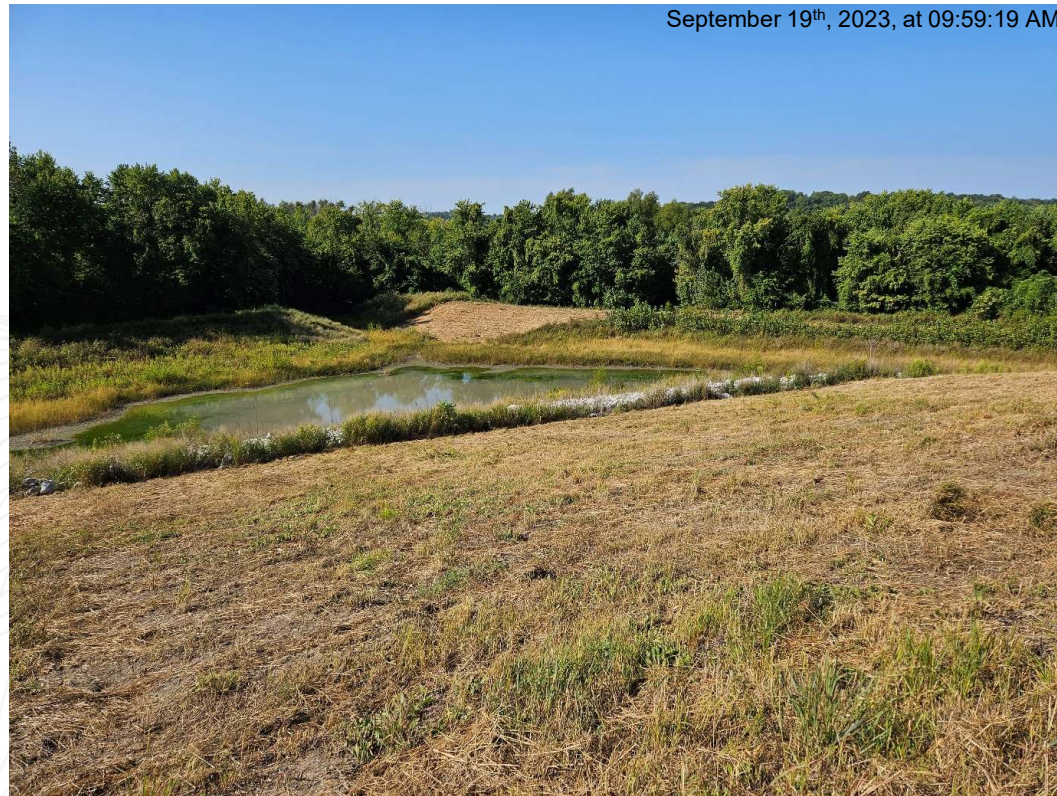
Ponding in the SW Corner of Site Basin Near the Outfall

Ponded area in southwest corner of basin near the outfall, as viewed from mowed impoundment cap.

Note: Mississippi River backwater enters the GTEC CCR Impoundment Basin when the river level gage operated by the U.S. Army Corps of Engineers at Grand Tower, IL reaches a stage of approximately 27 ft.

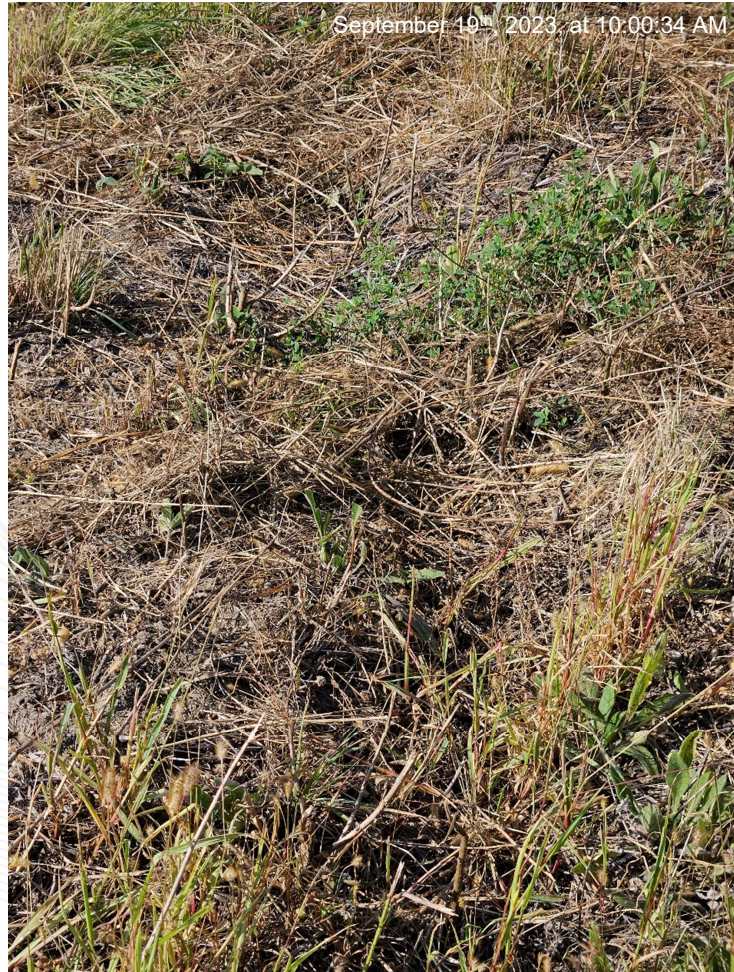
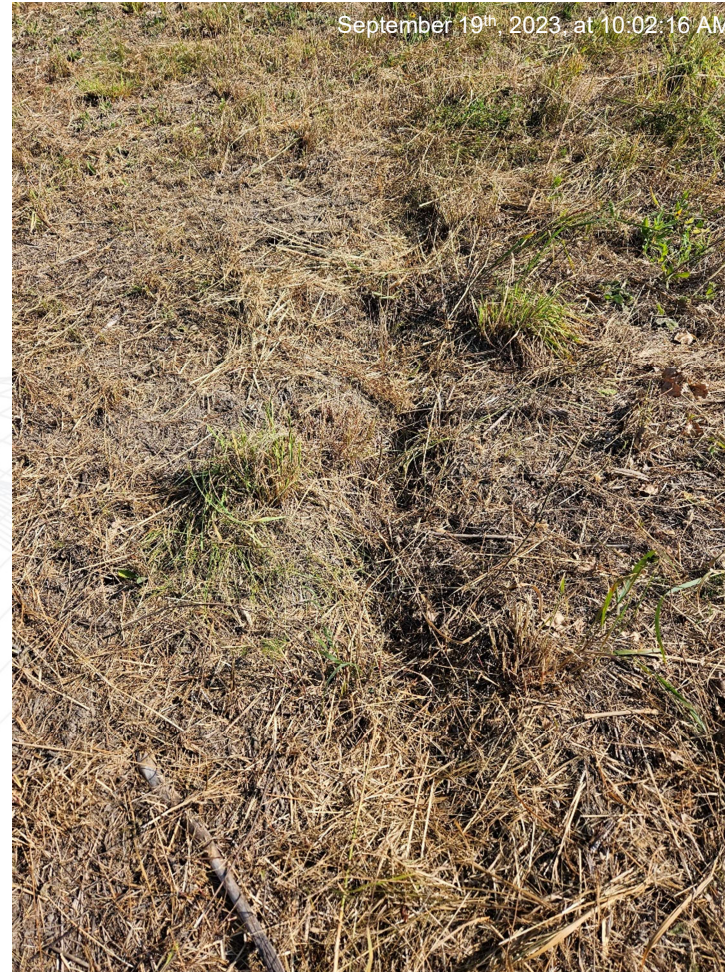
Erosional Channel Observations

Erosion facing southwest
from southern side of
impoundment cap.
