Grand Tower Energy Center Closed CCR Impoundment Quarterly Inspection Form	Date: 11/29/2023 Time: 11:45-12:05
		Name: Marshall Arendell (Inspector)
Weather:		
Temperature:		
45 deg. F		
⊠ Sunny	Observations:	
□ Cloudy	⊠ Erosion / Gullies	
□ Raining	Cracking / Sloughing	
□ Other	🛛 Ponding / Damp Area	as
	□ No Problems Identifie	ed
	─────────────────────────────────────	rowth
Conditions Limiting Visibili	ty:	
□ Snow Cover	-	
□ Vegetation		
⊠ None		
□ Other		
ERM onsite for the Q4 20	23 inspection of the CCR impoundment and gro	oundwater sampling event.
Repairs to the United State	es Army Corps of Engineers (USACE) and GTEC	levees continue to hold, and
successful revegetation of	levee face continues to progress.	
<ul> <li>Erosion noted across north</li> </ul>	, west, and southern CCR impoundment cap face	es up to 10" deep. This is an
incroses from OII door water	d in provious inspection events	· · ·
increase from 9° deep hote

# Grand Tower Energy Center Q4 2023 Closed CCR Impoundment Cap Inspection

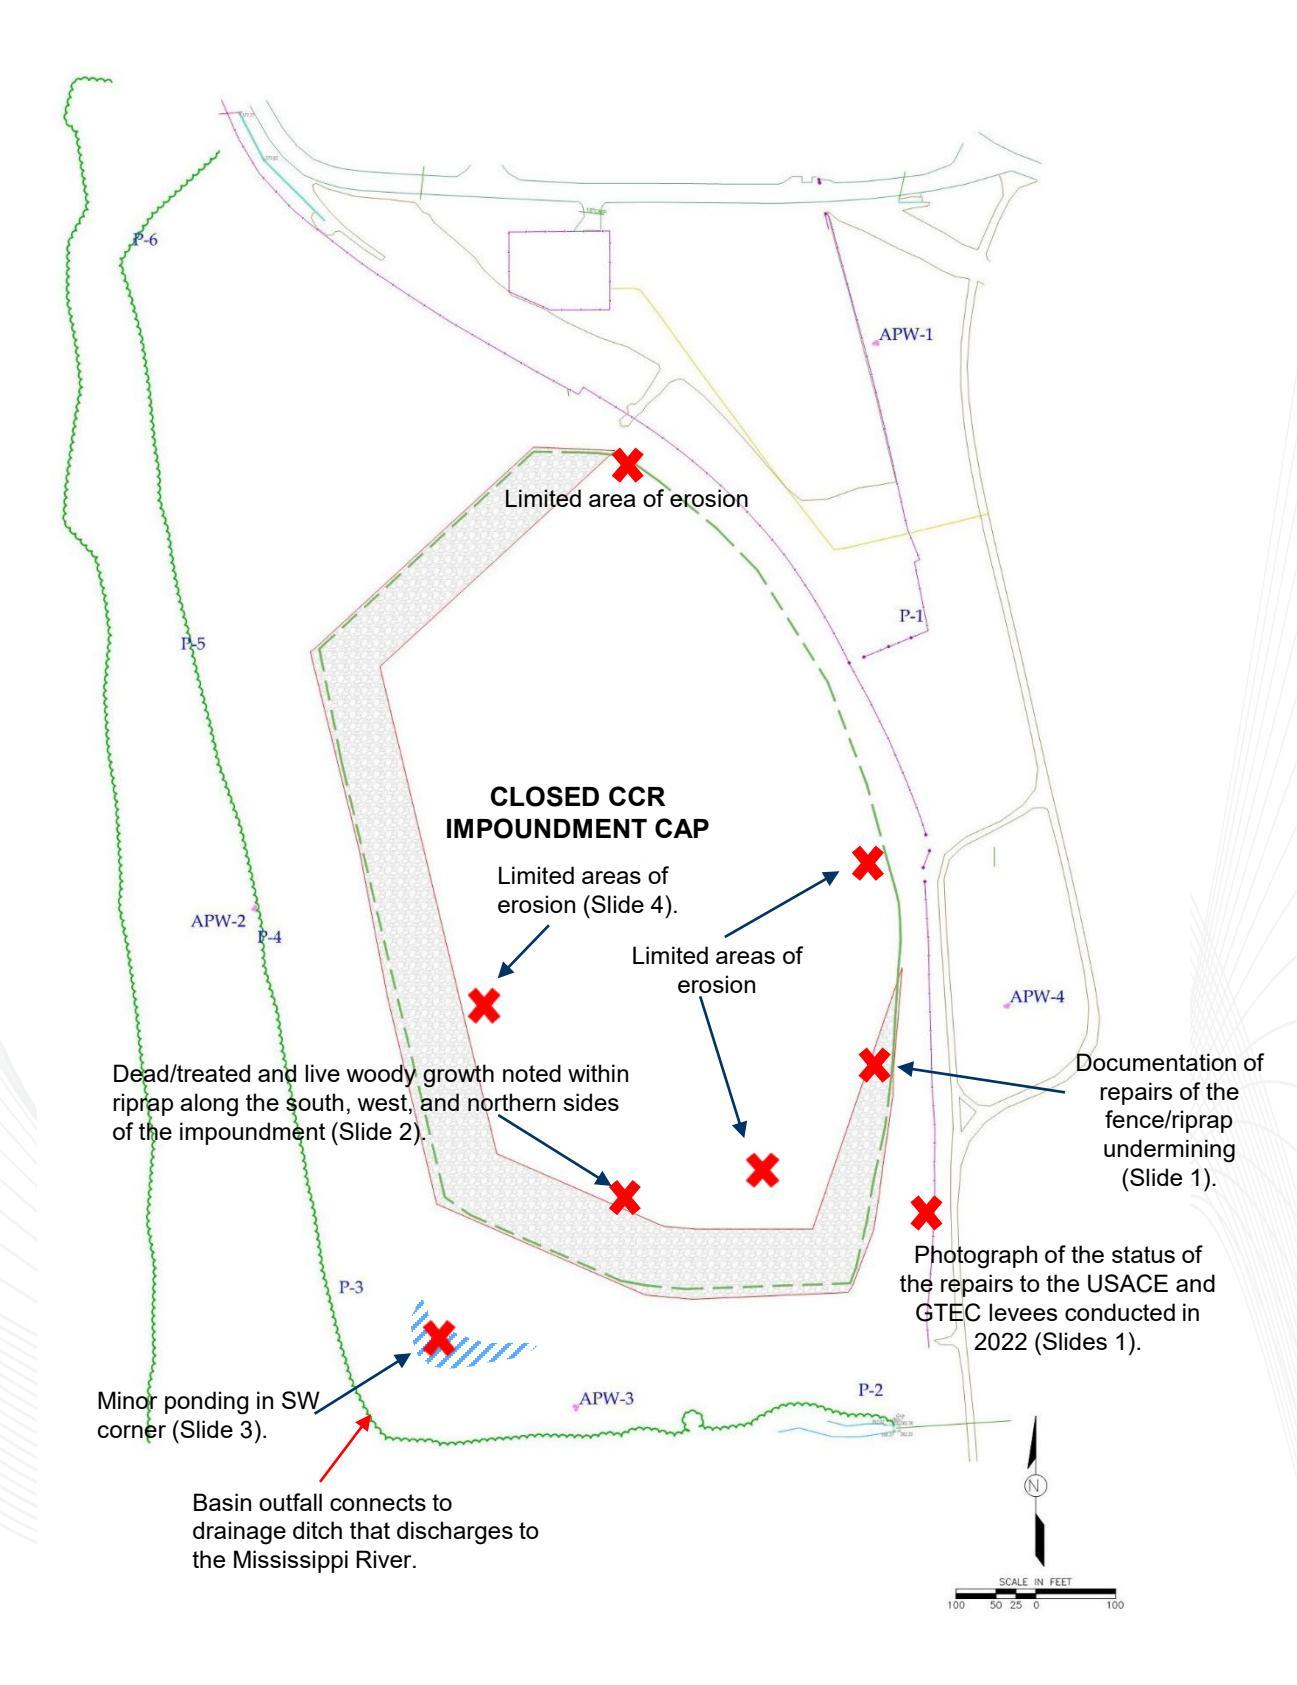
#### **Observation Locations Map**

<ul> <li>Ponding continues to be not</li> </ul>	ted in the SW corner of the basin near the outfall	albeit considerably reduced
compared to Q3 2023 obse	ervations.	
The impoundment cap was	mowed during Q3 2023 and found to be in gene	rally good condition.
The inspector recommender	s continued treatment of woody growth within the	riprap on the impoundment
cap with appropriate man	agement methods such as brushhogging, mow	ring, cutting, herbicide
applications, and the filling	g of the erosional channels noted above.	
	Please see observation locations on

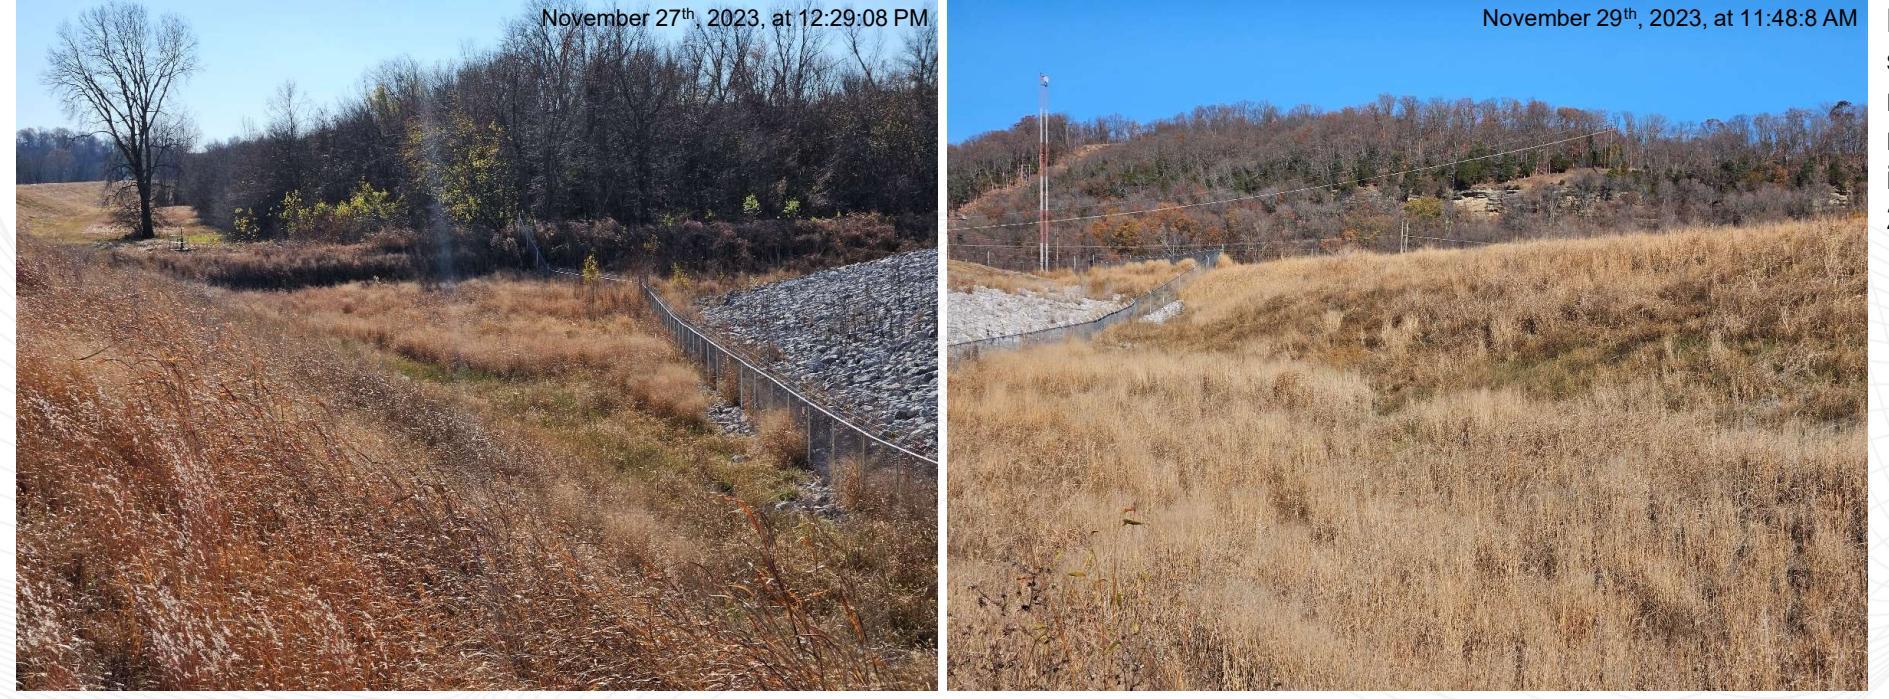
Repairs to the Fenceline and Levee area on the SE Side of Closed CCR Impoundment Cap

Levee has successfully revegetated since repairs were initiated during 2022.

Facing south along the repaired fence-line, riprap, and levee area.

Facing northeast along the repaired fence-line, riprap, and levee area.

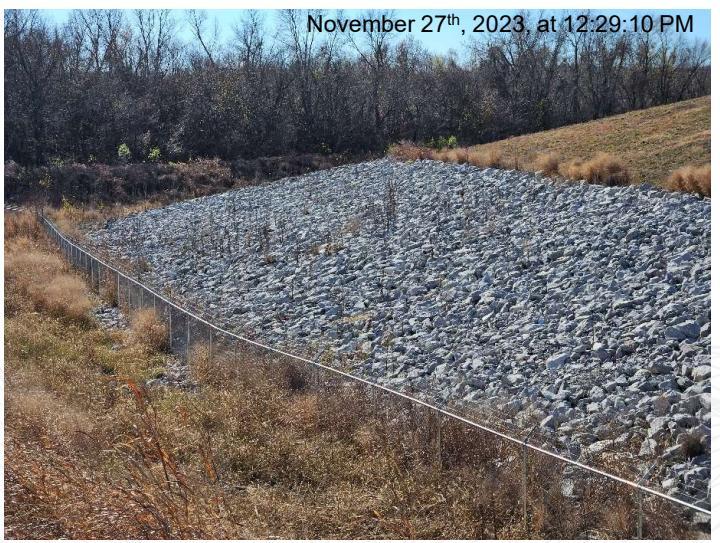
Facing southwest towards impoundment cap.

Dead/herbicide treated woody vegetation noted within riprap up to 1" diameter. Limited amount of live woody growth remains.

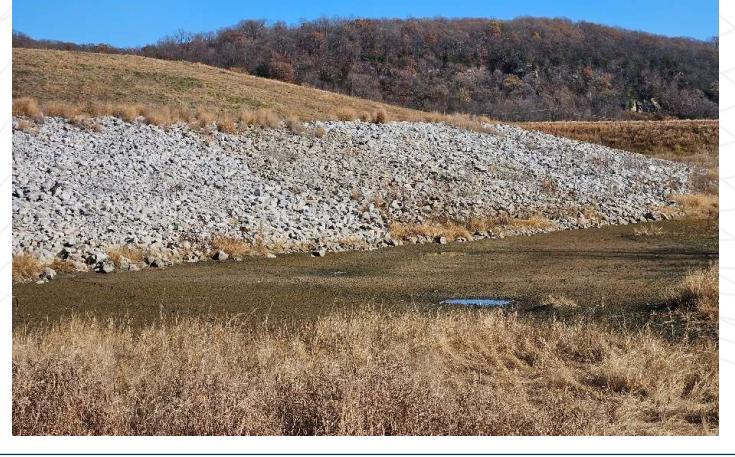
Facing northeast towards impoundment cap. November 27<sup>th</sup>, 2023, at 11:33:21 AM

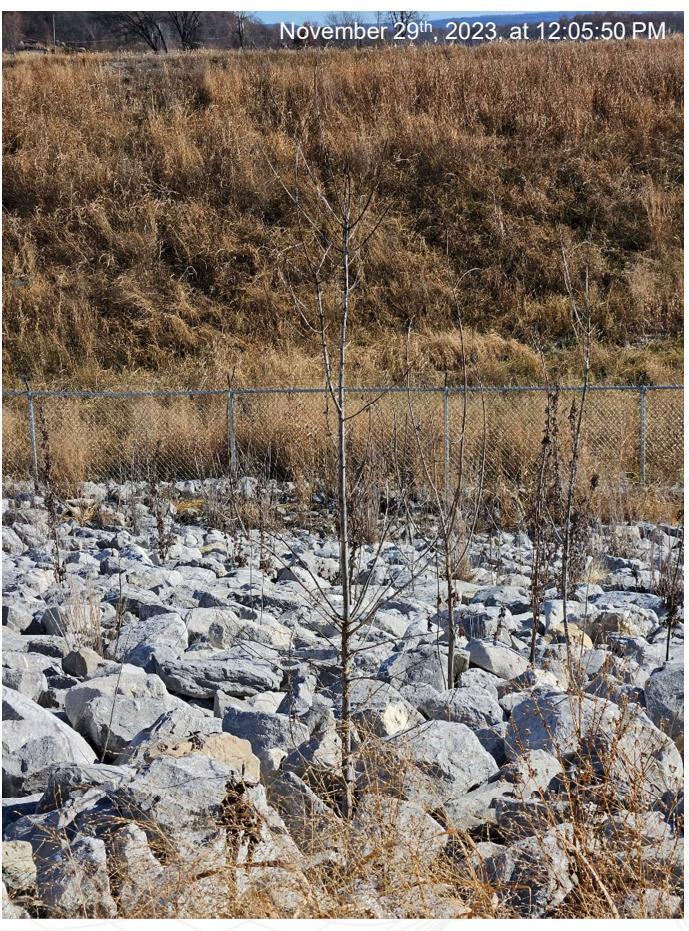
Facing east away from impoundment cap.

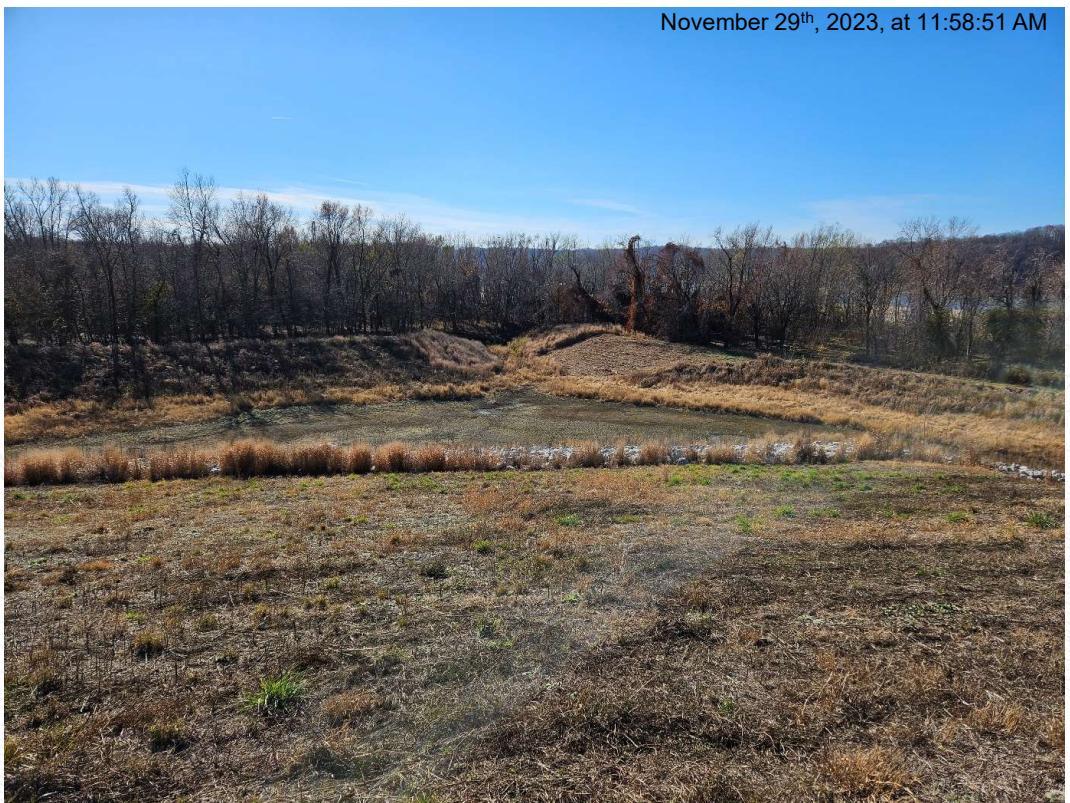
## Minor Ponding in the SW Corner of Site Basin Near the Outfall

Minor ponded area in southwest corner of basin near the outfall, as viewed from mowed impoundment cap. Note that ponding is much less than that noted in Q3 2023.

Note: Mississippi River backwater enters the GTEC CCR Impoundment Basin when the river level gage operated by the U.S. Army Corps of Engineers at Grand Tower, IL reaches a stage of approximately 27 ft.

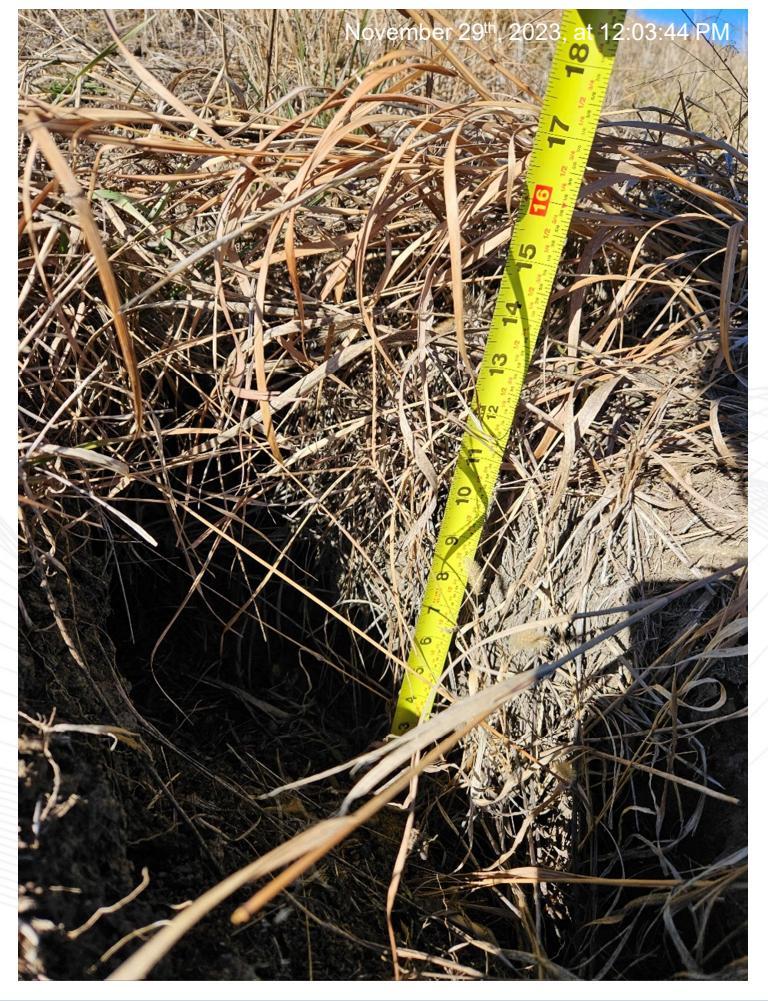
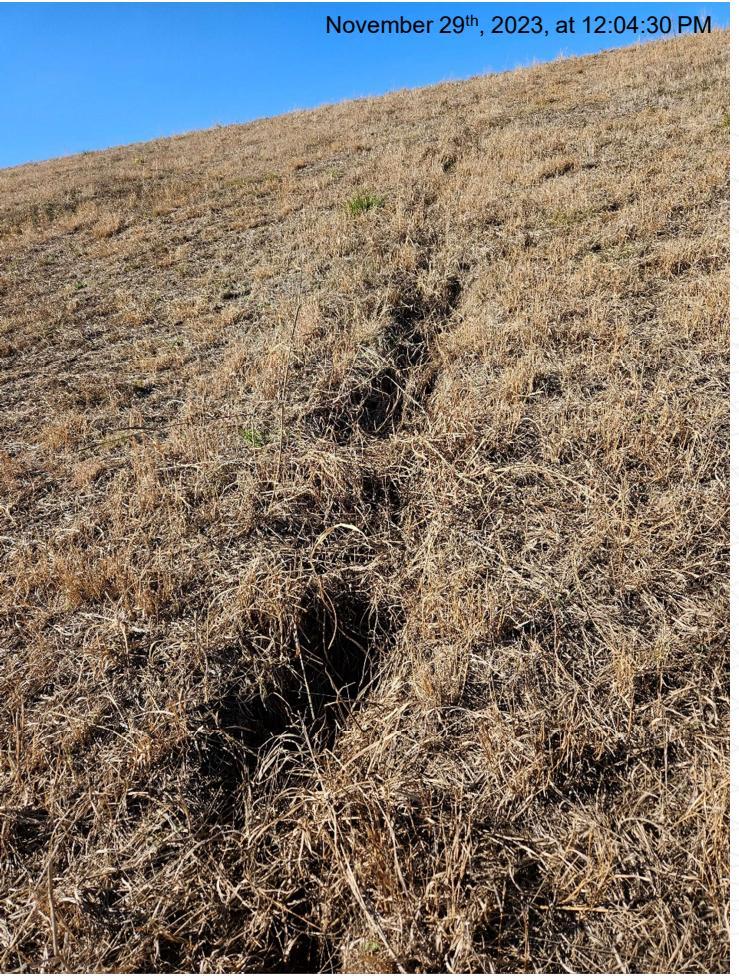
## **Erosional Channel Observations**

Erosion from western side of impoundment cap.
