Emergency Action Plan

Grand Tower Energy Center, LLC (GTEC) Inactive Ash Basin

DATE February 2024

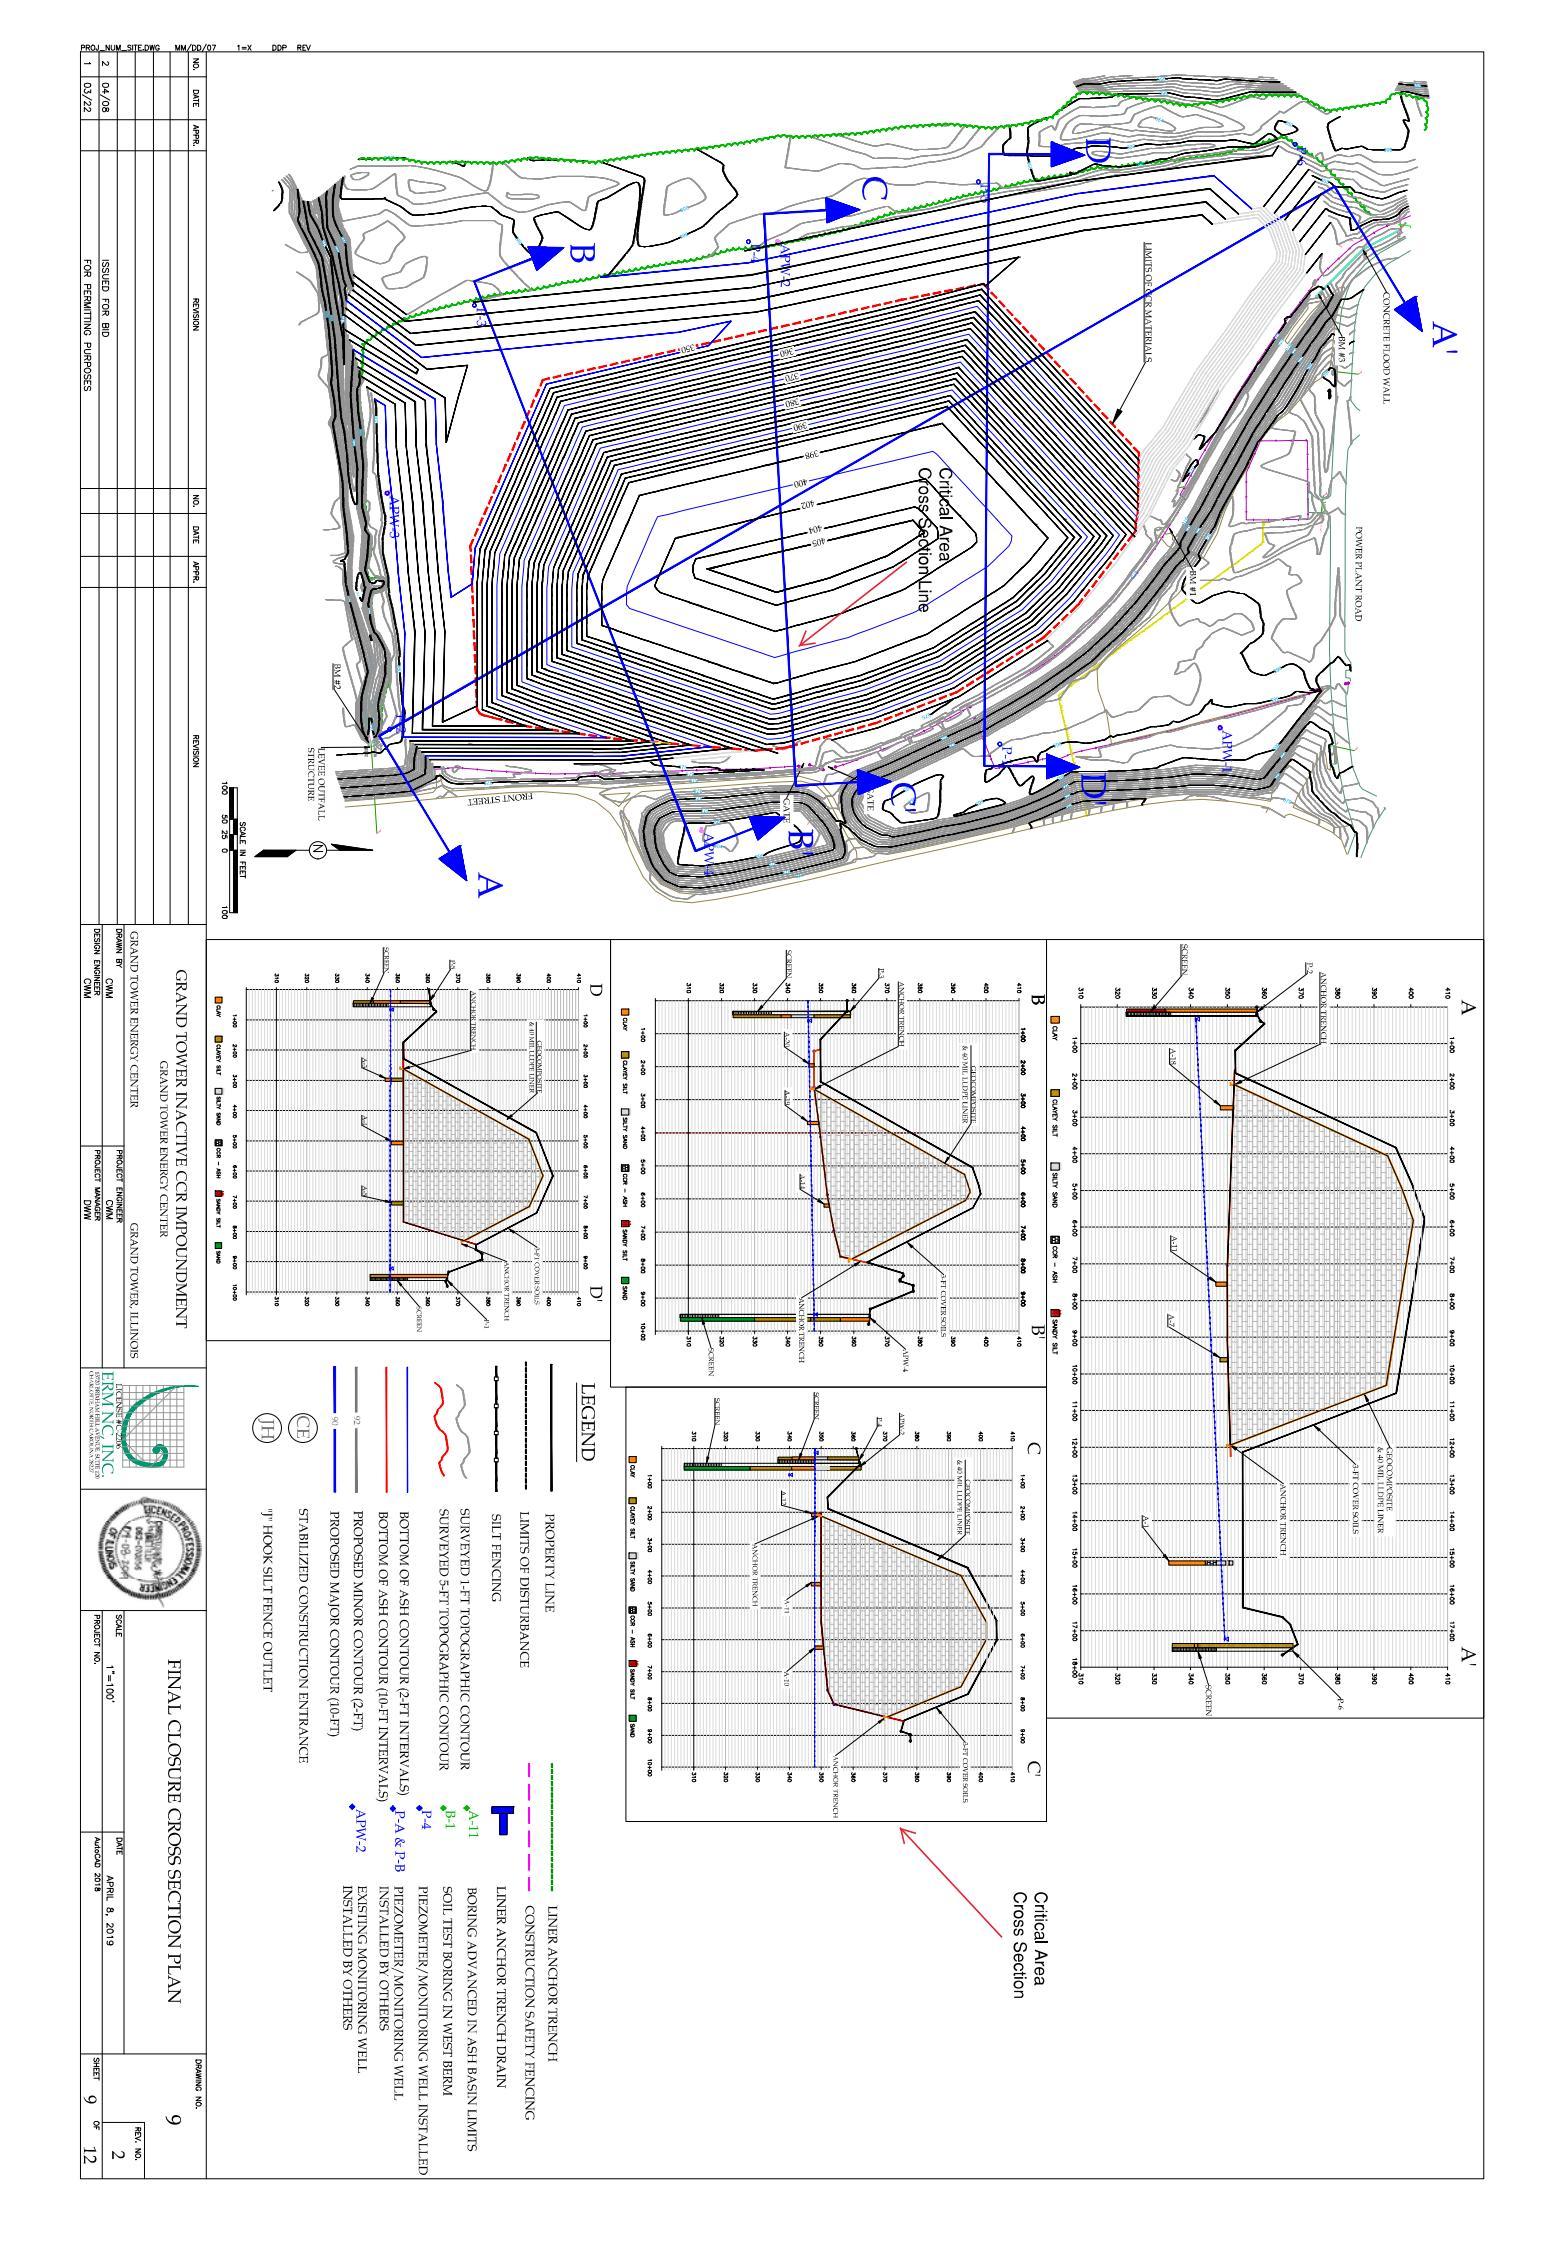
APPENDIX A FINAL CLOSURE CROSS-SECTION PLAN

ERM identified the critical section of the impoundment area as Section C-C' in the Grand Tower Inactive CCR Impoundment drawings (attached as Appendix A), with a typical design slope of four horizontal to one vertical and a maximum elevation difference of 52 feet. The geometry for the impoundment was entered into the Geo-5TM software, and the stability of the impoundment was analyzed using the Bishop method for circular analysis and the Janbu method for polygonal analysis.

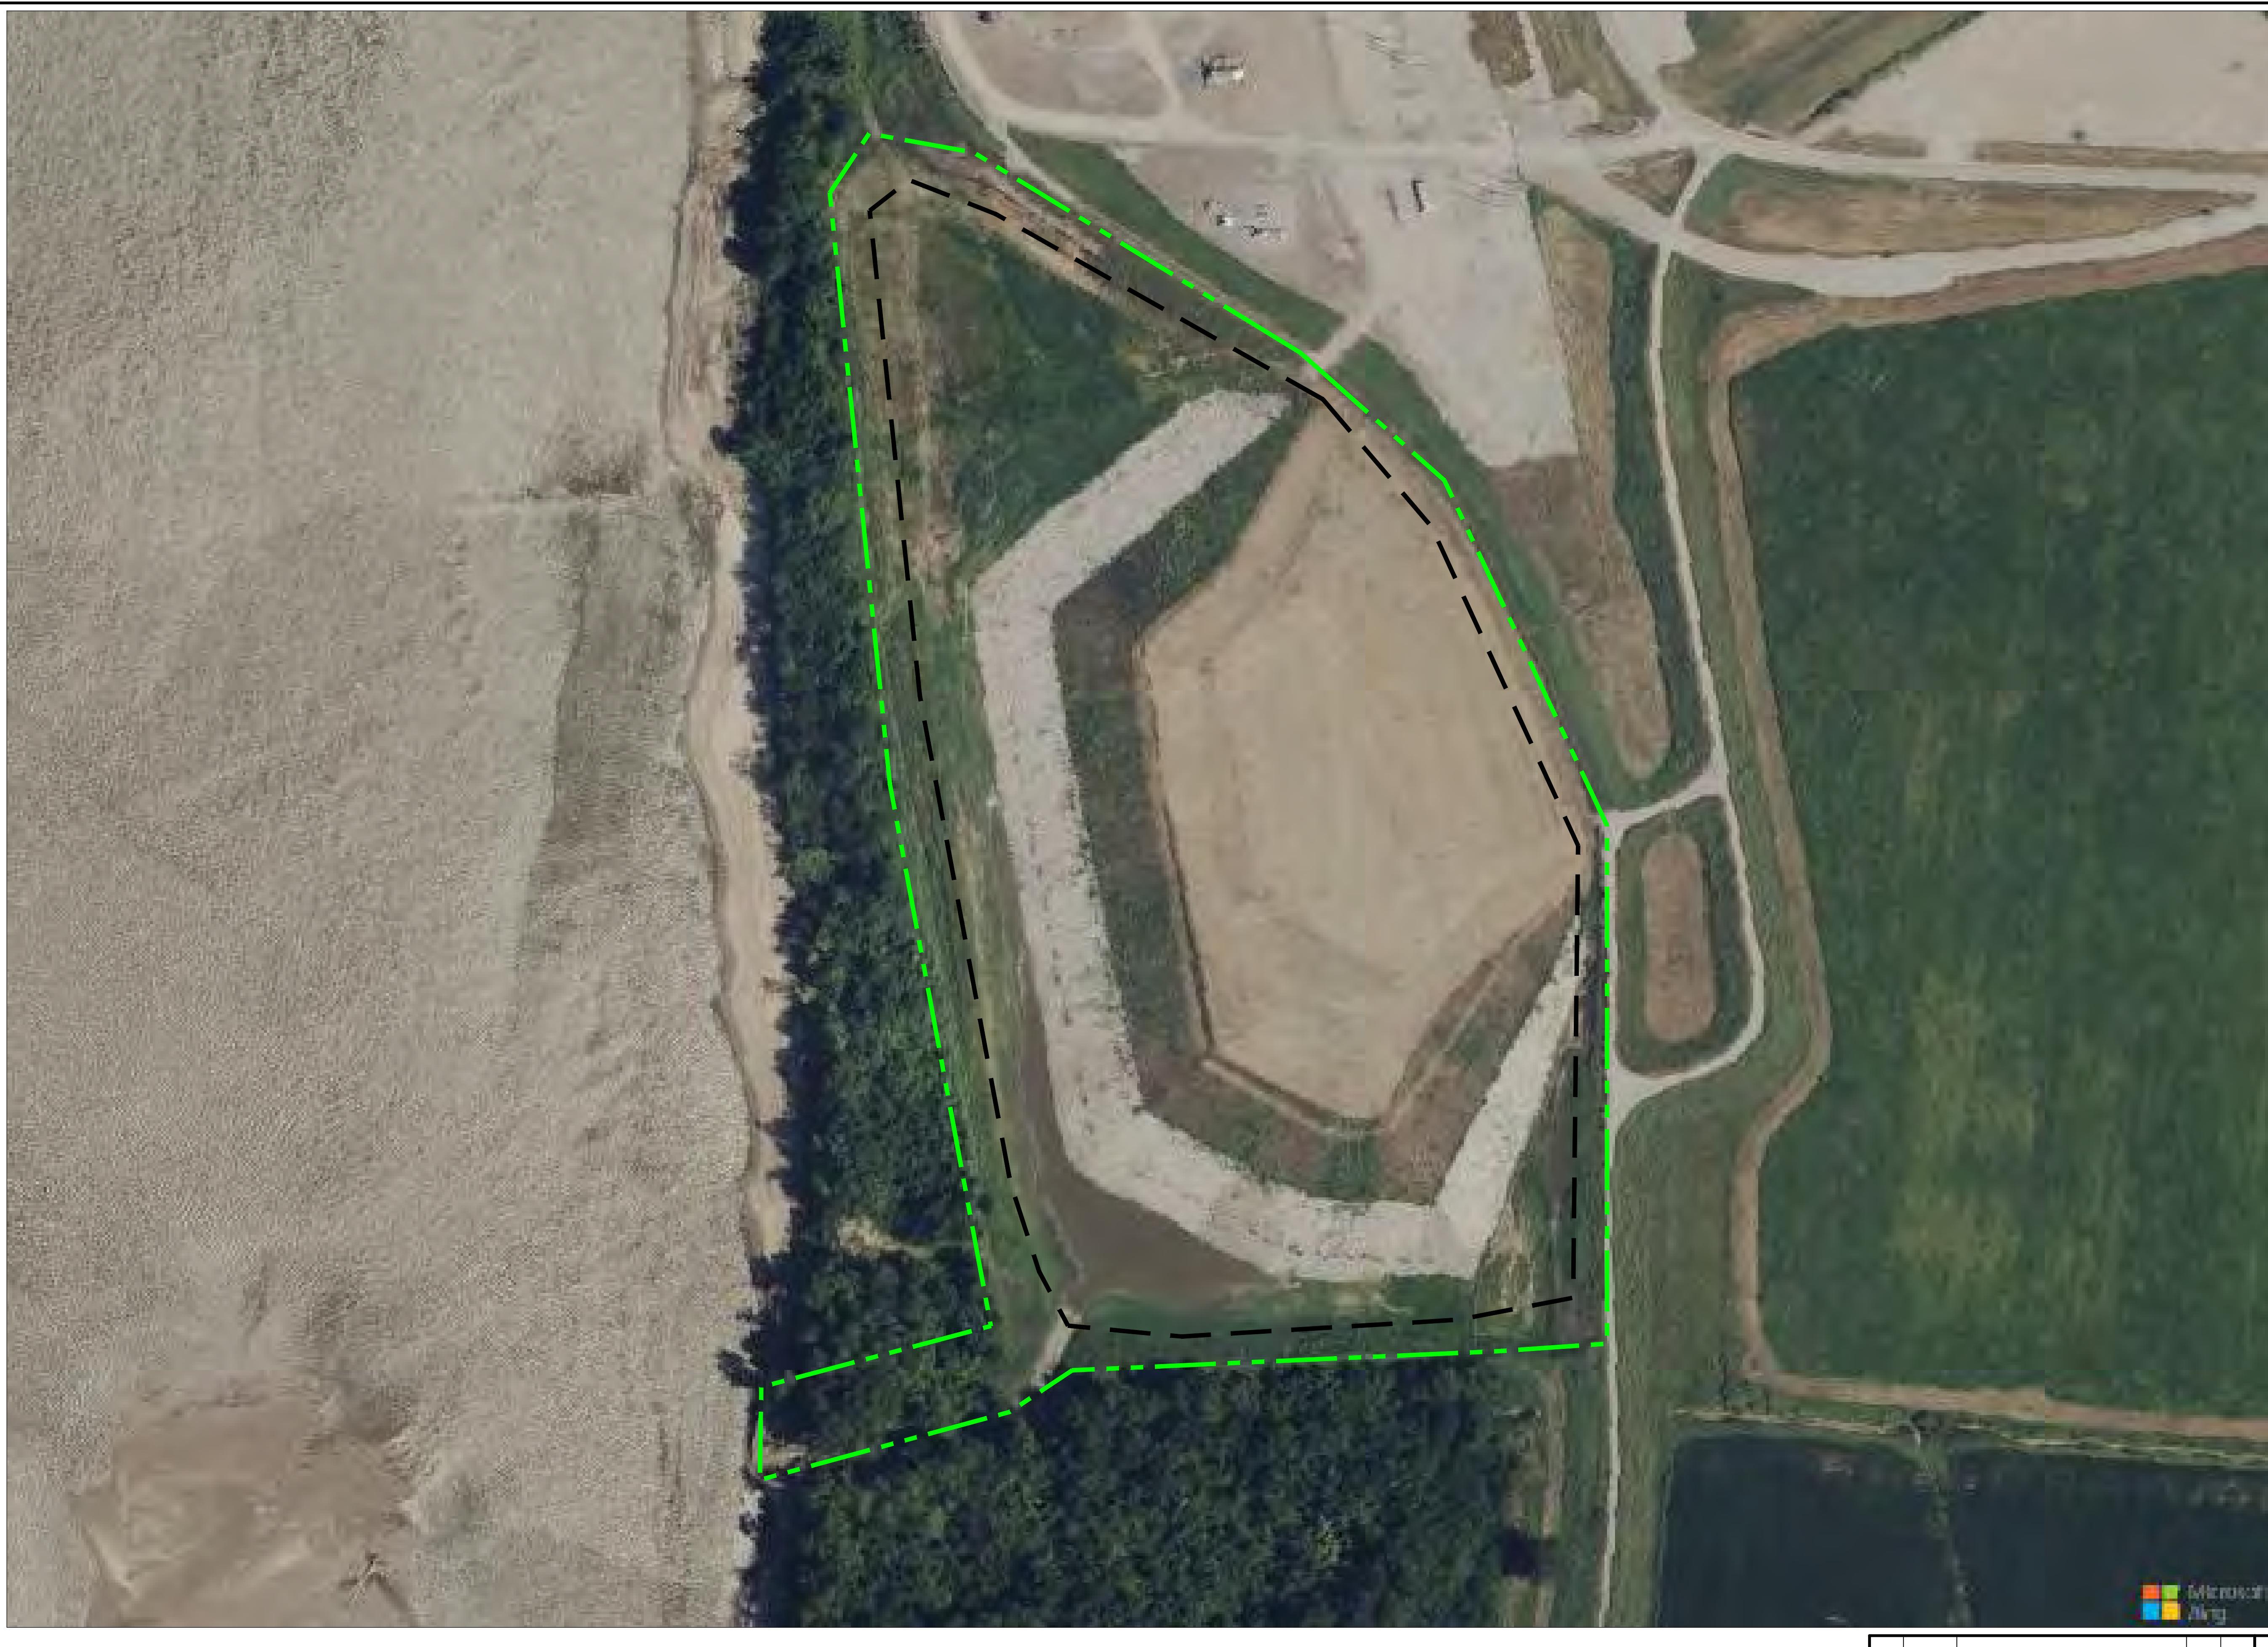
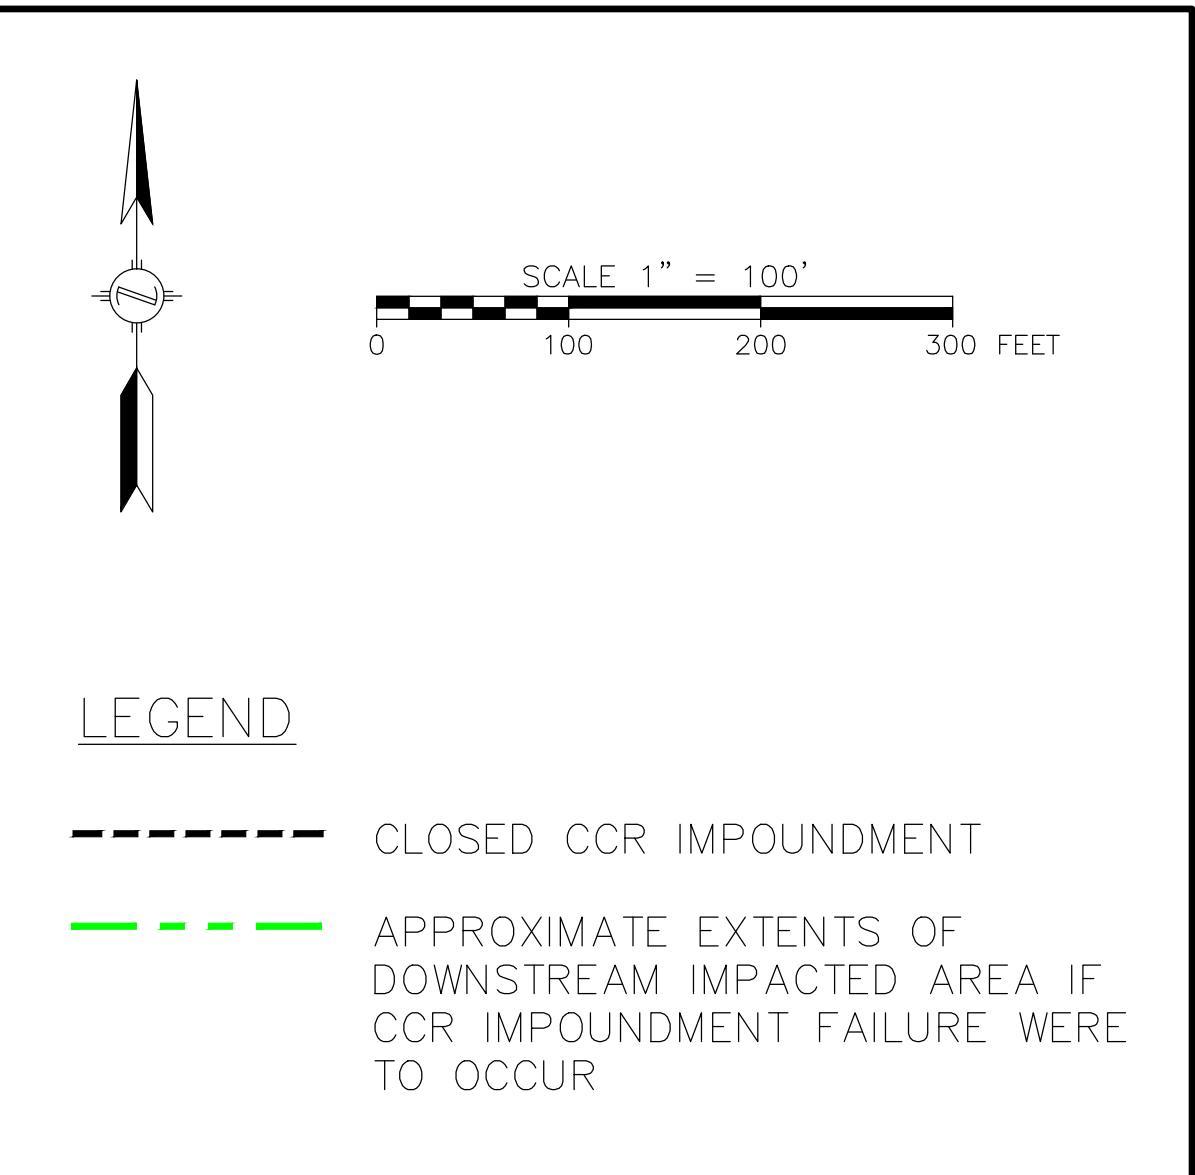
THE GTEC COAL COMBUSTION RESIDUALS (CCR) ASH BASIN WAS CAPPED AND CLOSED IN 2020, AND IS SUBJECT TO USEPA RULE 257 AND IEPA RULE 845, AS APPLICABLE. APPROXIMATELY 235,000 CUBIC YARDS OF CCR ARE PRESENT IN THE CLOSED IMPOUNDMENT. THESE MATERIALS HAVE BEEN EXCAVATED, STOCKPILED, AND COVERED BY A 40-MIL LLDPE LINER, COVER SOIL, AND GEOTEXTILE LINER WHICH COVERS AN 14-ACRE FOOTPRINT WITHIN THE SITE.
